## Kooi LLC

236 North Columbia Avenue  
Columbus, OH 43209

At your request, I performed a visual structural assessment of the residential structure at the above stated address on Thursday May 2, 2024. The structural assessment was requested to review the overall structural integrity of the existing structure. Existing documents were provided for my review. The existing two-story structure was constructed in 1953 and is comprised of conventional wood framing. The roof framing members are wood rafters supported on interior and exterior walls. The floor framing members are 2x10 @ 16"o.c. supported by exterior walls and interior beams and walls. The basement is comprised of CMU foundation walls. There have been several additions added to the original footprint of the structure. The front entrance is located on the north side of the structure and will be the main point of reference.

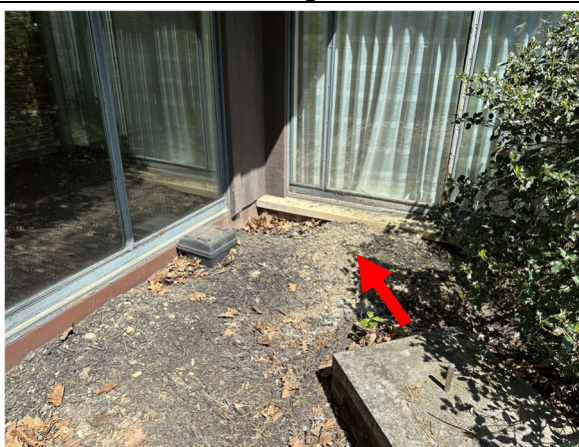
Exterior grade at south side

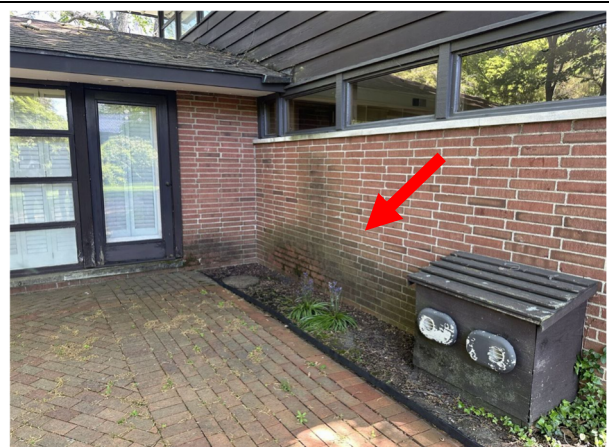
Exterior grade at west side

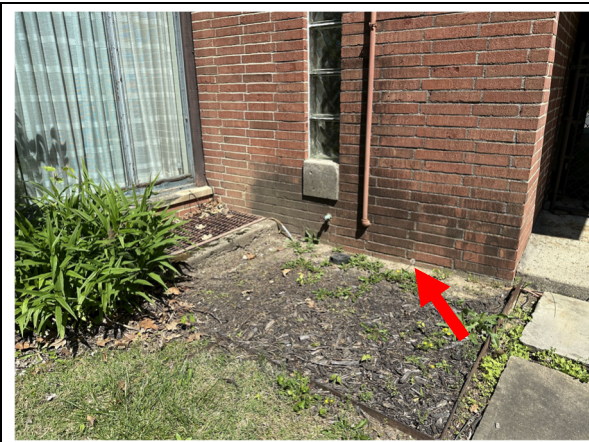
Exterior grade at east side

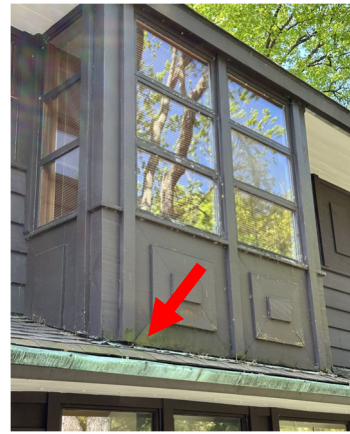
Exterior framing at north low roof

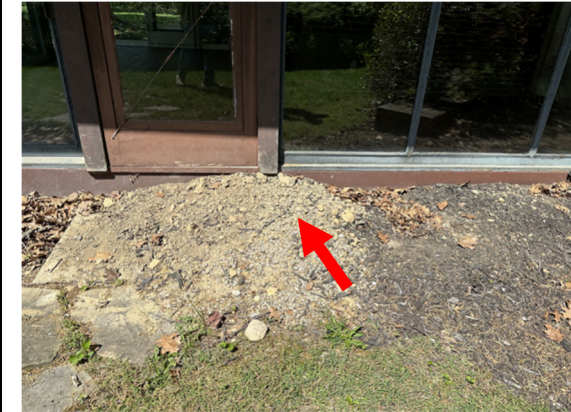
Exterior grade at south side

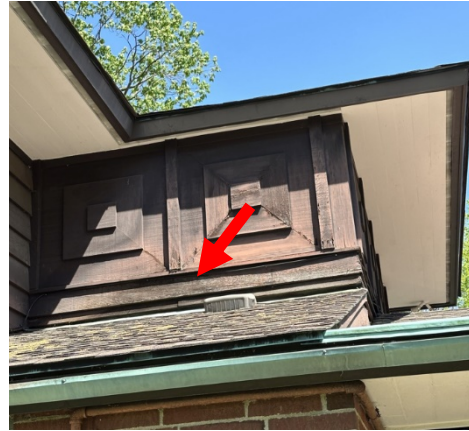
Exterior framing at south low roof

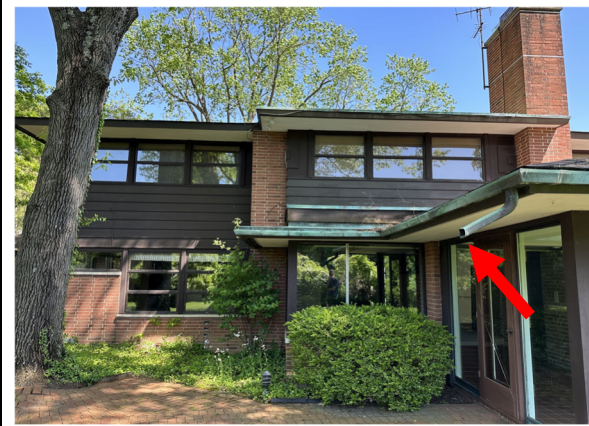
Gutter downspout at south side

- Proper water management will ensure longevity of the structure and minimize the opportunity for water infiltration into the structure. These measures include installing gutters and downspouts as this will lessen the water saturation around the perimeter of the structure at grade.

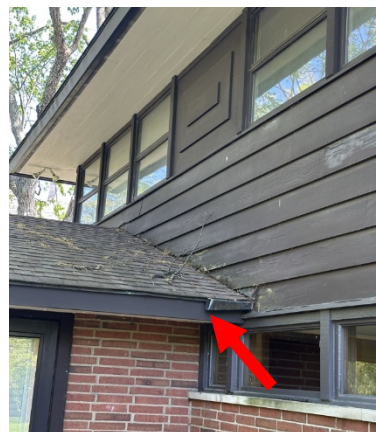
Exterior framing and downspout at west

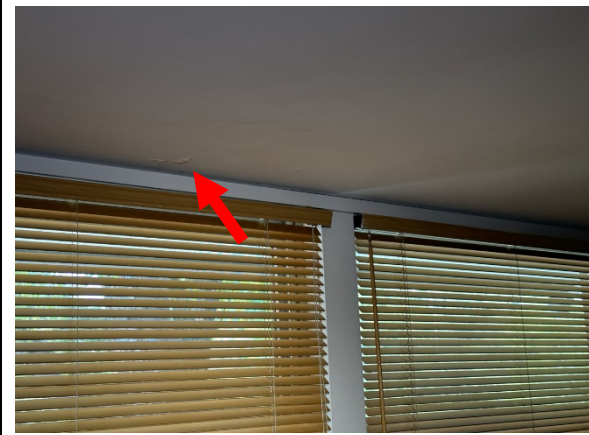
Ceiling patching

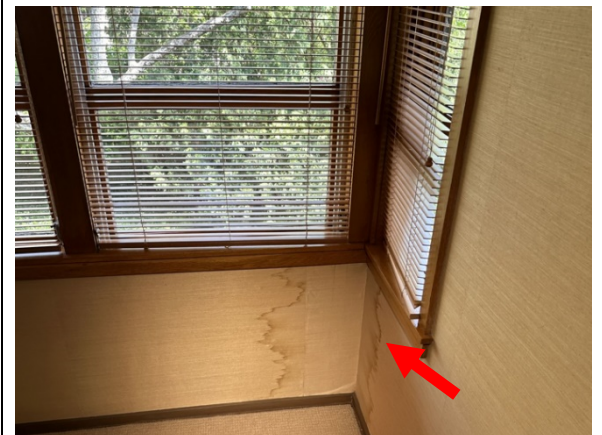
Water infiltration at north side wall / low roof

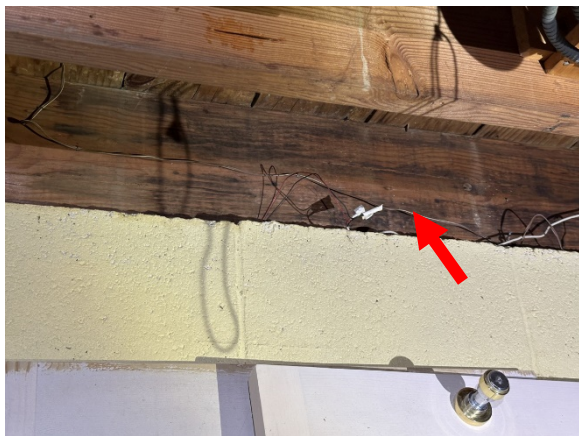
Rim board water infiltration

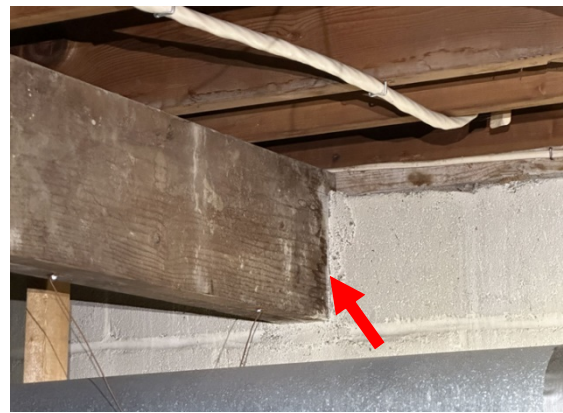
Beam water infiltration at end

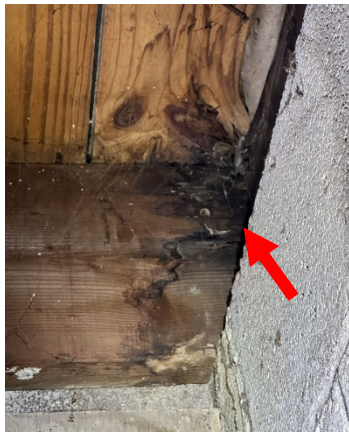
Rim board water infiltration at corner

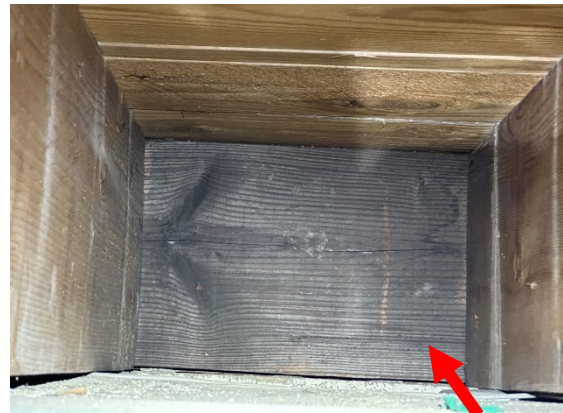
Rim board discoloration

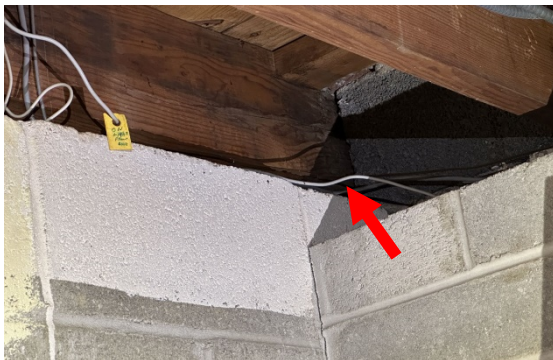
Rim board water infiltration

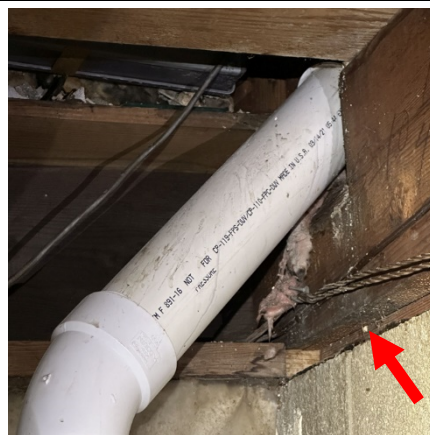
Rim board water infiltration at corner

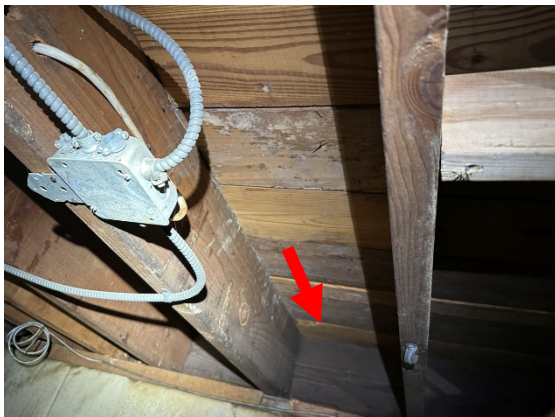
Rim board water infiltration at corner

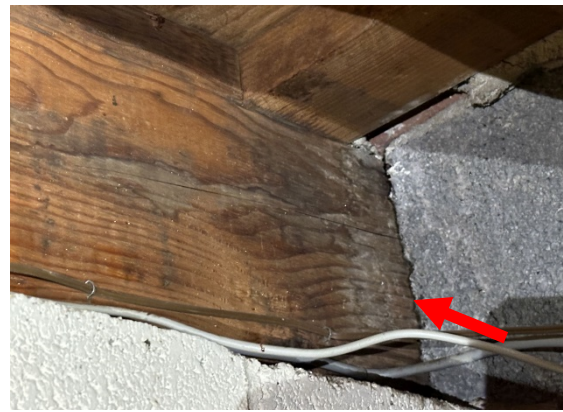
Rim board water infiltration at corner

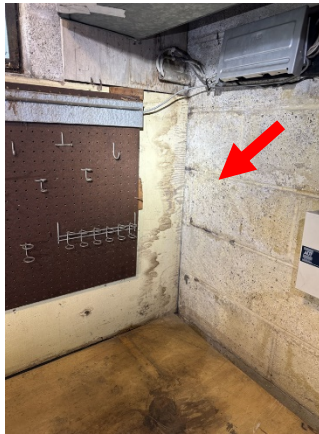
Water infiltration at CMU wall corner

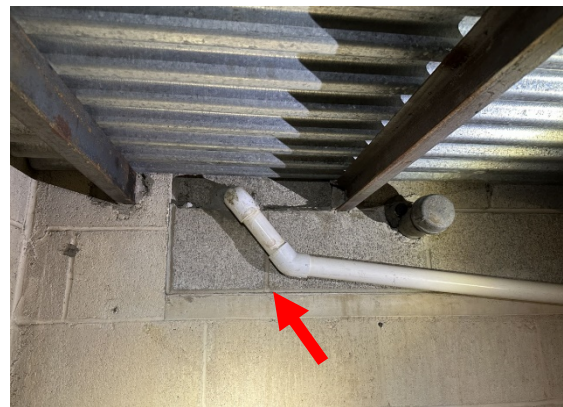
Window well infill and water mitigation framing

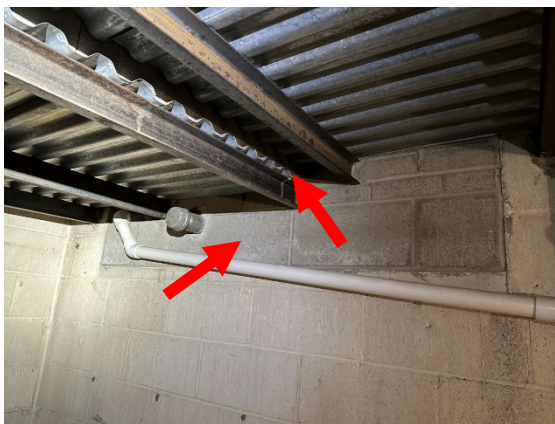
Window well infill and water mitigation framing

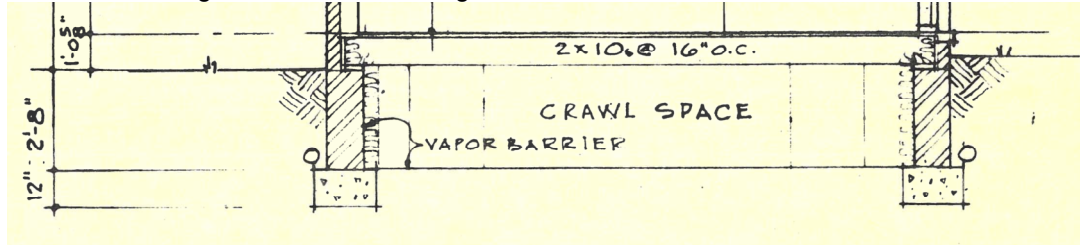
- Based on the existing construction documents, the grade is above the bottom sole plate of the wood framing as shown in the image below:

Based on my observations, this condition is prevalent around most of the perimeter of the structure. Without proper water management and precautionary measures, this detail will compromise the wood structure over time due to water infiltration. The photos that were taken are from the visible interior portion of the perimeter, however no access was available to inspect the brick to framing cavity. Water at grade would saturate the brick façade and the wood framing would absorb the moisture over time. The moisture will deteriorate the wood components and compromise the structural integrity of the exterior wall load bearing system. Without intervention, the structural integrity will be compromised, and the risk of failure would increase.

- Common practice and current building codes require the wood framed structure to be fully above the adjacent grade with an additional buffer to avoid any moisture infiltration via the sole plate or rim board.

- Below are several ways to address the water damaged structural components:
  1. Raise the entire structure to be above current grade and in compliance with building codes and replace all water damaged wood framing. This method would require every load bearing component and brick façade to be shored and jacked simultaneously. There is no guarantee that any of the brick façade would remain in place and the likelihood of the brick being compromised would be high. In my experience, rectangular houses have been raised off the foundation. This house contains many intricacies due to geometry and brick locations including a centrally located full height chimney. This option would require a very specialized contractor who is willing to accept the high risks associated with this work.

2. Lower the grade around the entire structure and throughout the property and replace all water damaged wood framing. This option to lower the grade may not be feasible due to adjacent lots that are at similar elevations. If the grade is lower surrounding the structure, then negative drainage may occur therefore bringing more water from surrounding areas, including adjacent lots, to this structure's basement and foundation. If proper drainage is achievable, the next topic to review would be the surrounding vegetation and trees. By lowering the grade, it will likely adversely impact the tree root system. Further consultations by a civil engineer for drainage and grading, and an arborist for tree and vegetation management would be required to further explore this option.

3. Selective replacement the water damaged wood framing. This would require partial temporary shoring of the exterior wall and replacing the wood components. This would not be a permanent fix as it will not address water infiltration, however it would decrease the likelihood of a structural failure. This is a temporary solution and not recommended for long term usage.

4. Complete removal of the structure and replacement with a new code compliant structure that has proper water management measures in place.
