June 29, 2020

Subject: Merkle Residence Fire Damage

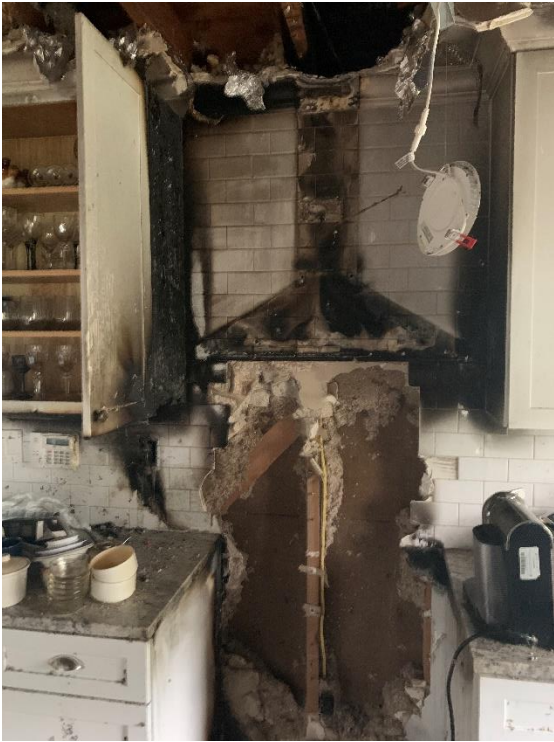
The fire was caused by a falling tree hitting the power lines feeding the single-family home. The fire appeared to have originated at the electrical outlet serving the stove. Most of the fire activity was in the kitchen and ceiling above. The electric above kitchen ceiling was damaged as well as the wood joists and roof framing above. Smoke damage was observed throughout the home.

Figure 1. Kitchen Stove Area Fire Damage

Rebuilding would require demolition, rehab, and new work to the structural, mechanical, and electrical systems. This would include the replacement of wood joists, roof framing, and roofing materials on the main level, repairing/replacing the electrical system, and testing/repairing the HVAC system where contaminated and damaged. Due to smoke, water damage, mold, and odor build-up there would also be extensive work to replace many of the finishes throughout the house including water-damaged sheetwork, smoke stains, and soot residue in various areas of the house.

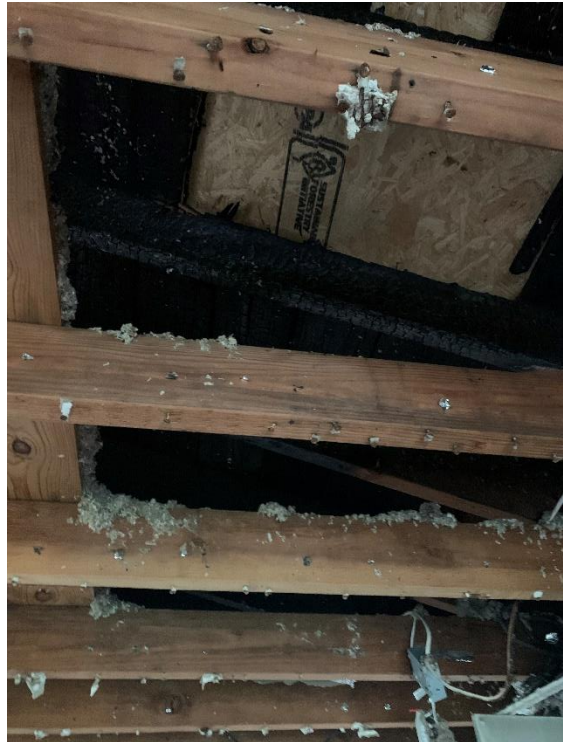
Figure 2. Kitchen Fire Damaged Roof Trusses

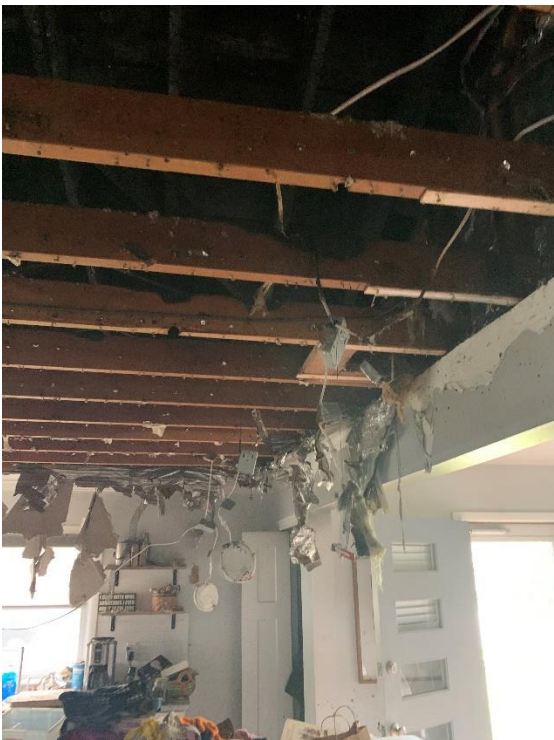
Figure 3. Kitchen Fire Damaged Roof Trusses

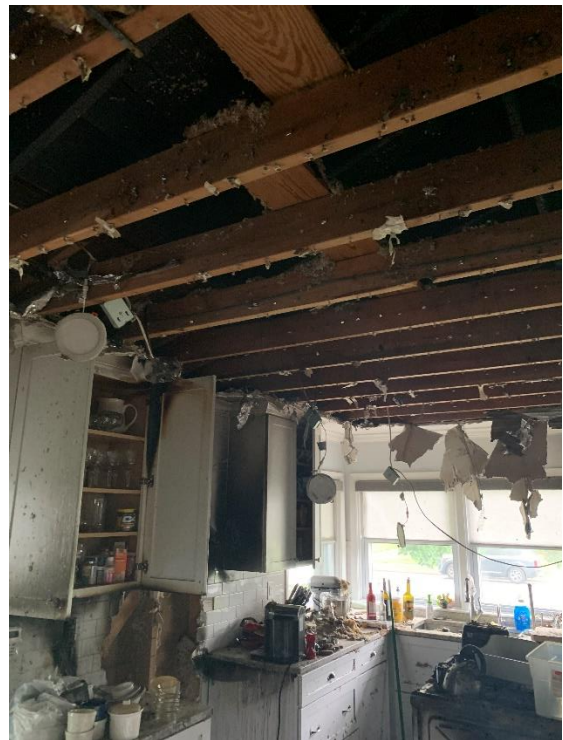
Figure 4. Kitchen Fire Damaged Roof Trusses
