Kooi LLC

236 North Columbia Avenue
Columbus, OH 43209

At your request, I performed a visual structural assessment of the residential structure at the above stated address on Thursday May 2, 2024. The structural assessment was requested to review the overall structural integrity of the existing structure. Existing documents were provided for my review. The existing two-story structure was constructed in 1953 and is comprised of conventional wood framing. The roof framing members are wood rafters supported on interior and exterior walls. The floor framing members are 2x10 @ 16"o.c. supported by exterior walls and interior beams and walls. The basement is comprised of CMU foundation walls. There have been several additions added to the original footprint of the structure. The front entrance is located on the north side of the structure and will be the main point of reference.

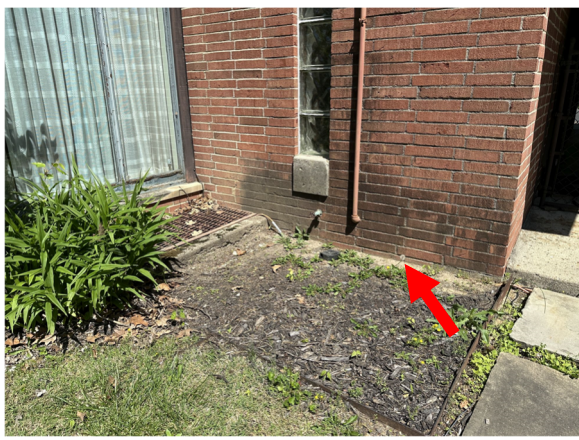
Exterior grade at east side

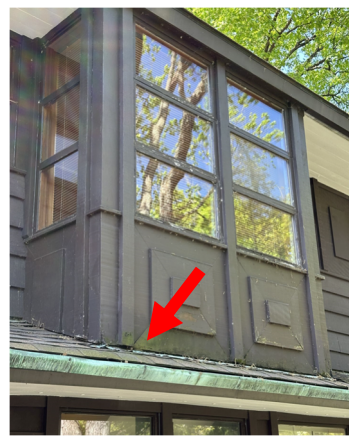
Exterior framing at north low roof

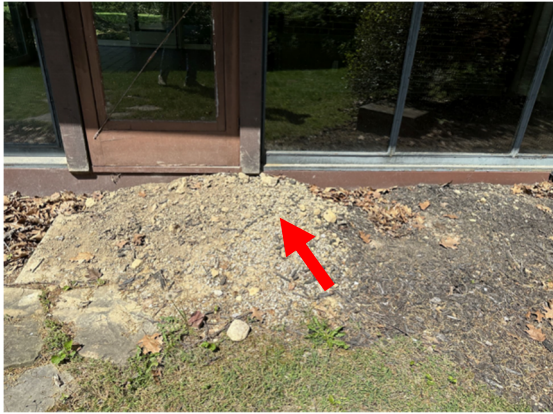
Exterior grade at south side

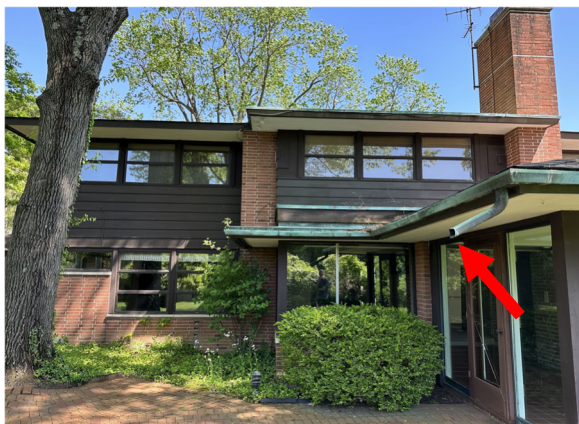
Gutter downspout at south side

- Proper water management will ensure longevity of the structure and minimize the opportunity for water infiltration into the structure. These measures include installing gutters and downspouts as this will lessen the water saturation around the perimeter of the structure at grade.

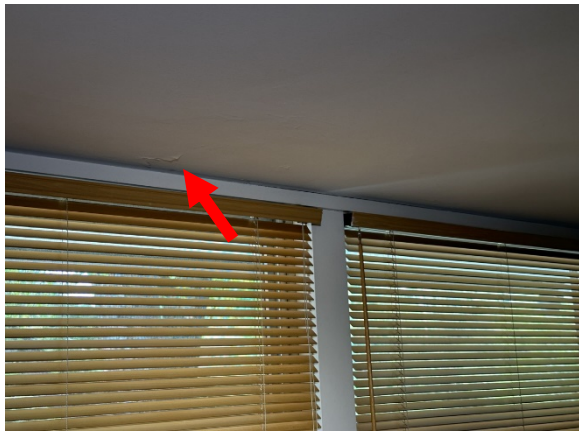
Ceiling patching

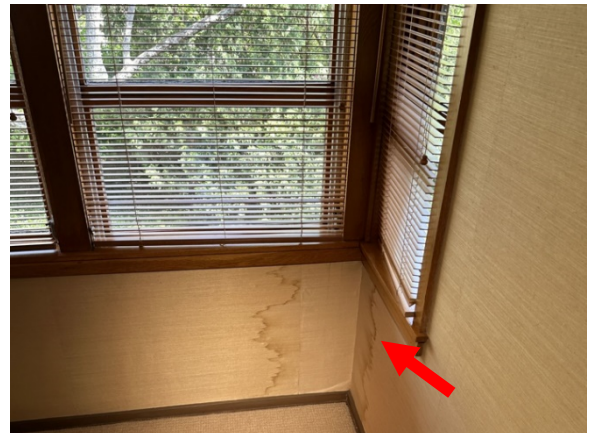
Water infiltration at north side wall / low roof

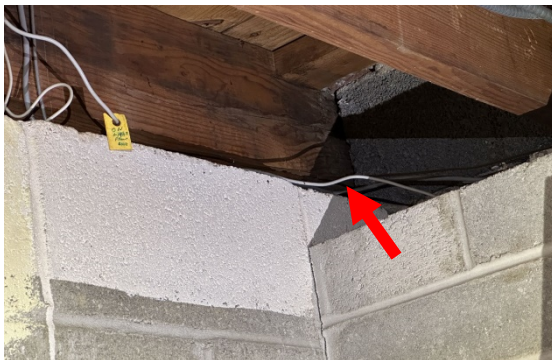
Rim board water infiltration

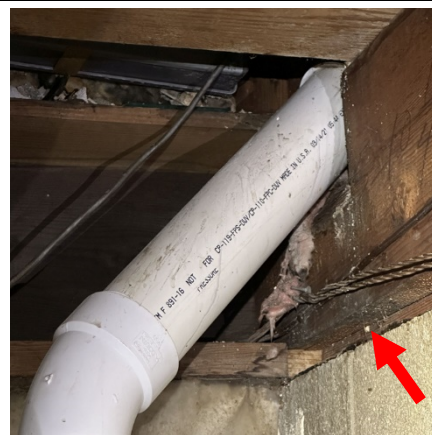
Rim board water infiltration at corner

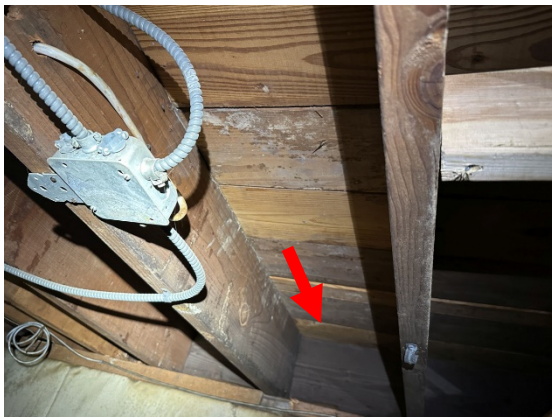
Rim board water infiltration at corner

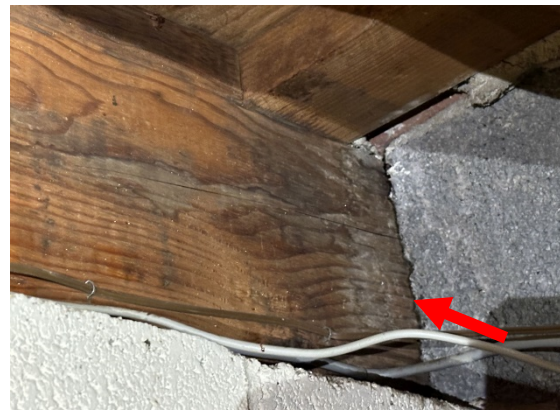
Rim board water infiltration at corner

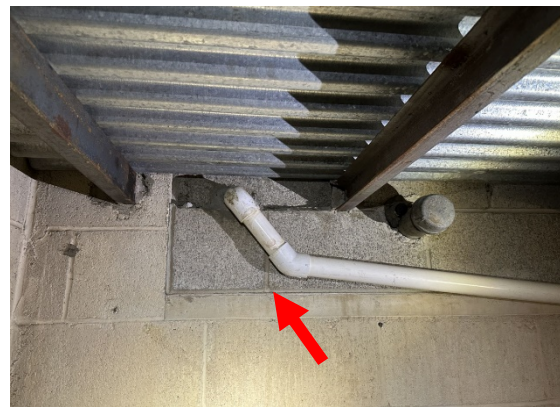
Window well infill and water mitigation framing

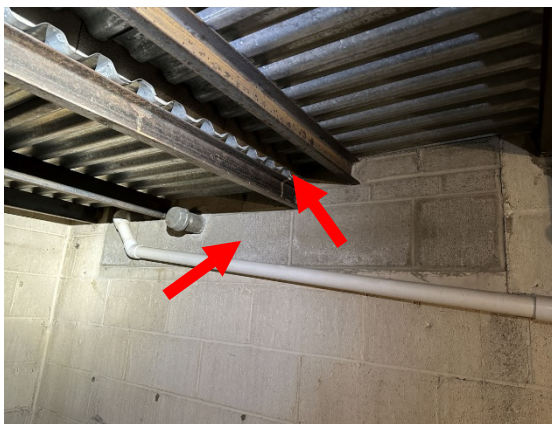
Window well infill and water mitigation framing

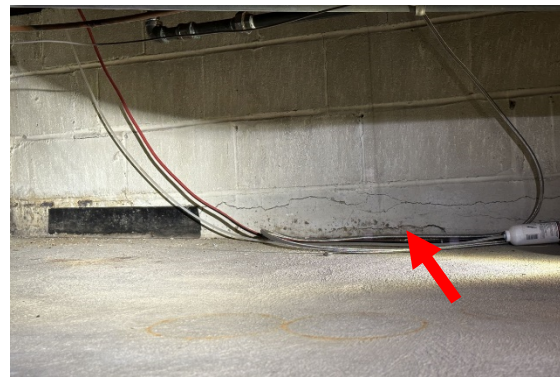
Concrete lintel cracks due to internal corrosion

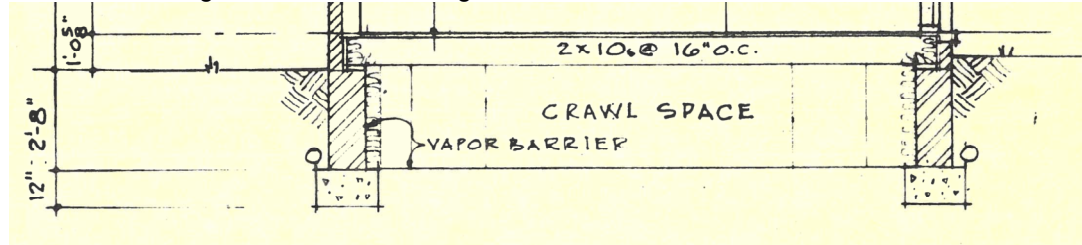
- Based on the existing construction documents, the grade is above the bottom sole plate of the wood framing as shown in the image below:

Based on my observations, this condition is prevalent around most of the perimeter of the structure. Without proper water management and precautionary measures, this detail will compromise the wood structure over time due to water infiltration. The photos that were taken are from the visible interior portion of the perimeter, however no access was available to inspect the brick to framing cavity. Water at grade would saturate the brick façade and the wood framing would absorb the moisture over time. The moisture will deteriorate the wood components and compromise the structural integrity of the exterior wall load bearing system. Without intervention, the structural integrity will be compromised, and the risk of failure would increase.

- Common practice and current building codes require the wood framed structure to be fully above the adjacent grade with an additional buffer to avoid any moisture infiltration via the sole plate or rim board.

- Below are several ways to address the water damaged structural components:
 1. Raise the entire structure to be above current grade and in compliance with building codes and replace all water damaged wood framing. This method would require every load bearing component and brick façade to be shored and jacked simultaneously. There is no guarantee that any of the brick façade would remain in place and the likelihood of the brick being compromised would be high. In my experience, rectangular houses have been raised off the foundation. This house contains many intricacies due to geometry and brick locations including a centrally located full height chimney. This option would require a very specialized contractor who is willing to accept the high risks associated with this work.

2. Lower the grade around the entire structure and throughout the property and replace all water damaged wood framing. This option to lower the grade may not be feasible due to adjacent lots that are at similar elevations. If the grade is lower surrounding the structure, then negative drainage may occur therefore bringing more water from surrounding areas, including adjacent lots, to this structure's basement and foundation. If proper drainage is achievable, the next topic to review would be the surrounding vegetation and trees. By lowering the grade, it will likely adversely impact the tree root system. Further consultations by a civil engineer for drainage and grading, and an arborist for tree and vegetation management would be required to further explore this option.

3. Selective replacement the water damaged wood framing. This would require partial temporary shoring of the exterior wall and replacing the wood components. This would not be a permanent fix as it will not address water infiltration, however it would decrease the likelihood of a structural failure. This is a temporary solution and not recommended for long term usage.

4. Complete removal of the structure and replacement with a new code compliant structure that has proper water management measures in place.
