CITY OF BEXLEY, OHIO

FINAL OEPA SUMMARY OF
SANITARY SEWER EVALUATION SURVEY FINDINGS
AND IMPLEMENTATION SCHEDULE

February 11, 2014

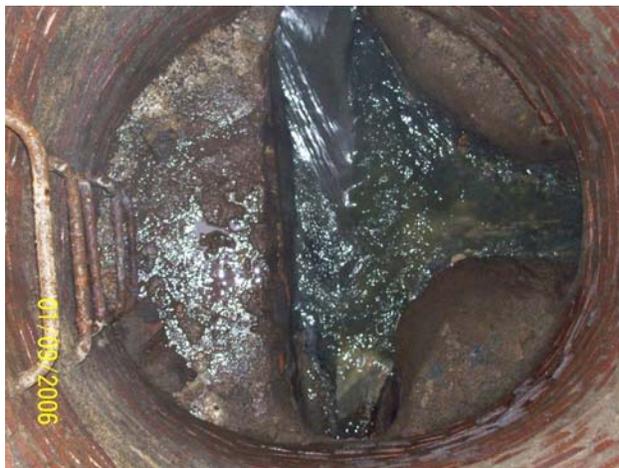
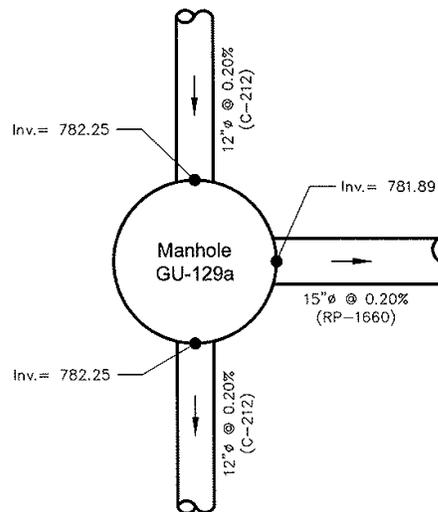
Figure 3-1: Denver Avenue Cross-Connection Configuration

The Denver Avenue cross-connection is located in Manhole GU-129a. **Figure 3-1** illustrates the configuration of the connection. This manhole was constructed in 1956, 26 years after the 12-in Gould Road Trunk Sewer was built for the purpose of connecting a 15-in pipe to relieve flow to Columbus. The flow entering the manhole can either exit through the 15-in pipe to Columbus (east) or through the 12-in pipe to Bexley (south).

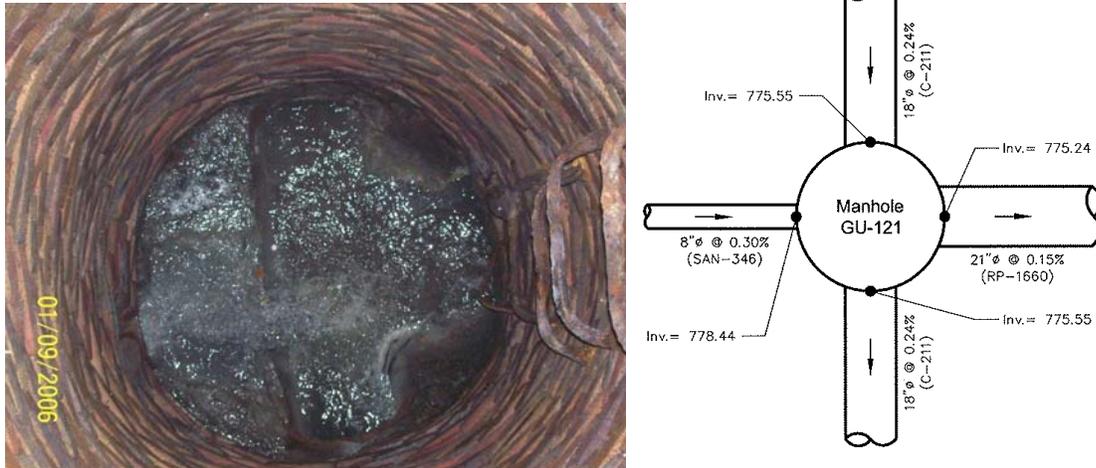
Figure 3-2: Powell Avenue Cross-Connection Configuration

The Powell Avenue cross-connection is located in Manhole GU-121. **Figure 3-2** illustrates the configuration of the connection. The 18-in Gould Road Trunk Sewer, built around 1930, flows into the manhole from the north and exits to the south. An 8-in sewer from the west, serving the Powell Avenue Sub-Area, also drops into this manhole. In 1956, a 21-in relief pipe was connected to manhole so that flow entering the manhole can continue flowing south in the trunk sewer or flow to the east through the 21-in City of Columbus sewer line.

The 8-in pipe in Powell Avenue discharging to Manhole GU-121 of the Gould Road Trunk Sewer, where the Powell Avenue cross-connection exists, appears to be affected by backwater conditions. The flow monitoring data shows that the depth jumps when the flow exceeds 0.20 cfs. Despite the backwater conditions, the depth did not exceed 6-in during any of the rainfall events. Possible explanations for the backwater condition include sagging, broken or collapsed pipe and the malfunction of the outside drop at the Powell Avenue cross-connection.

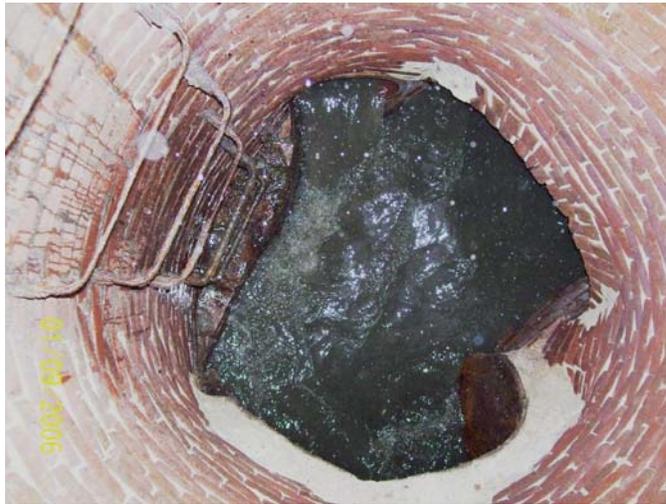
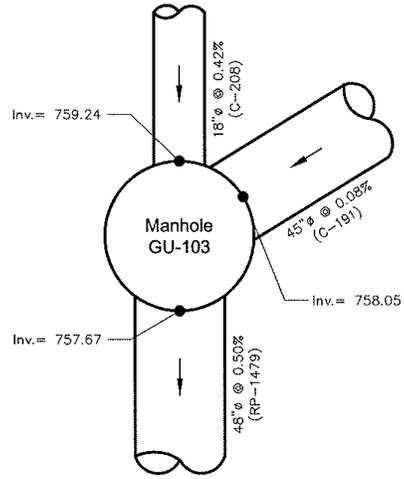
Figure 3-3: Charles Street Cross-Connection Configuration

The Charles Street cross-connection is located in Manhole GU-103. At this manhole, the 18-in Gould Road Trunk Sewer combines with the 45-in Truro #1 Subtrunk serving the Charles Street Sub-Area. Both of these sewers were constructed around 1930. Originally, the flow from both sewers was conveyed south through a 36-in pipe. However, the 36-in pipe was abandoned in 1955 and replaced with the current 48-in pipe. **Figure 3-3** illustrates the configuration of the connection.

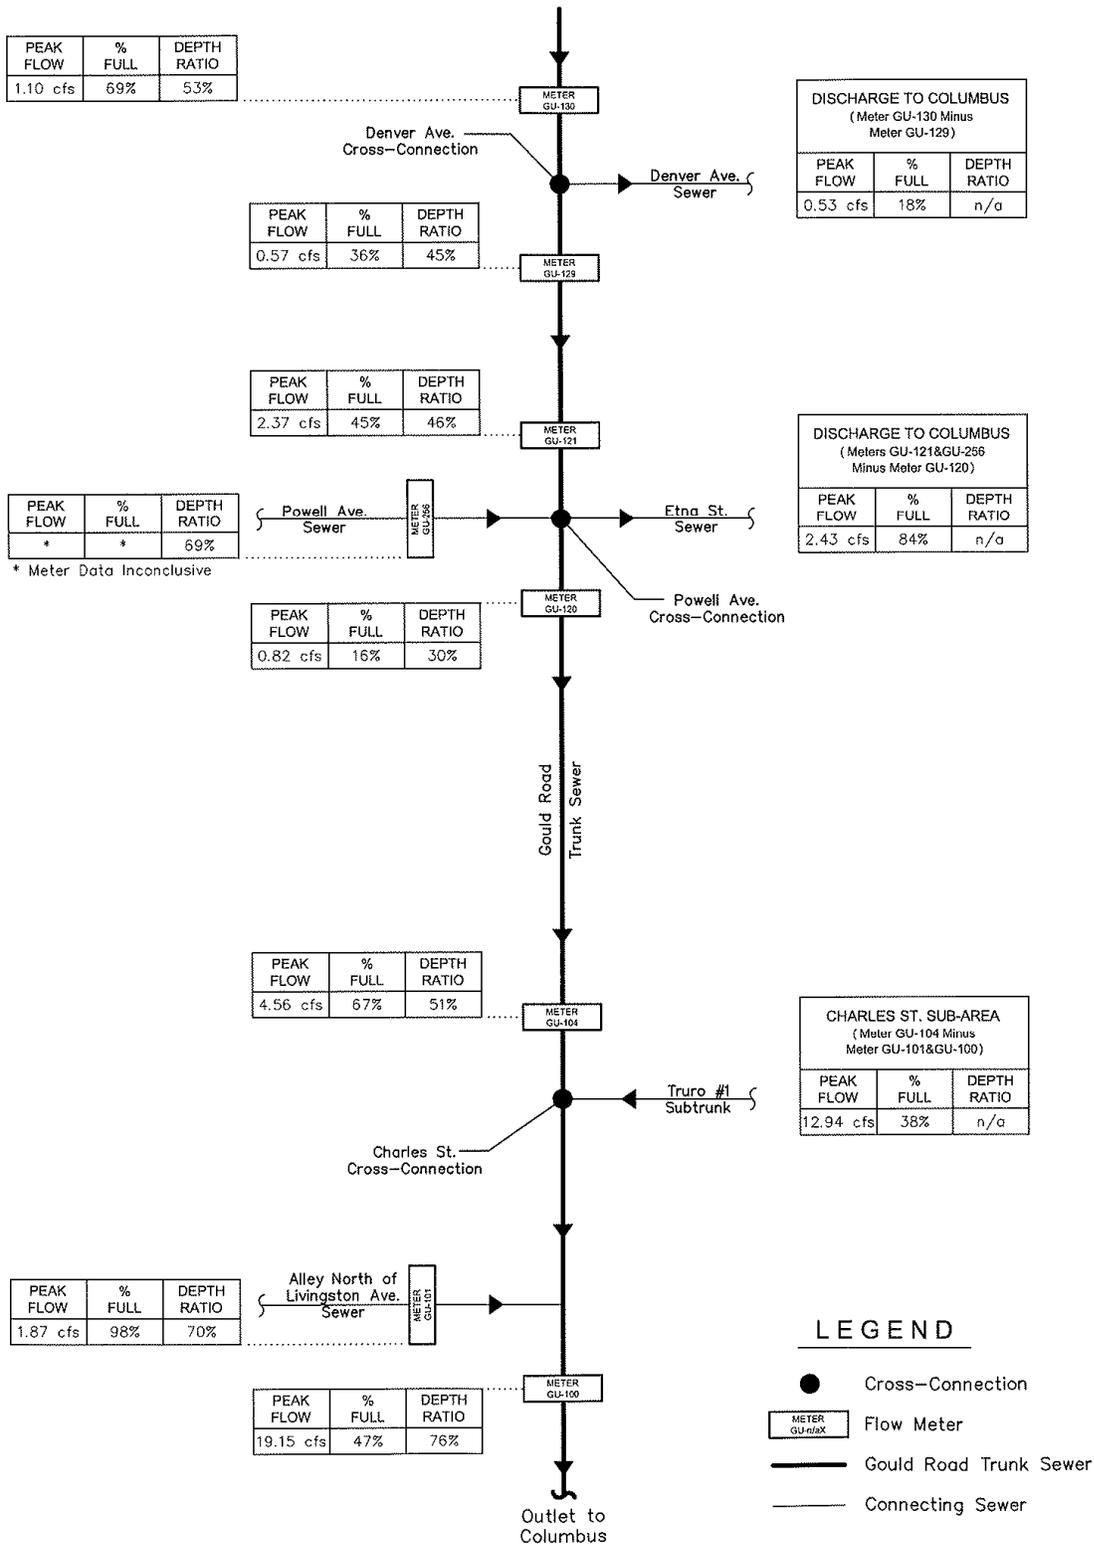
Figure 4-2: Gould Road Wet Weather Performance Overview

Figure 4-2 presents an overview of the wet weather performance by illustrating the peak flow, percent full and depth ratio within the system for the largest rainfall event, which occurred on July 27, 2007. The system reached 45% to 65% of its capacity and appears to be operating under normal conditions.

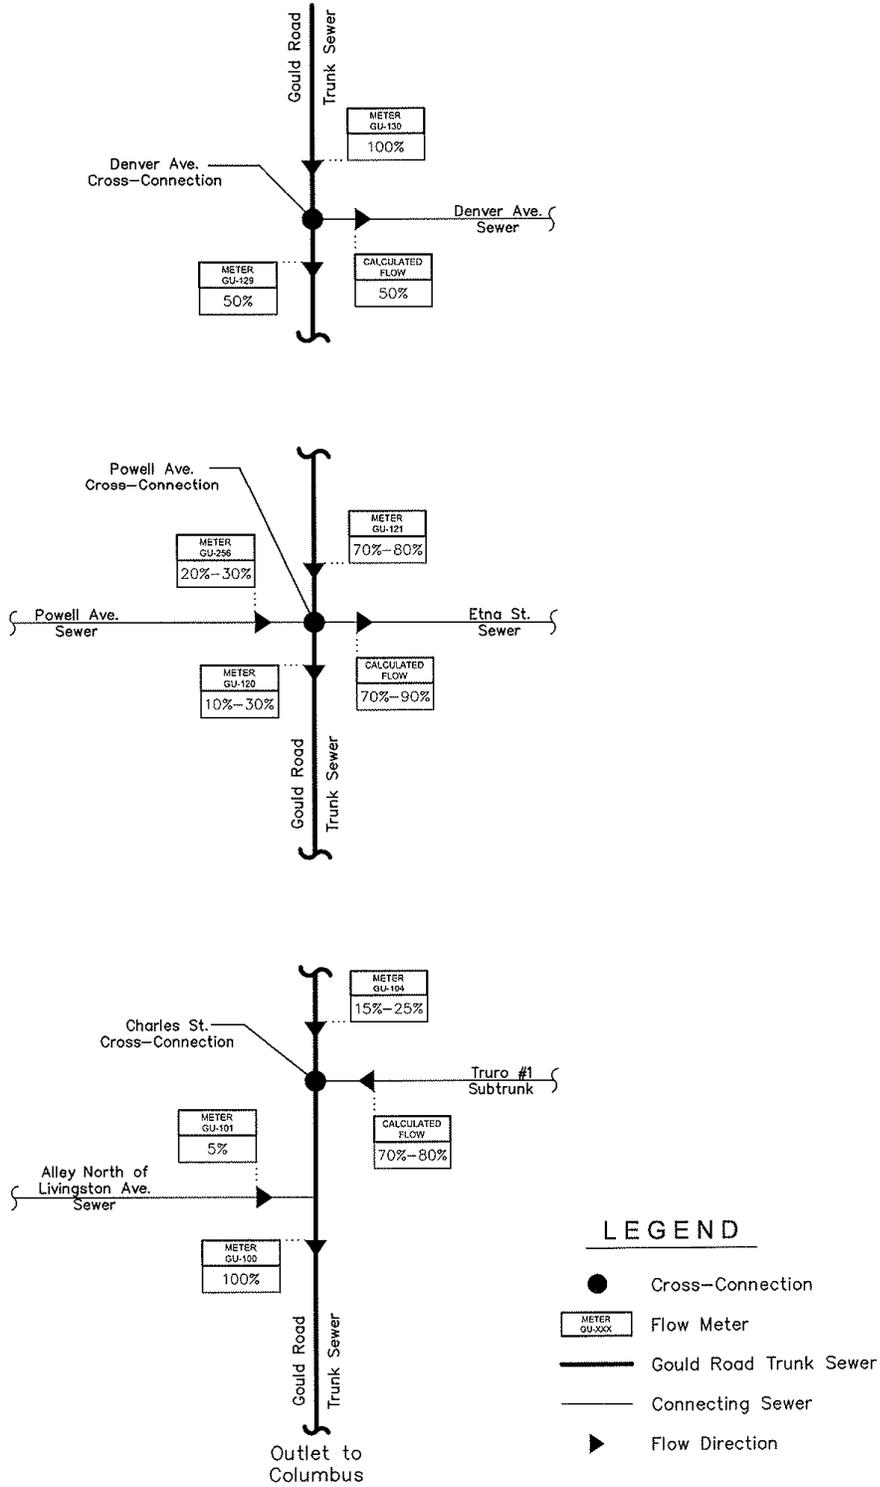
Figure 4-3: Cross-Connection Performance Wet Weather Flow Balance

The Charles Street cross-connection is where the Gould Road Trunk Sewer serving the City of Bexley joins with the Truro #1 Subtrunk serving the City of Columbus. One flow meter is located upstream (Meter GU-104) of the cross-connection and two meters are located downstream. The downstream meters are located at the outlet to the City of Columbus (Meter GU-100) and at the 12-in sewer conveying flow from the Livingston Avenue Sub-Area into the Gould Road Trunk Sewer at the alley north of Livingston Avenue (Meter GU-101). The flow from the two downstream meters can be subtracted from the flow upstream to estimate the flow entering the system from the City of Columbus at the Charles Street cross-connection (Meter GU-104 minus Meters GU-100 and GU-101). This calculated flow from Columbus at the Charles Street will also include a small amount of flow discharging to the Gould Road Trunk Sewer from a 15-in sewer to the east located in the alley north of Livingston Avenue.

From the observed flow monitoring data, it is estimated that the Bexley collection system contributes only 20%-30% of the flow discharging to Columbus at the outlet. The 45-in Truro #1 Subtrunk flowing into the Charles Street cross-connection accounts for approximately 70%-80% of the total flow at the outlet to the City of Columbus at Livingston Avenue.

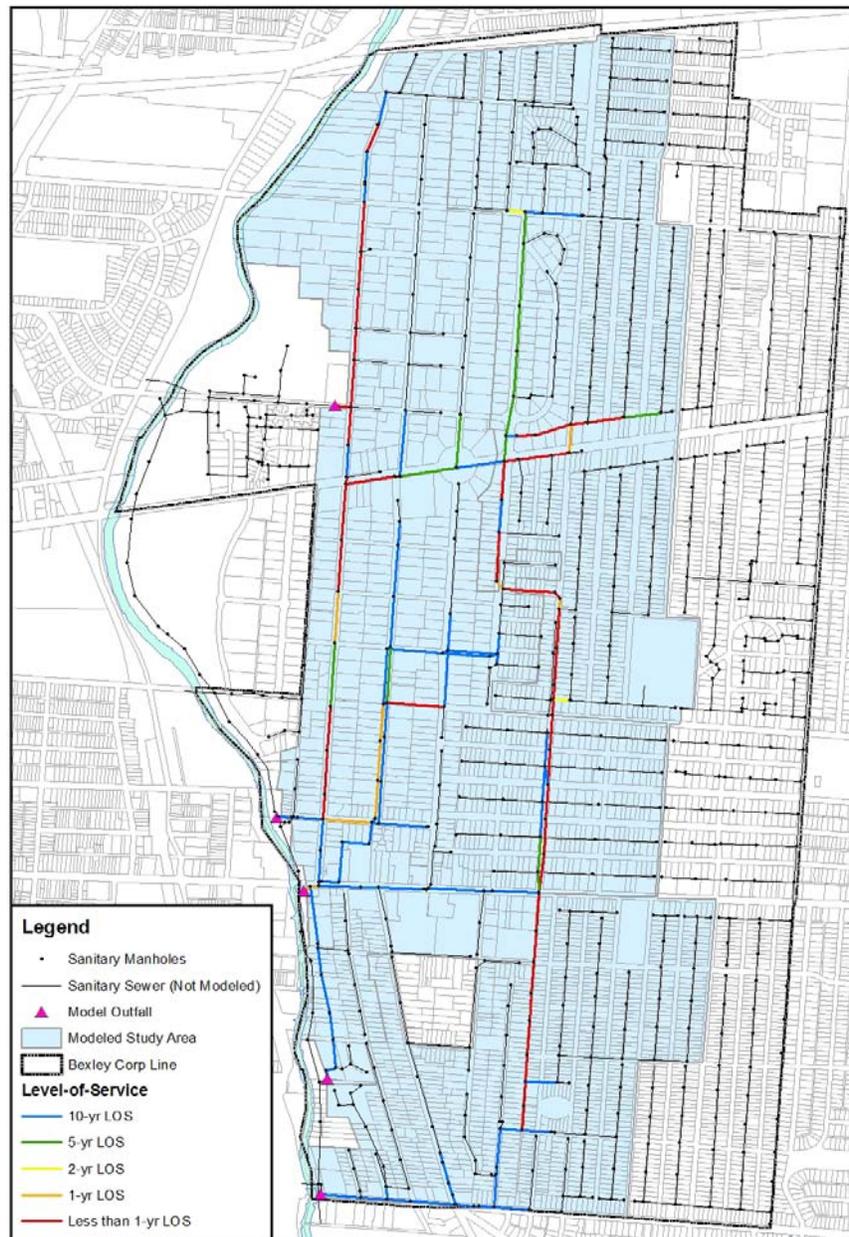
Figure 5-6: Existing Level of Service

The existing system was evaluated with various design storms to determine where the capacity issues in the system are located and at what LOS the system can achieve. (The LOS is described in Section 2.5.) **Figure 5-6** illustrates the segments that have capacity issues and their expected LOS.

There are three specific areas that show major capacity issues in the model and are as follows:

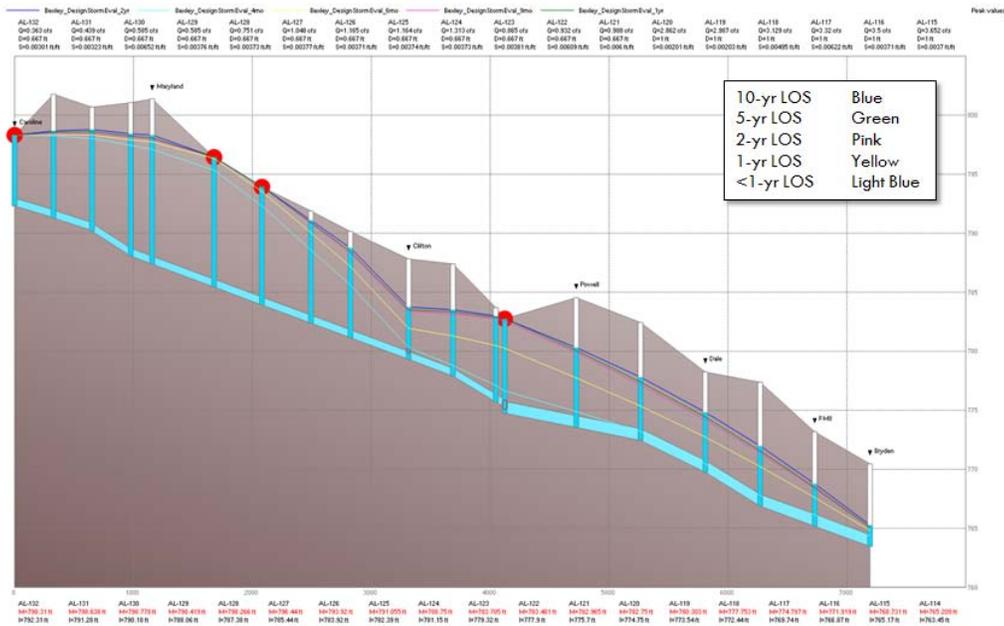
Figure 5-7: Hydraulic Profile of Parkview Avenue Sewer for Existing Conditions

- Parkview Ave. (Bryden Rd. to Caroline Ave.)** – This reach of sewer is a 12-inch pipe from Bryden Rd. to Broad St. and an 8-inch pipe from Broad St. to Caroline Ave. The area tributary to the sewer is among the highest RDII areas in the system and consumes the system capacity quickly. The sewer experiences high surcharge and backup, which activates a relief connection at Clifton Avenue and has potential for water-in-basements or flooding at low-lying manholes. A profile of the maximum hydraulic grade line for each LOS is shown in **Figure 5-7**.

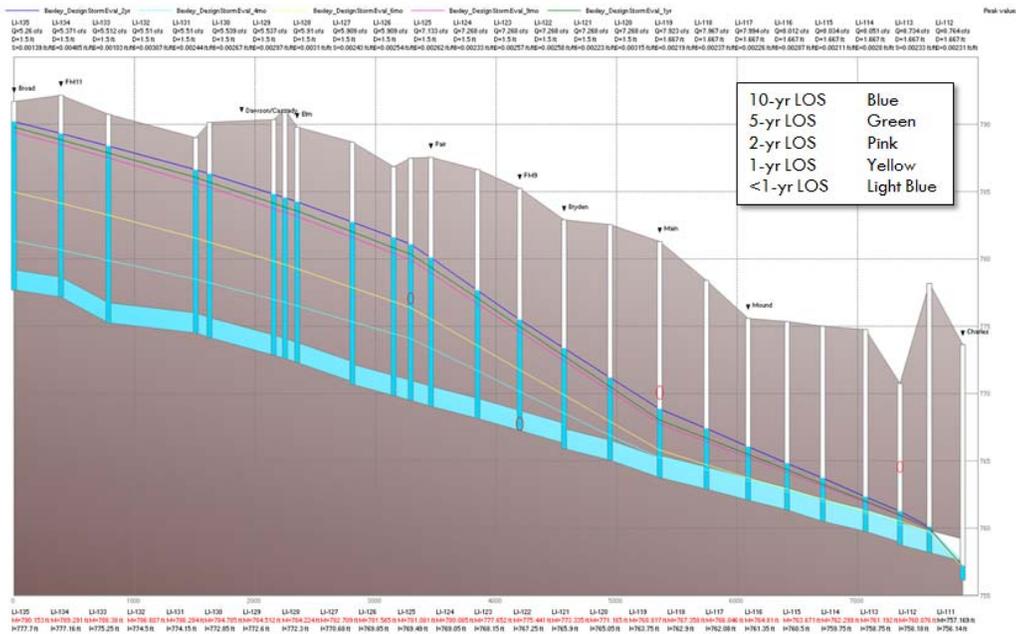
Figure 5-8: Hydraulic Profile of Cassidy & Dawson Avenue Sewer for Existing Conditions

- Cassady Ave. & Dawson Ave. (Charles St. to Broad St.)** – This reach of sewer is an 18-inch to 20-inch pipe, which discharges into a 36-inch pipe. The sewer is deep and runs parallel to and below a large storm trunk sewer. Problems may arise at the 2-year LOS when the HGL comes within five feet of the ground elevation. A profile of the maximum hydraulic grade line for each LOS is shown in **Figure 5-8**.

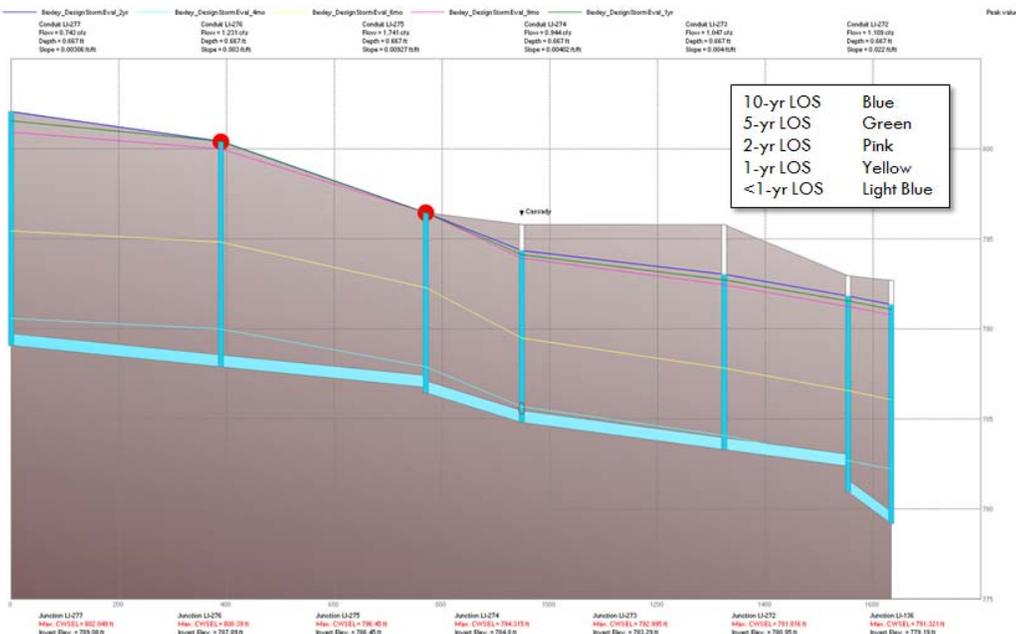
Figure 5-9: Hydraulic Profile of Alley n/o Broad St. for Existing Conditions

- Alley north of Broad St. (Stanberry Ave. to Cassingham Ave.)** – This reach of sewer is an 8-inch pipe which has capacity problems due to high RDII and backwater from the 18-inch sewer in Dawson Avenue. The sewer splits at Cassady Avenue and flows south to Broad Street which provides some relief. There is potential for WIBs and manhole flooding at the 2-year LOS. A profile of the maximum hydraulic grade line for each LOS is shown in **Figure 5-9**.

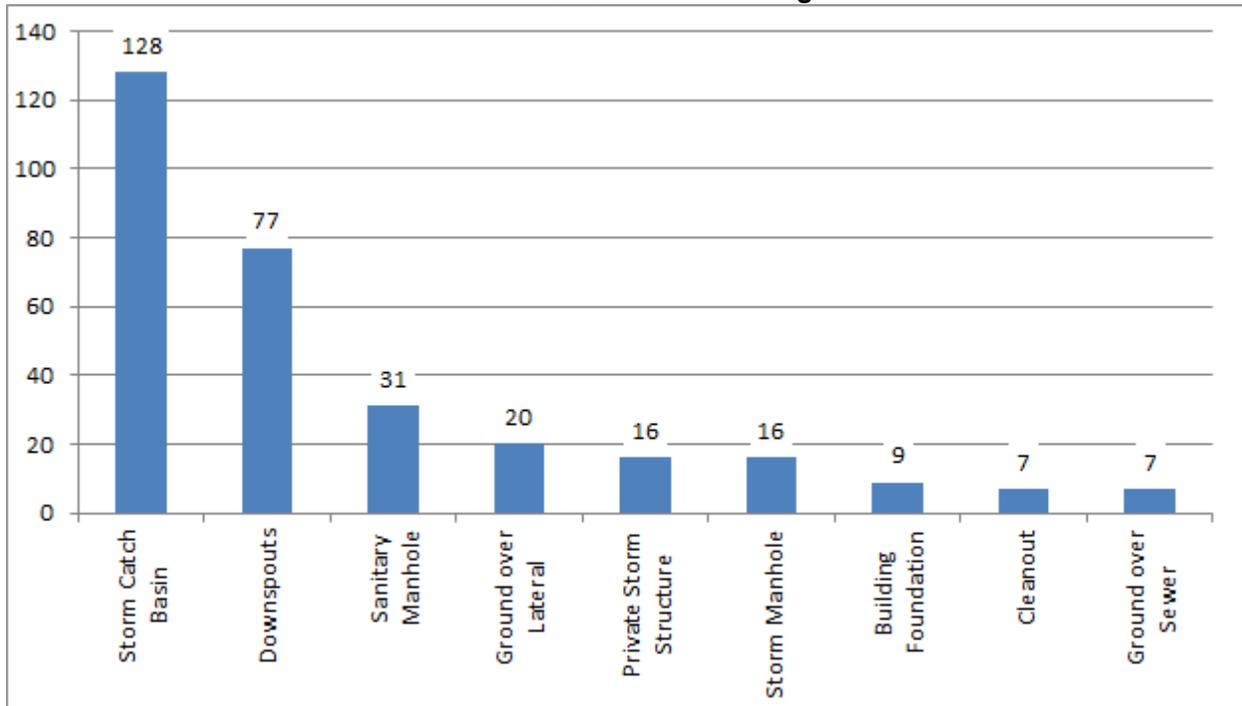
Refer to **Figure 6-3** for the locations of observed smoke and type of defect. The following table illustrates the types and number of defects found.

The stormwater system exhibited the most smoke with 128 catch basins, 16 storm manholes and 16 private storm structures. Smoke emanating from these structures indicates direct/indirect connections between the storm and sanitary sewer systems. The means of the connection cannot
