## 236 Columbia Ave trees

From TJ Nagel <tj@russelltreeexperts.com>

Date Thu 10/31/2024 9:40 AM

I stopped out yesterday, 10/30/24, at the 236 Columbia Ave. Bexley, OH 43209 address to take a second look at the mature landscape trees on the property you requested. I visited the property initially with you on Friday 10/11/24 to identify tree species and record trunk diameters.

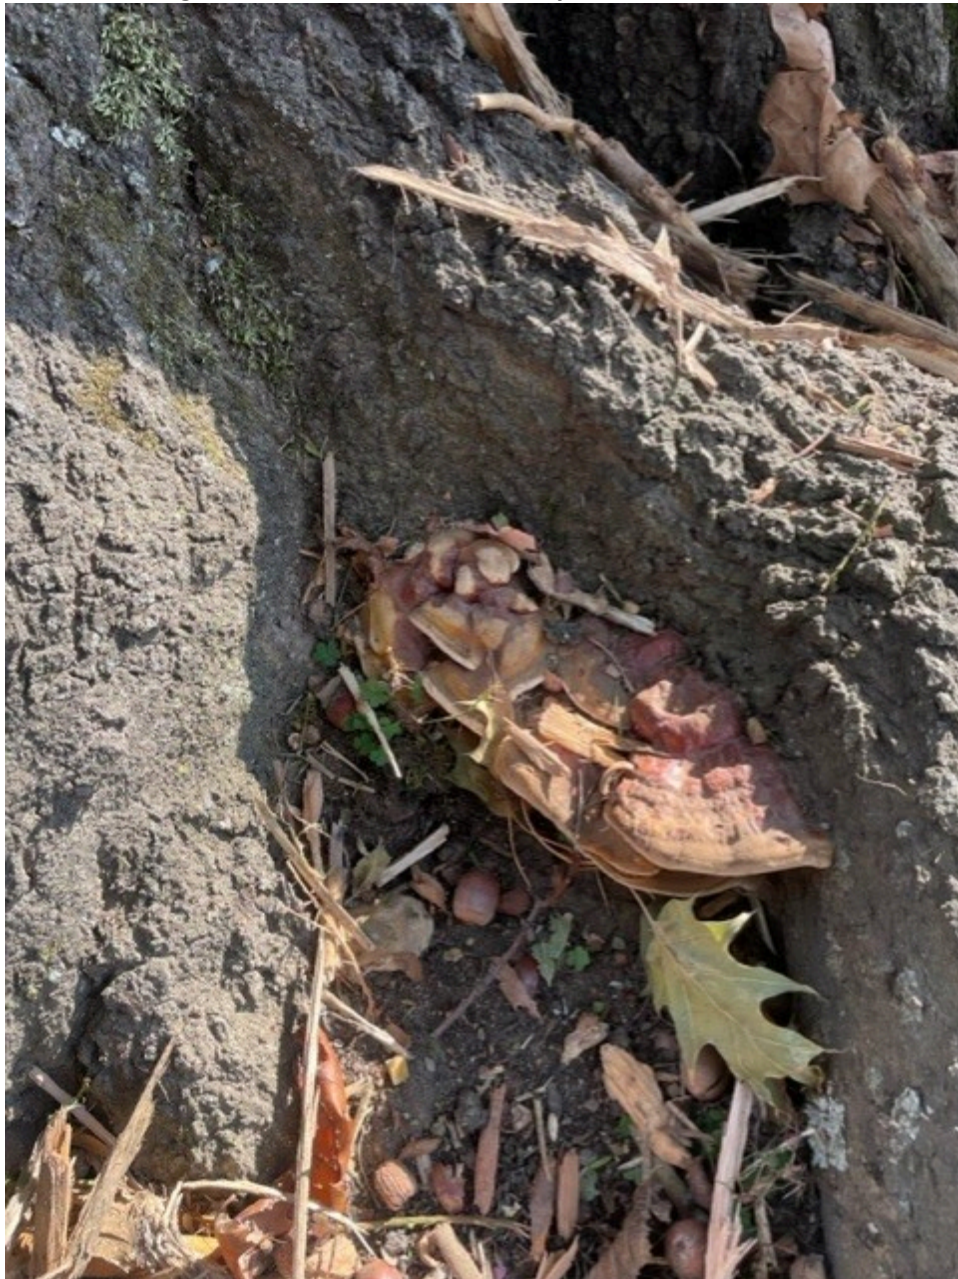
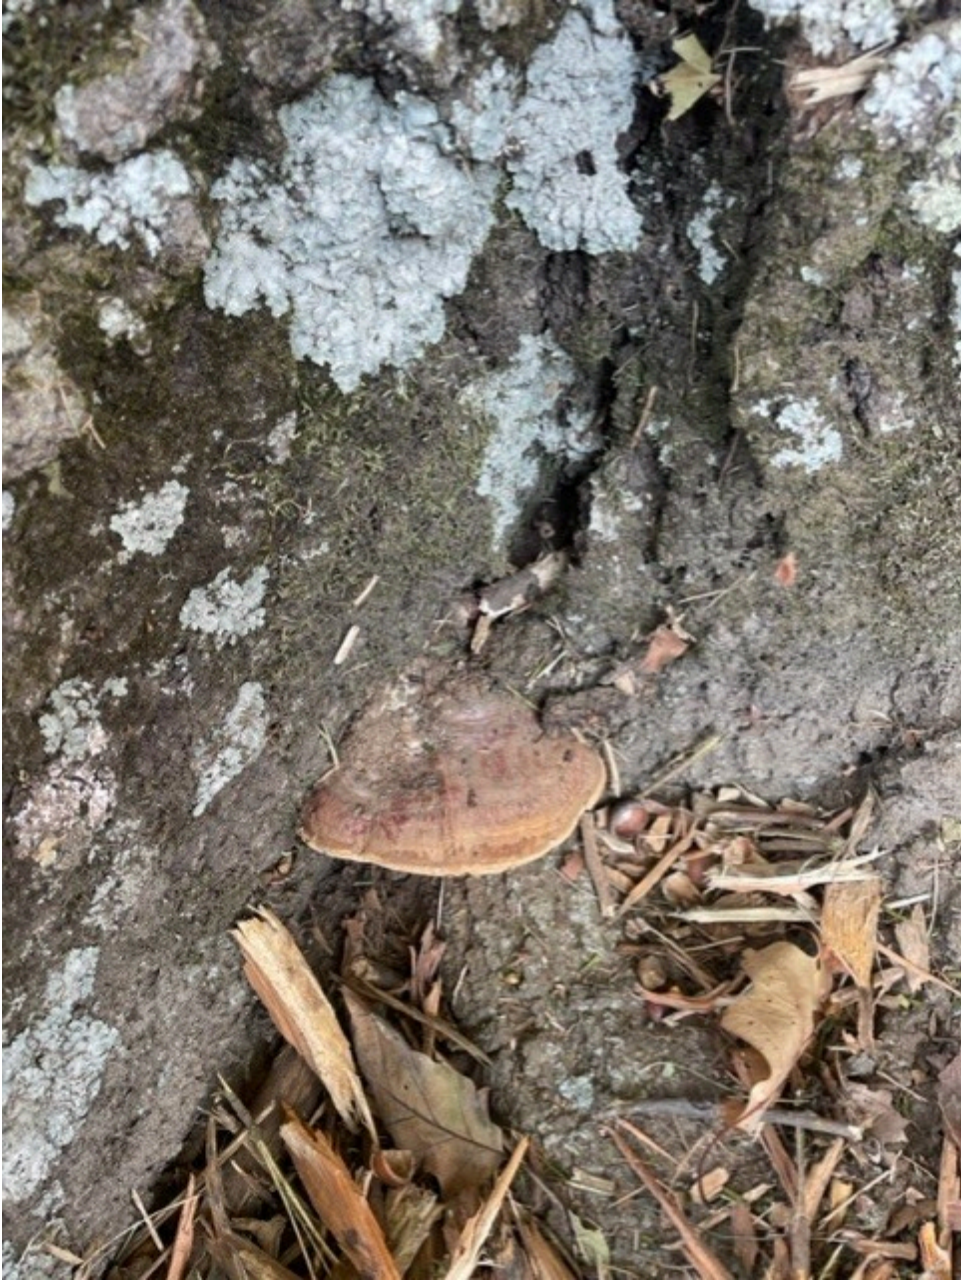
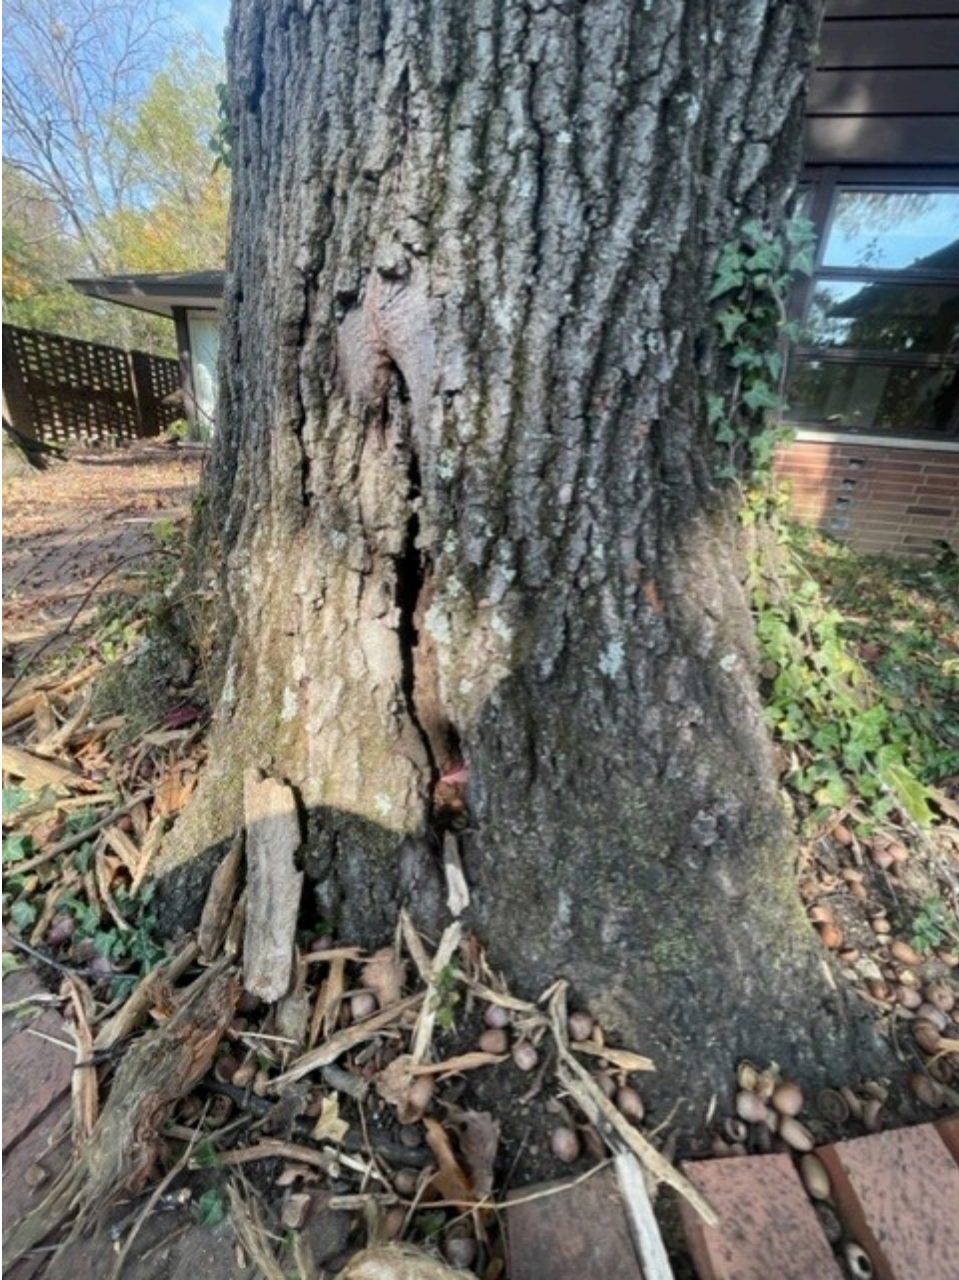
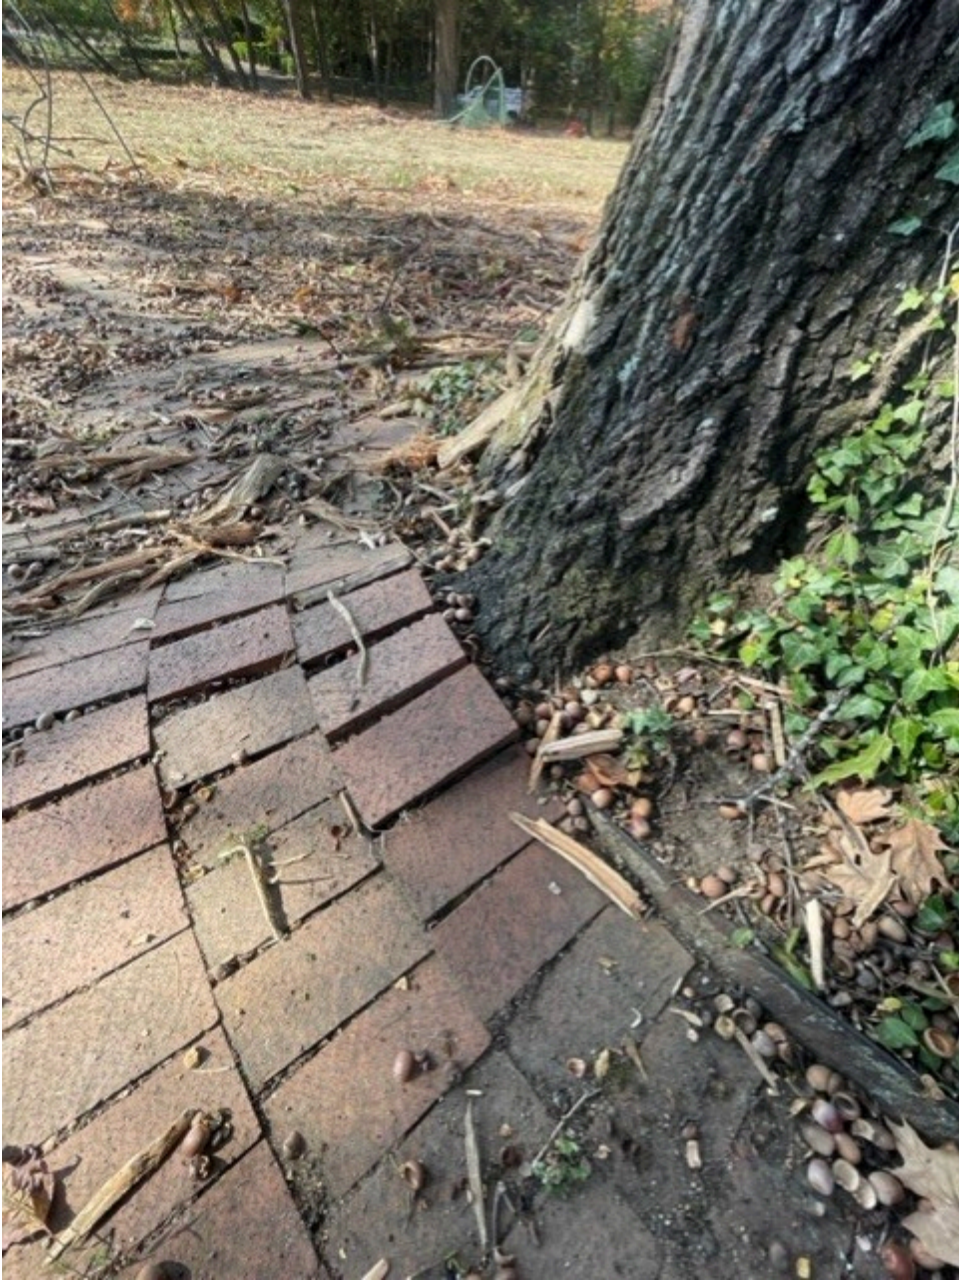
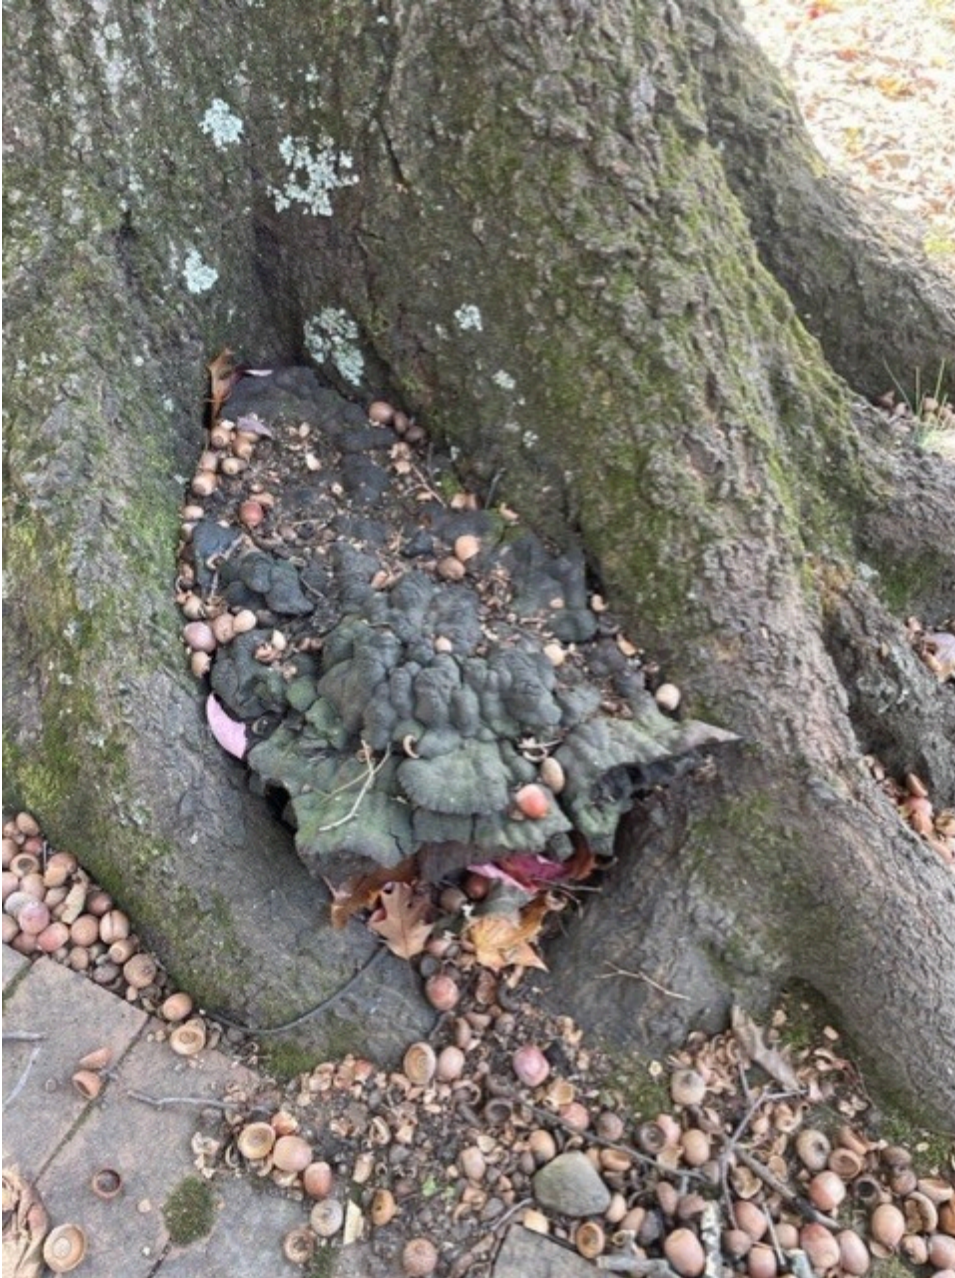
Below are images taken of the buttress root systems of three Red oak trees on SW corner of home

I observed fungal conks (which are the fruiting body of decay) and hollow cavities on the buttress roots of all three of the mature Northern Red oak on the SW corner of the house. These fungal conks are most likely the fruiting body of Ganoderma buttress rot, an aggressive decay pathogen that degrades the wood fibers of its host near ground level and ultimately impacts the stability of the tree. It is quite common for trees with Ganoderma buttress rot to fail under significant load bearing events like high winds or significant ice/snow accumulation. Removal of these three trees is recommended. I have included some photos of the defects in these trees at the bottom of this letter.

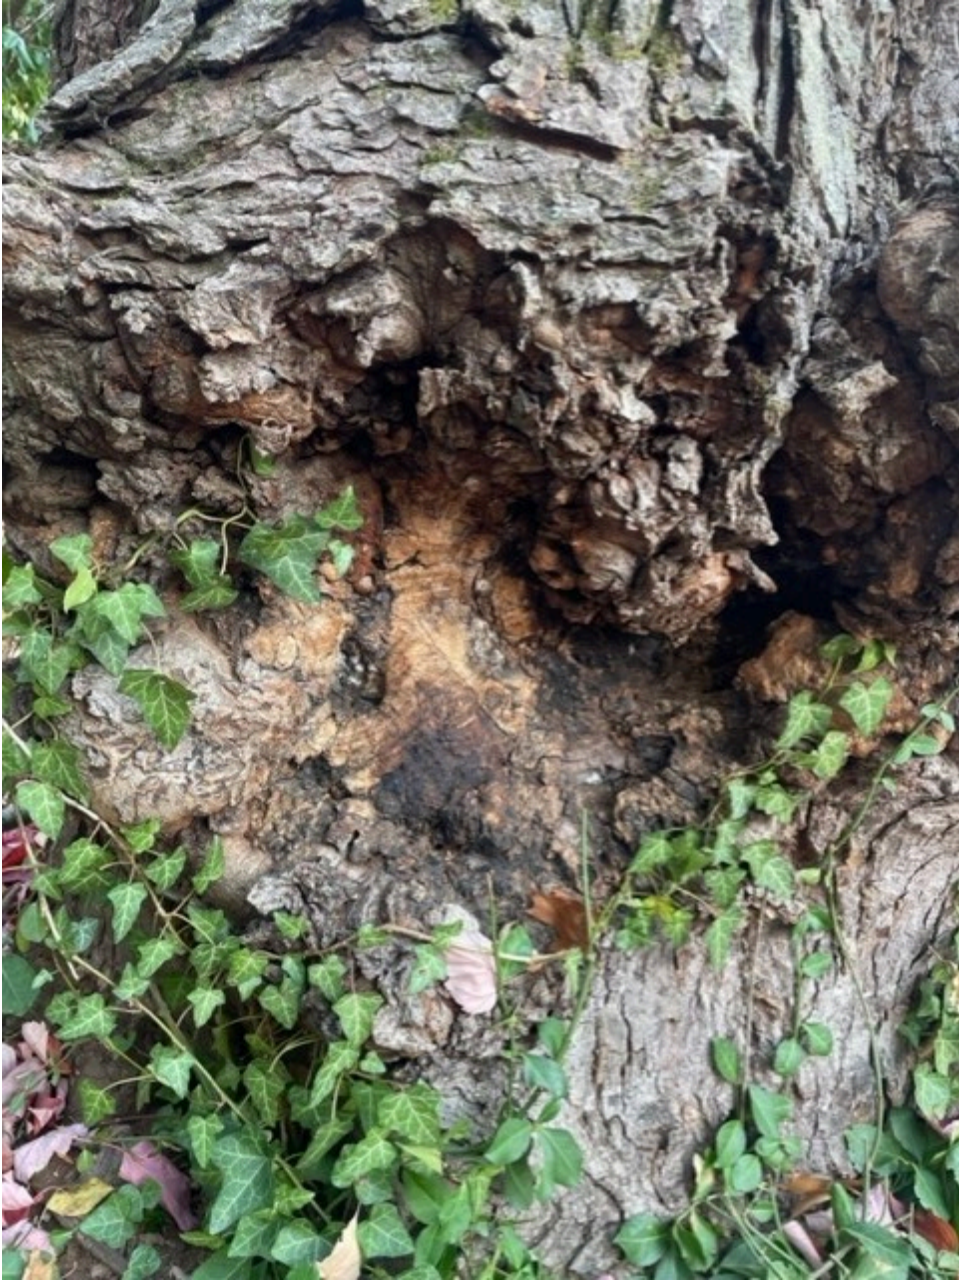
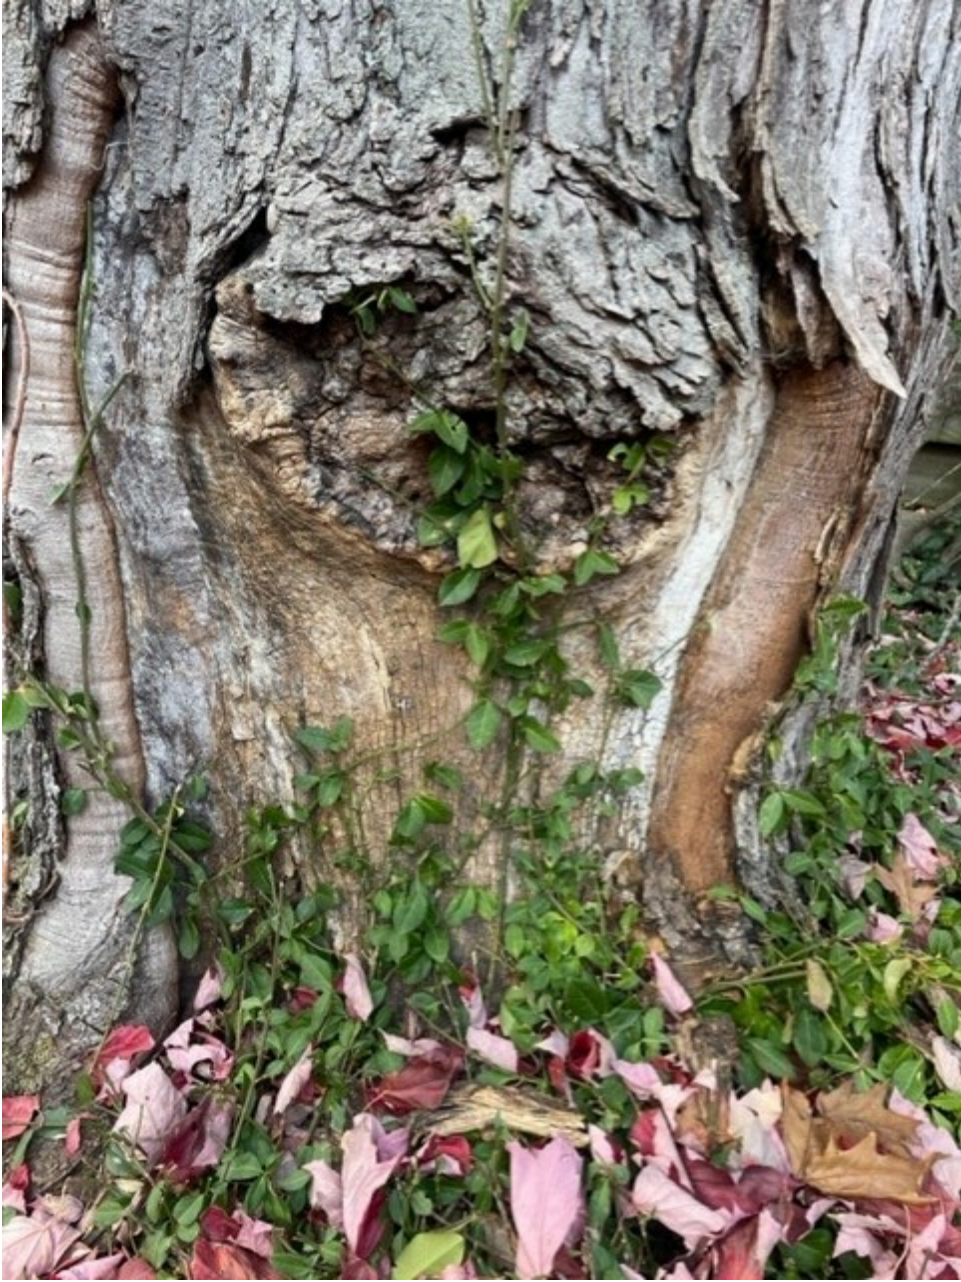
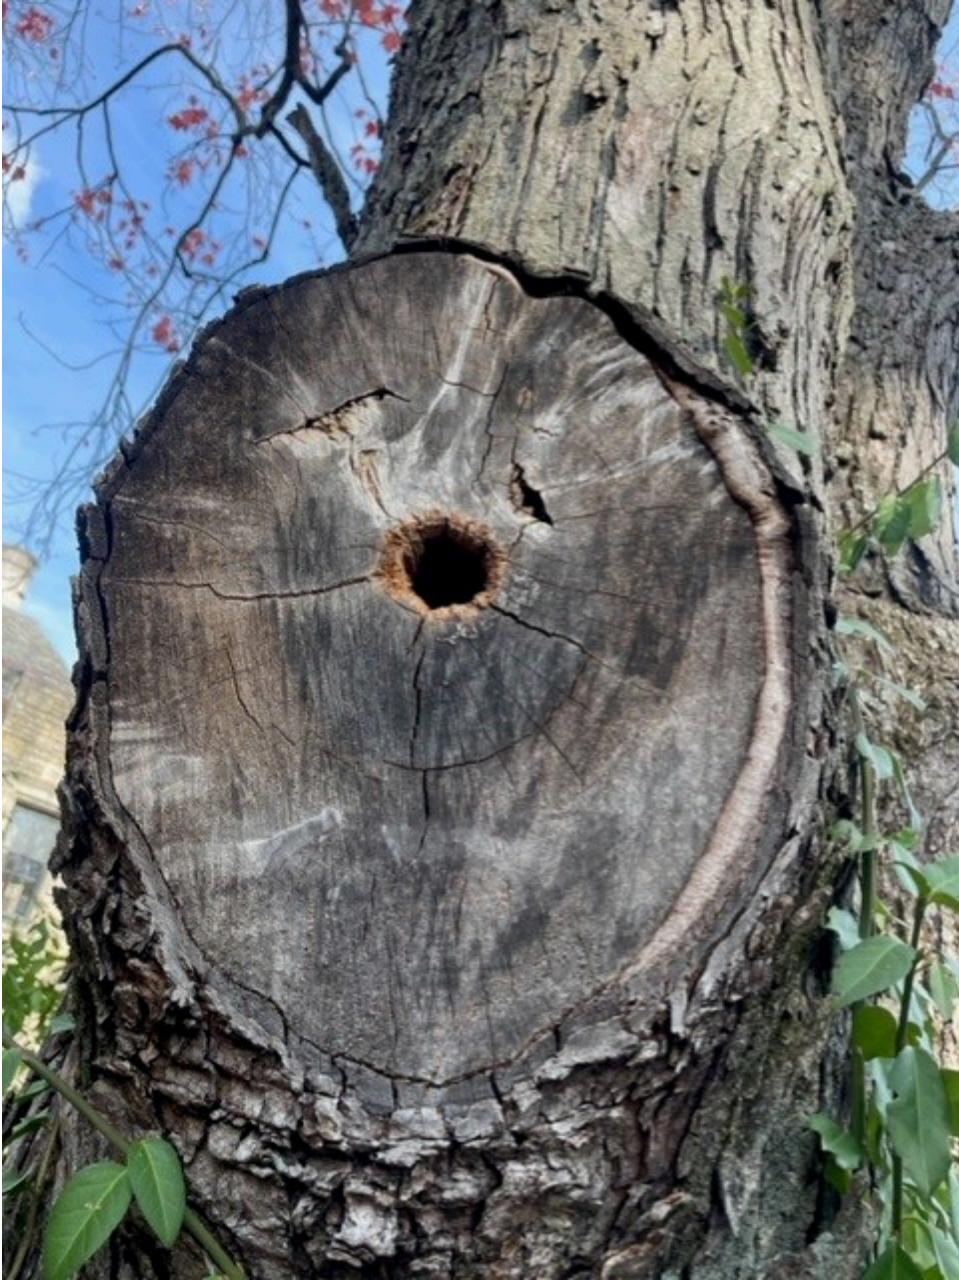
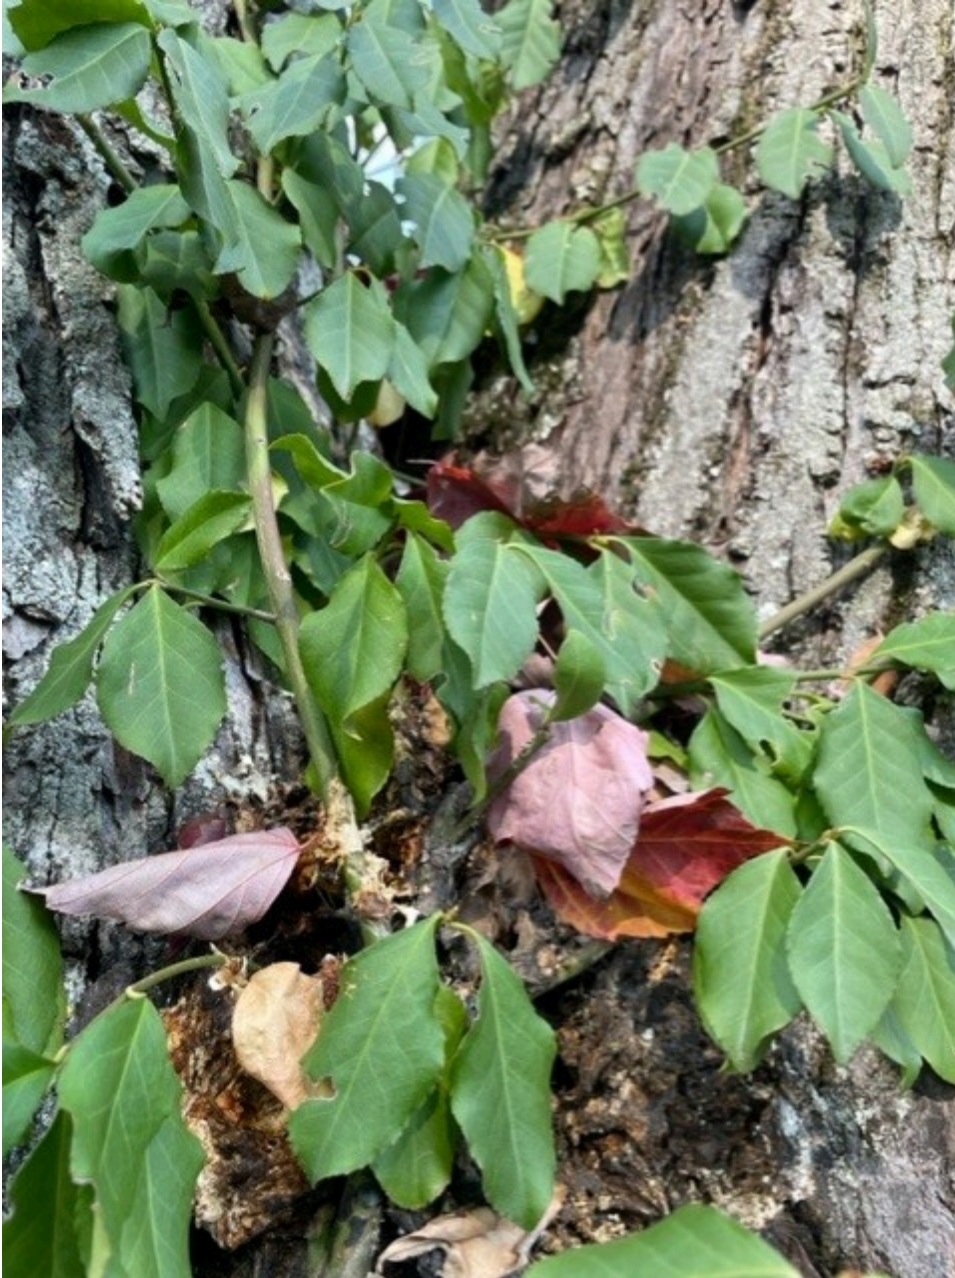
Below are images of Red maple North side of house/driveway 10/30

The large Red maple on the North side of the house and driveway has 3 existing steel cables to support the union where the two main stems come together. There is also decay present at this union. Additionally, there is little response growth around old existing pruning cuts indicating the overall vigor of this tree is poor. I observed two large existing wounds with decay present on the lower portions of the main stem. Removal of this tree is recommended. I have attached pictures below of the defects in this tree (the decay in the main stem attachment is partially blocked by a euonymus vine).
