**Phase I & II  
Environmental Site Assessment**

**Franklin County Parcels 020-000157  
and 020-003693  
Sheridan Avenue  
Bexley, Ohio 43209**

**Prepared for:  
City of Bexley  
2242 East Main Street  
Bexley, Ohio 43209**

**May 2007**

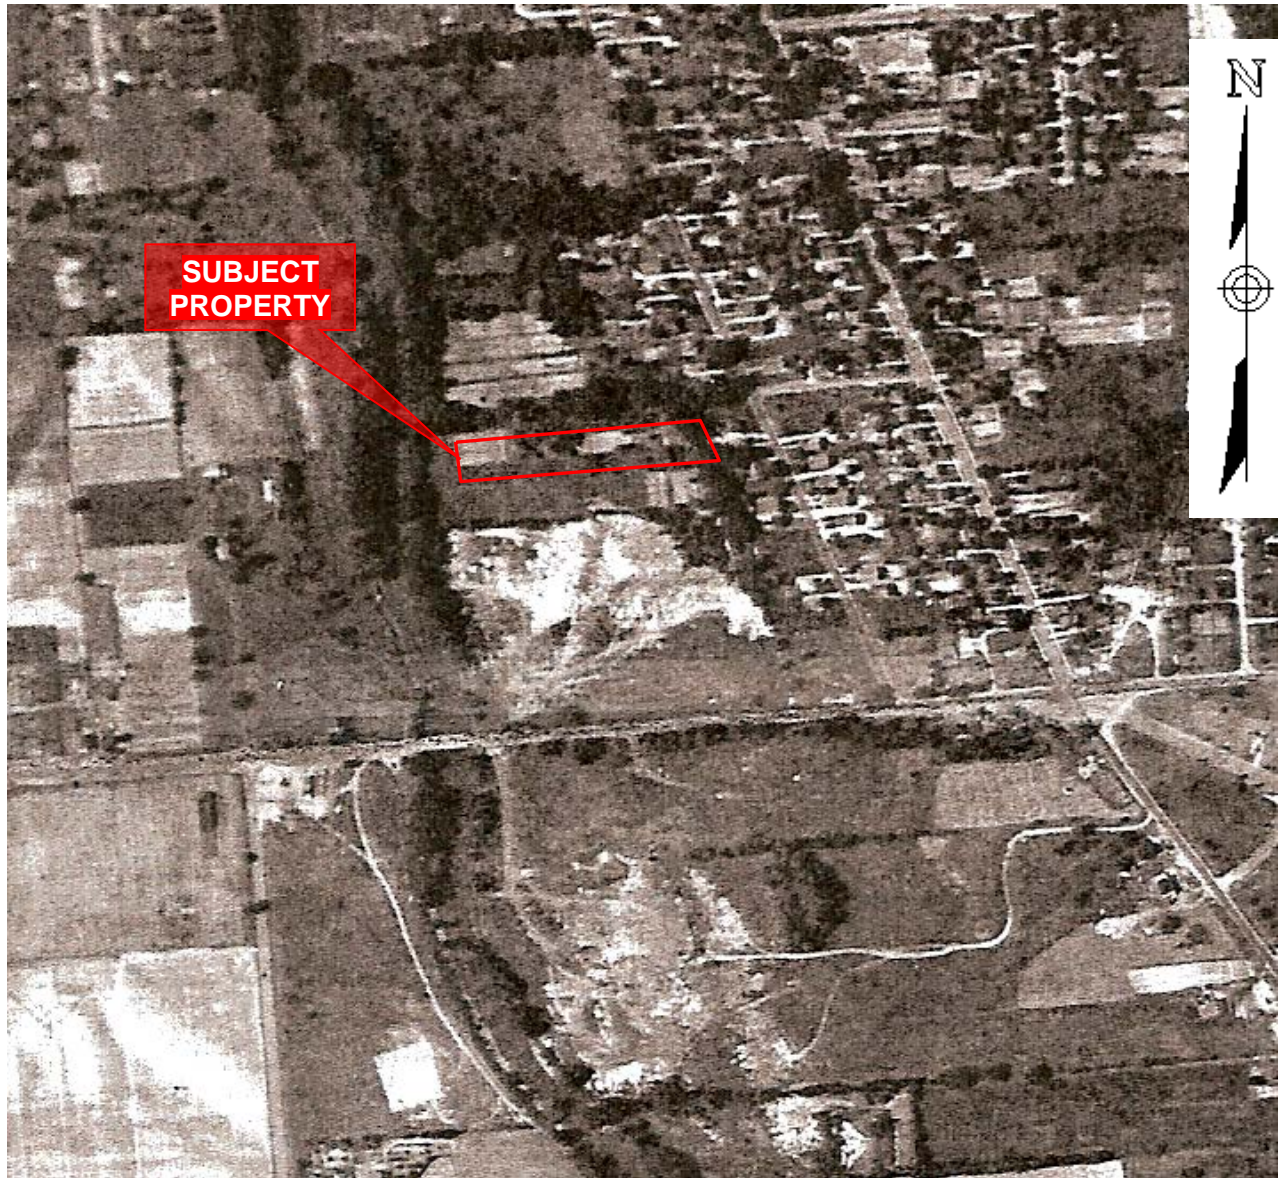
FIGURE 5I – 1938 Aerial Photo

Historical use information indicates evidence of historical recognized environmental conditions in connection with past uses of adjoining property. In a 1938 aerial photograph, property south of the subject property appears to have been used as a landfill. According to a Phase I ESA performed by H.C. Nutting in February 2003, the area was used as a residential landfill prior to 1950. This information was obtained from an interview conducted by H.C. Nutting with an Administrator for the City of Bexley. Also, subsurface geotechnical investigations in the area performed by H.C. Nutting revealed glass present in the soil. The glass is likely from the landfill activities and due to the presumed age of the glass, the glass may contain lead which has the potential to leach into the soil.

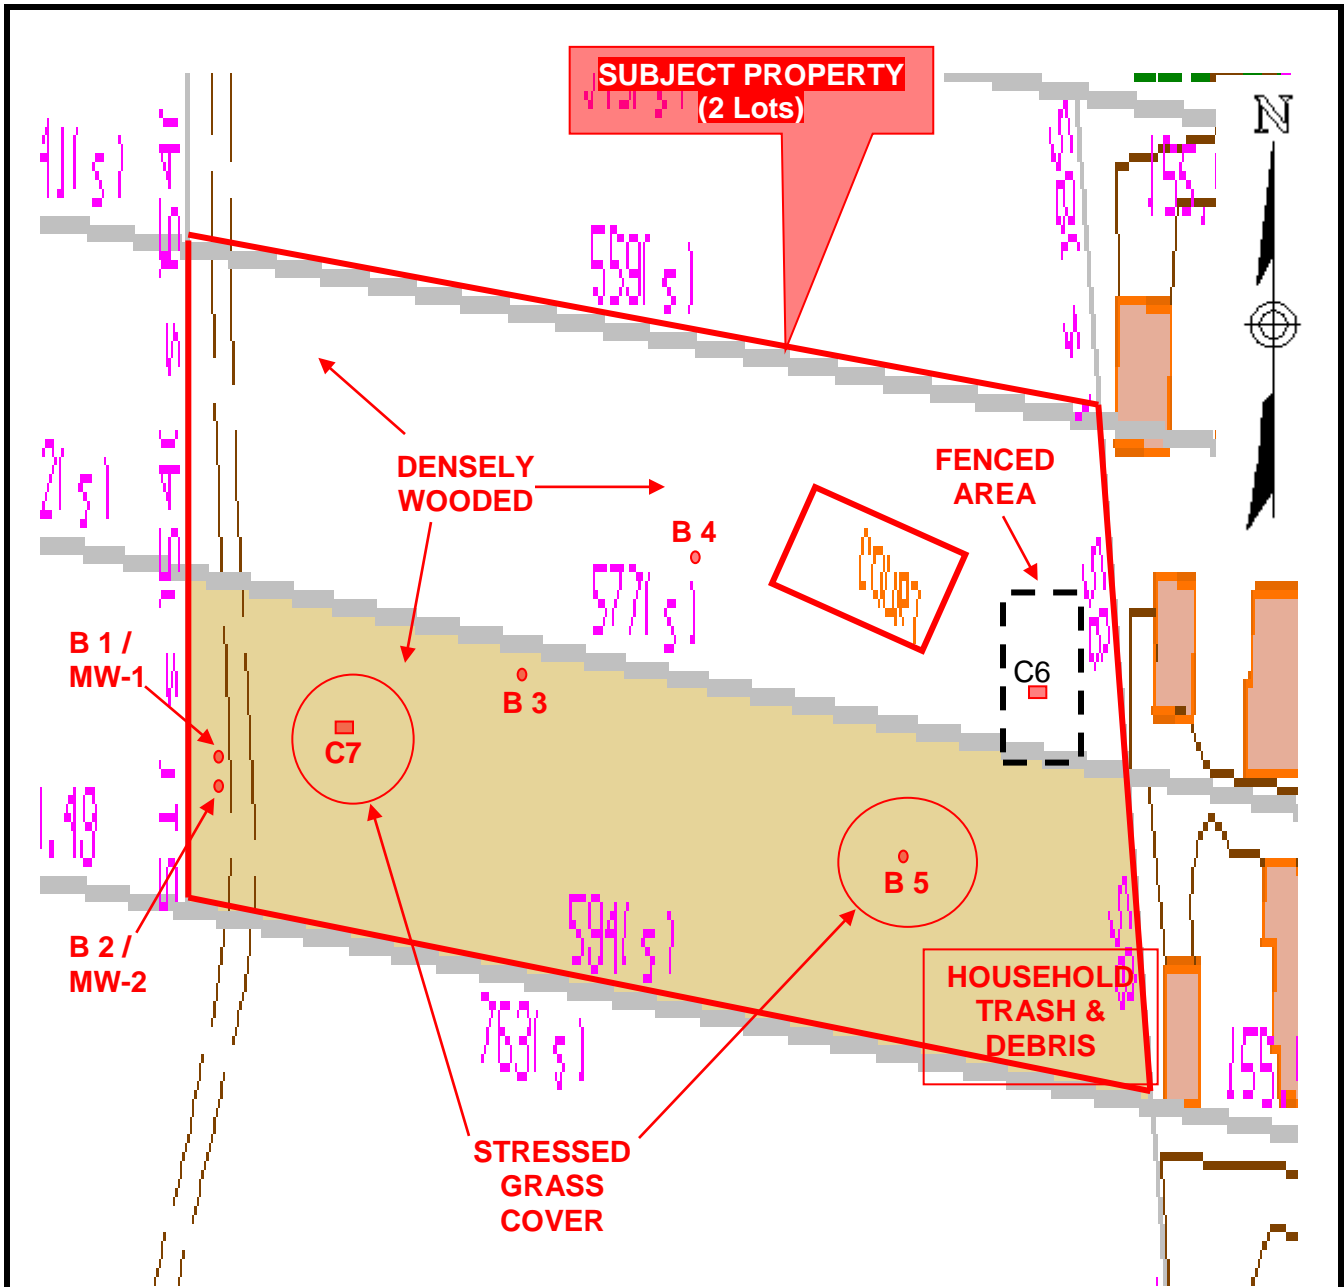
FIGURE 7 – Site Map w/ Boring and Sample Locations

Soils from each boring remained consistent throughout the property with topsoil and silty sand and clay to approximately 2 feet bgs, unnatural materials including glass, cinders, organic matter from decay, and brick to approximately 8 feet bgs, and silt clay and clay to gray mottled clay to approximately 24 feet bgs (boring B2). Ground water was encountered at approximately 12 feet bgs and 18.5 feet bgs on the western portion of the subject property. Borings B1 and B2 were converted to temporary 1-inch diameter monitoring wells. Boring B1 (MW-1) was set at 15 feet bgs with 5 feet of screened casing to 10 feet bgs to capture the uppermost aquifer. Boring B2 (MW-2) was set at 22 feet bgs with 5 feet of screened casing to 17 feet bgs to capture the lower aquifer at the depth of Alum Creek.

Two areas of stressed vegetation were observed and targeted as an area of concern. Composite samples C6 and C7 were collected from these areas by using a clean, dedicated stainless steel trowel and bowl. Samples C6 and C7 were analyzed for heavy metals and volatile organic compounds. Analytical results are summarized in Sections 8 and 10.

- Phase II investigations indicate the subject property is part of former landfill.
- Two areas of stressed grass cover were observed on the eastern and western portion of the subject property, respectively. Surface soil samples were collected from each area (samples C 6 and C 7) and subsequently analyzed for metals and VOCs.
