236 NORTH COLUMBIA AVE
BEXLEY, OH
SITE PLAN

Connor Residence

236 Columbia Ave trees

CONNOR RESIDENCE - LANDSCAPE MASTER PLAN
236 NORTH COLUMBIA AVENUE, BEXLEY, OHIO 43209

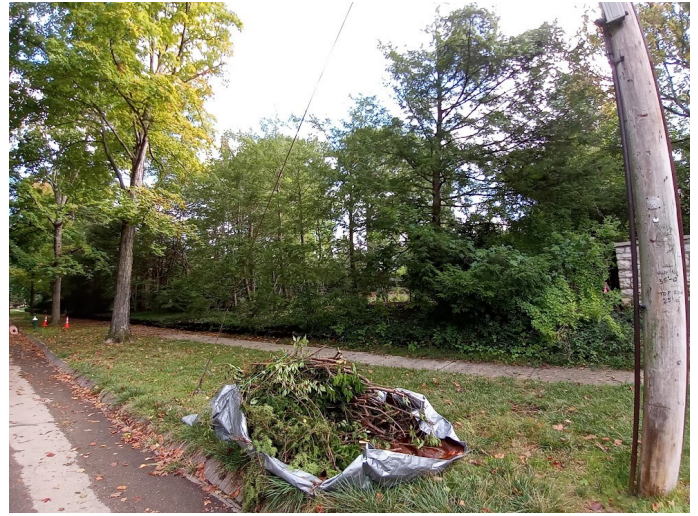
View East to property of viable Hemlock on street

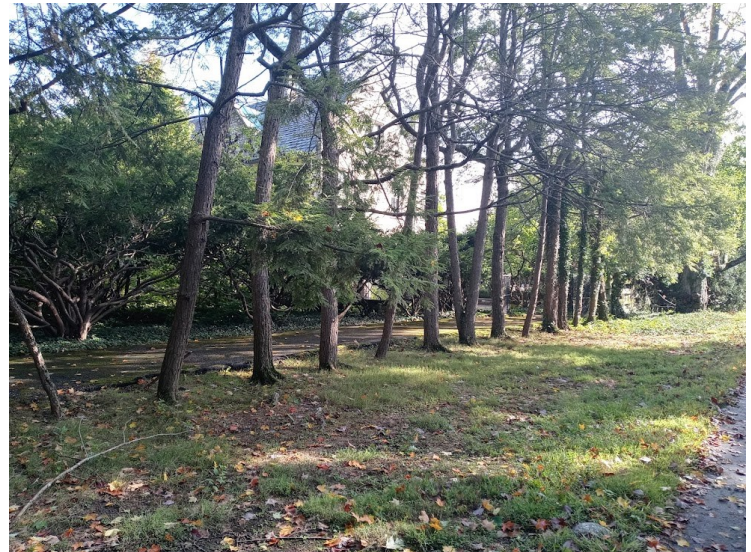
Hemlock row on North property line

The Canadian hemlocks along the North and West perimeter of this property are in fair to poor condition. The canopies are thin and have a high volume of dead limbs. A couple of the Canadian hemlocks are entirely dead. Others are infested with elongate hemlock scale which is a difficult pest to manage and will likely lead to further decline in these trees. Mature Canadian hemlock have poor regenerative growth and it is unlikely that these will ever be an effective screen or landscape plant again. Removal and replacement is recommended.

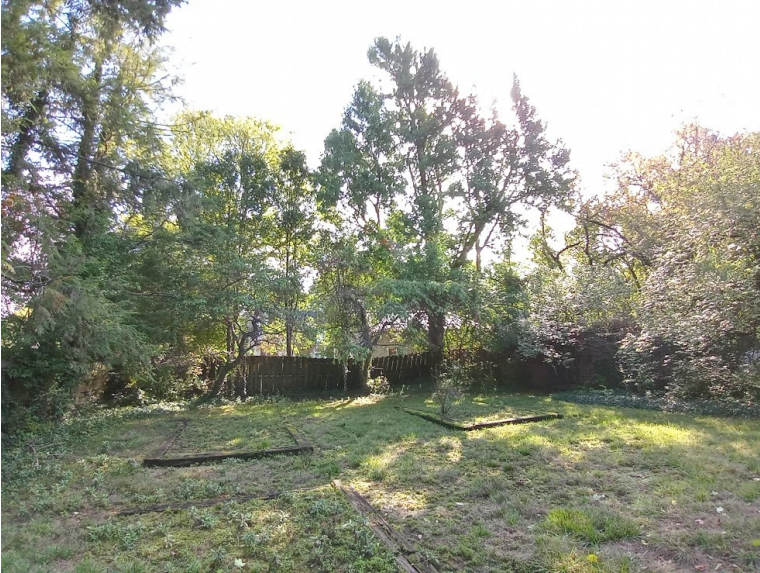
View of East property line and Large Ginkgo tree

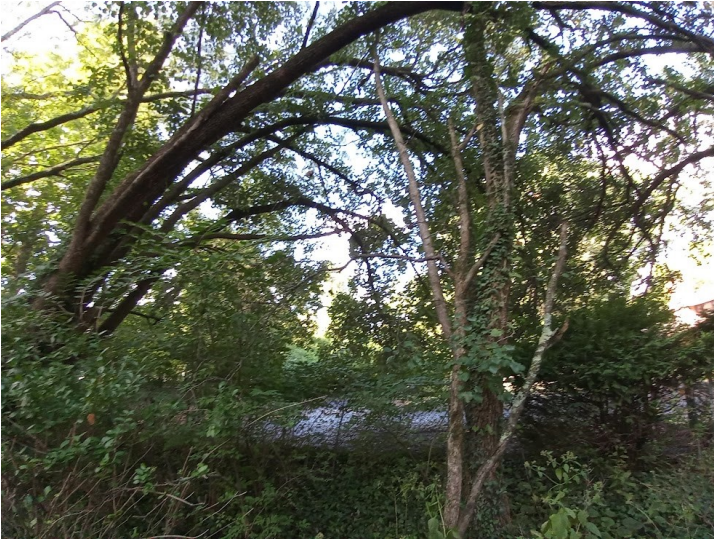
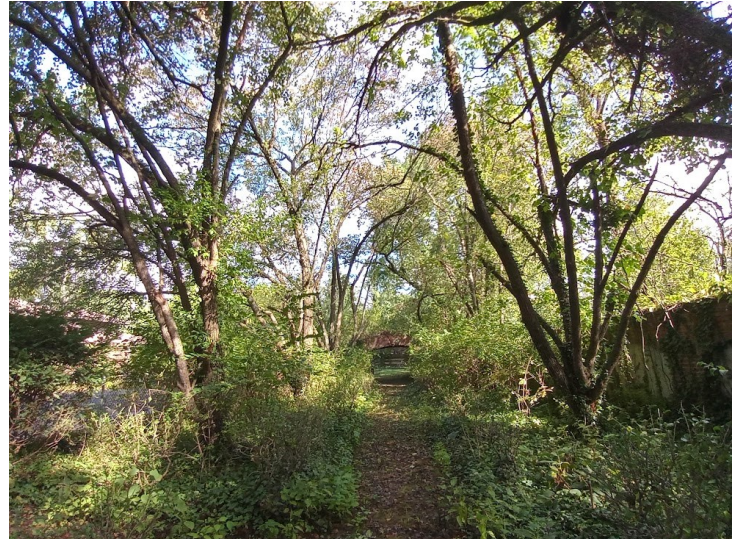
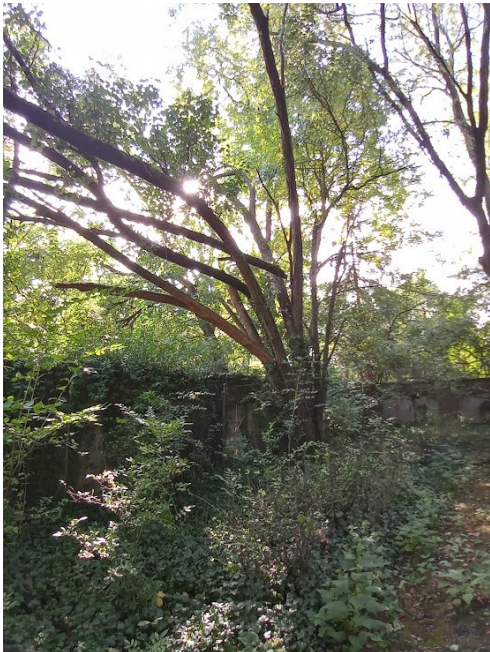
Existing Pears in "secret Garden"

The group of 10 Callery pear along the East side of the property in the secret garden have been neglected over the years and all have developed poor structure. Several of the trees have already had whole stems fail and all of the canopies have large diameter broken limbs and hangers. These trees are beyond long term preservation and removal is recommended.

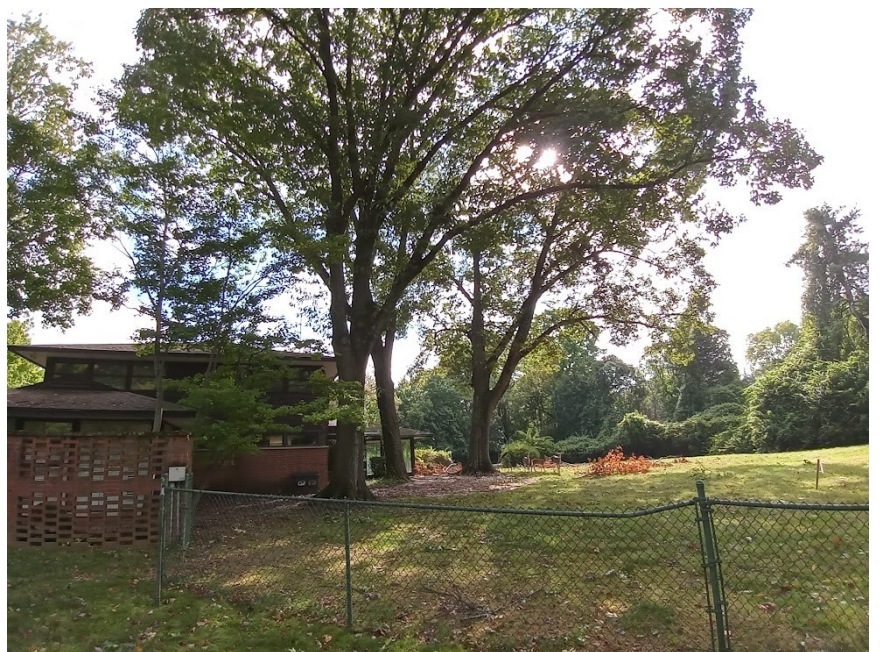
Three Oaks in the middle of the property

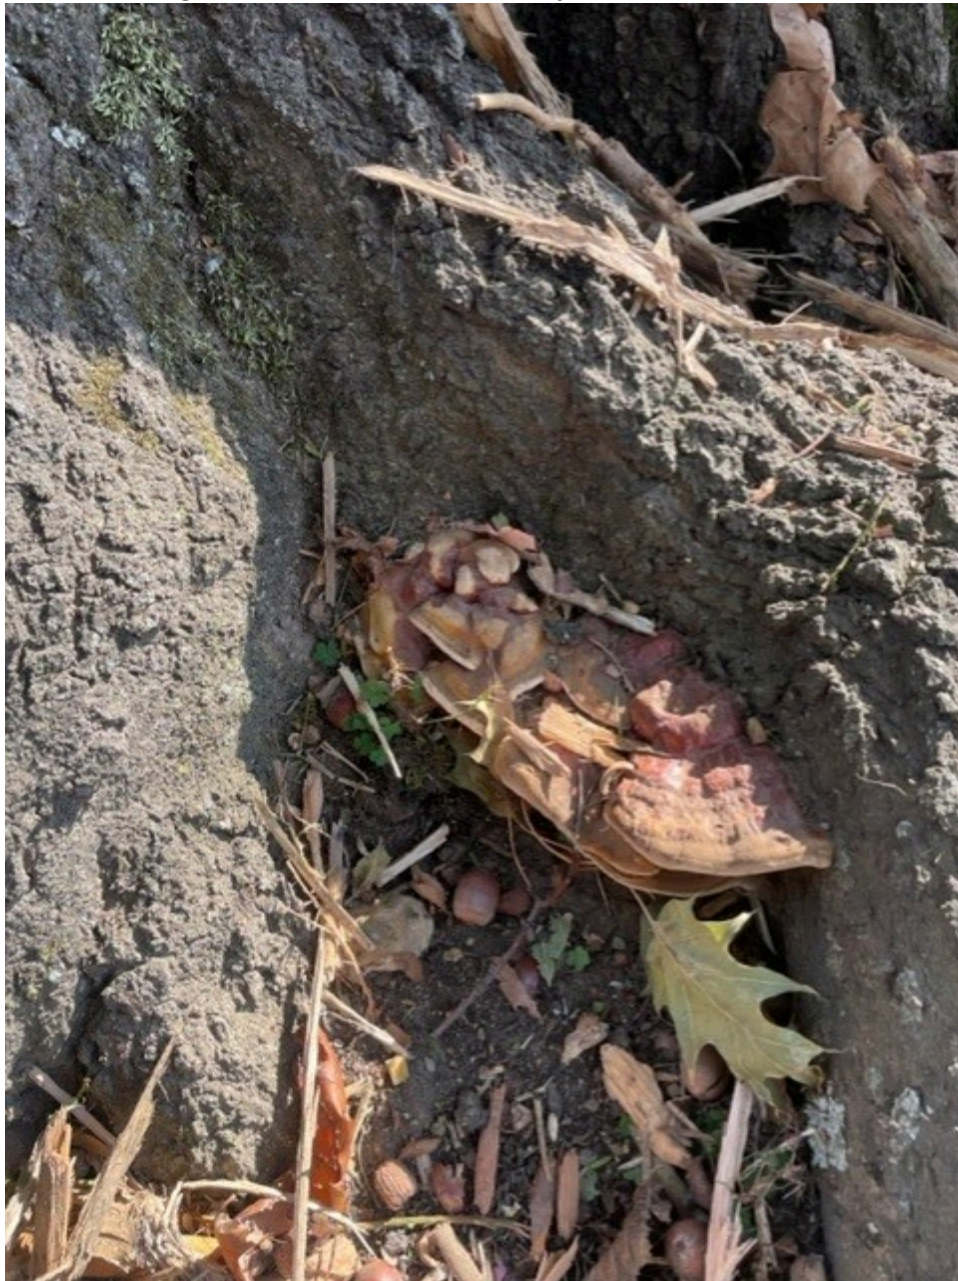
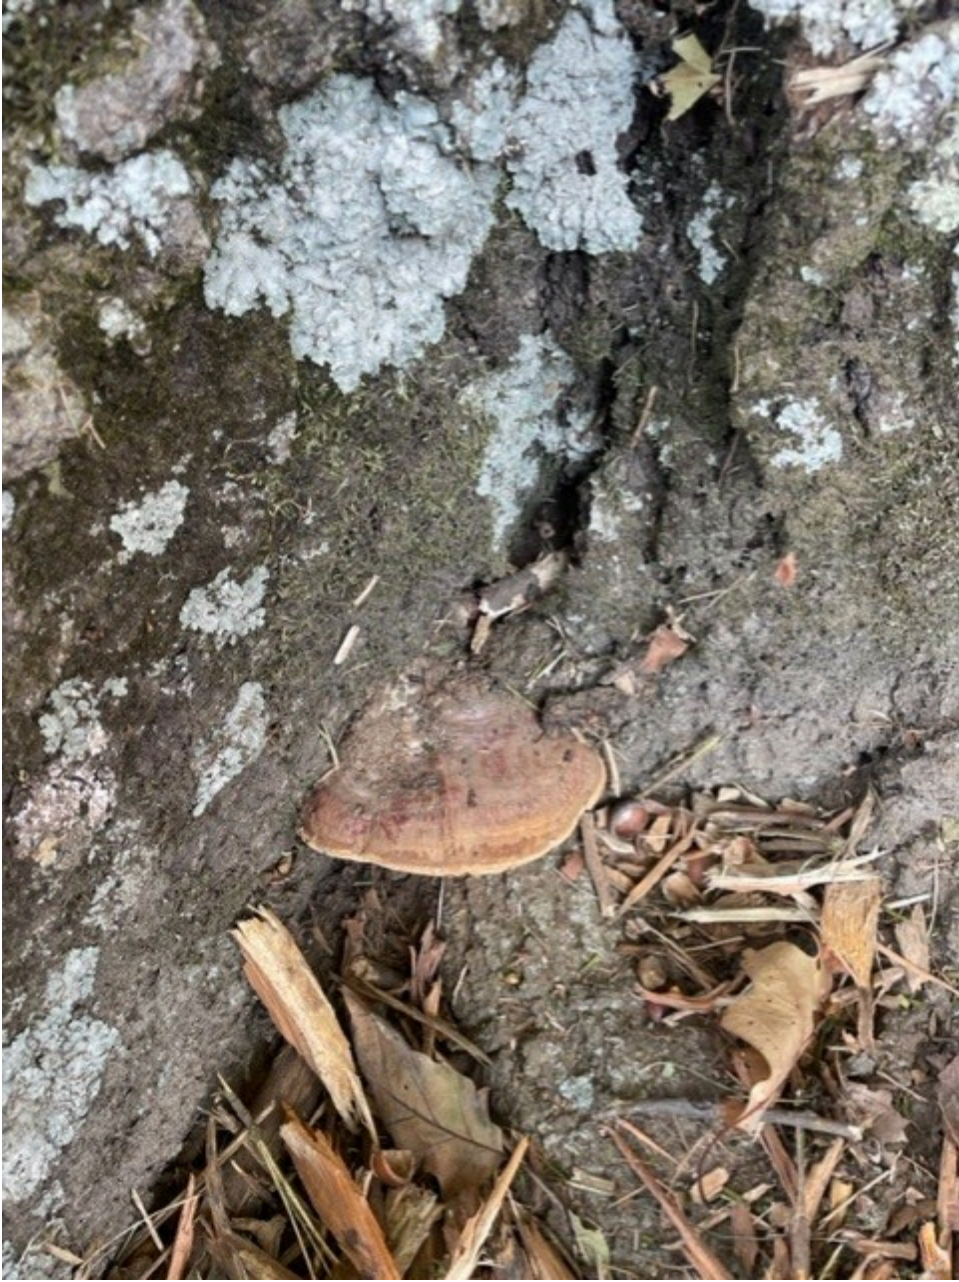
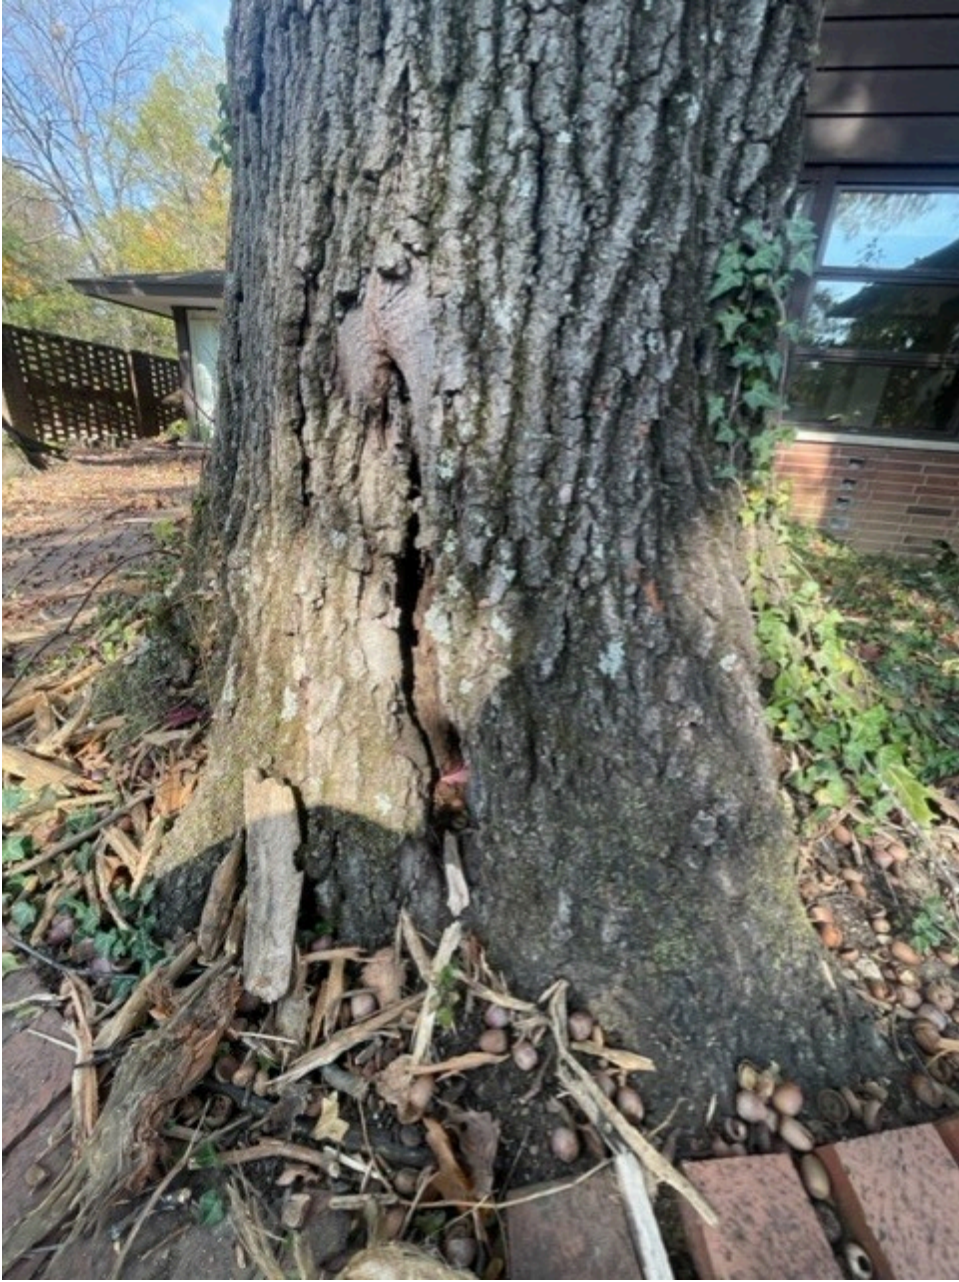
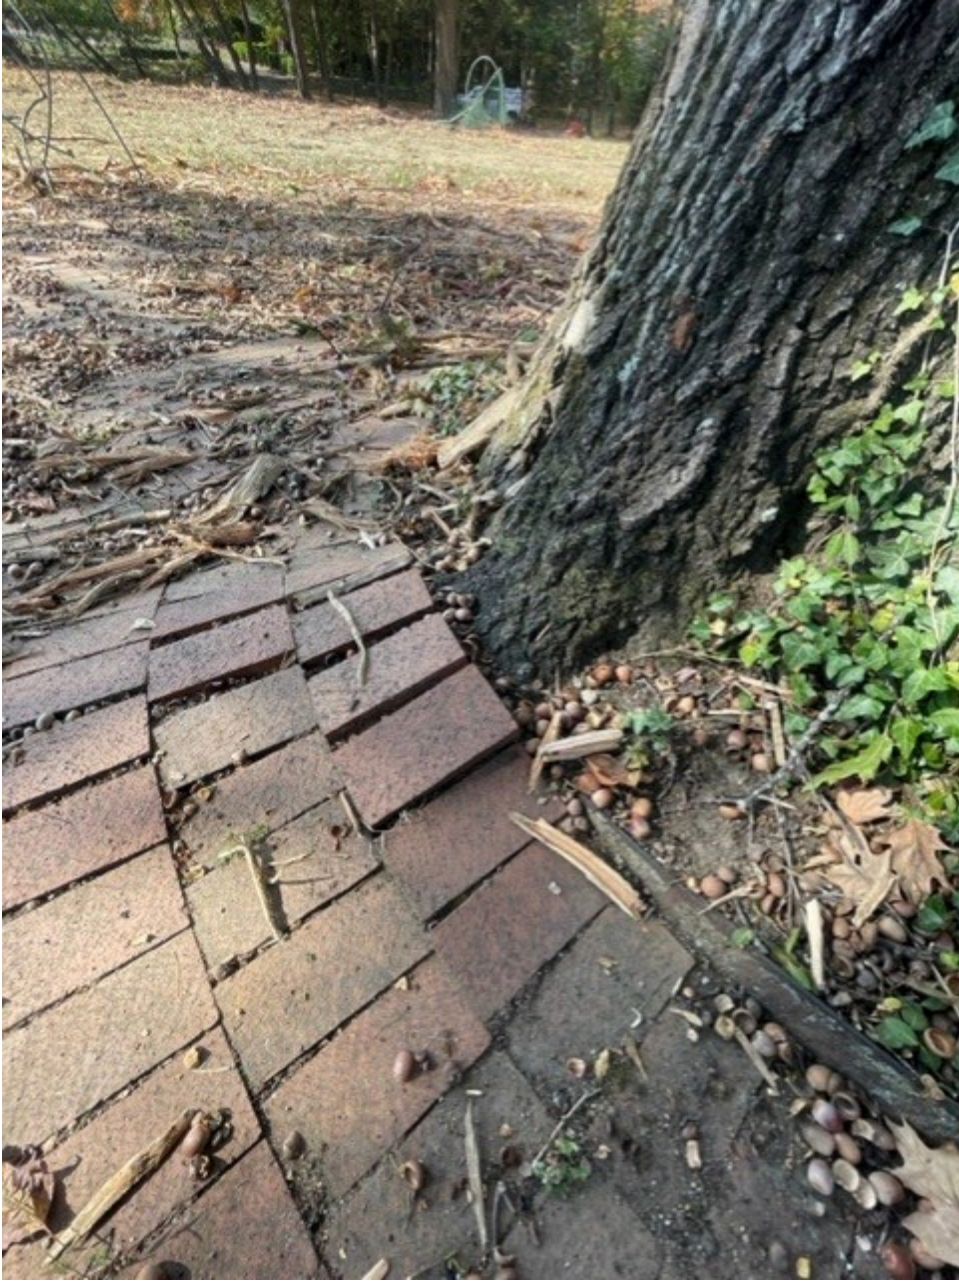
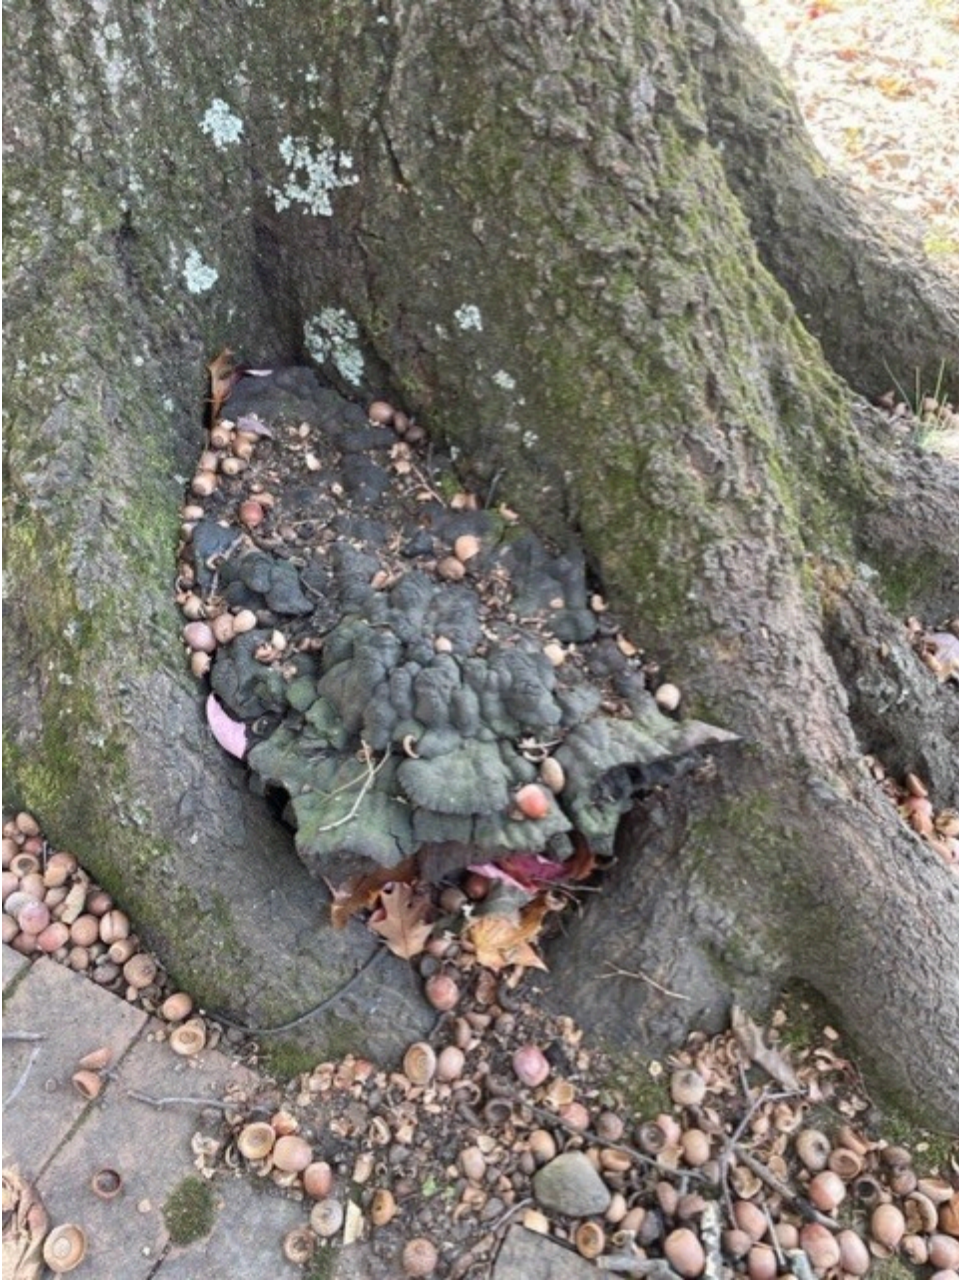
I observed fungal conks (which are the fruiting body of decay) and hollow cavities on the buttress roots of all three of the mature Northern Red oak on the SW corner of the house. These fungal conks are most likely the fruiting body of Ganoderma buttress rot, an aggressive decay pathogen that degrades the wood fibers of its host near ground level and ultimately impacts the stability of the tree. It is quite common for trees with Ganoderma buttress rot to fail under significant load bearing events like high winds or significant ice/snow accumulation. Removal of these three trees is recommended. I have included some photos of the defects in these trees at the bottom of this letter.

Below are images taken of the buttress root systems of three Red oak trees on SW corner of home

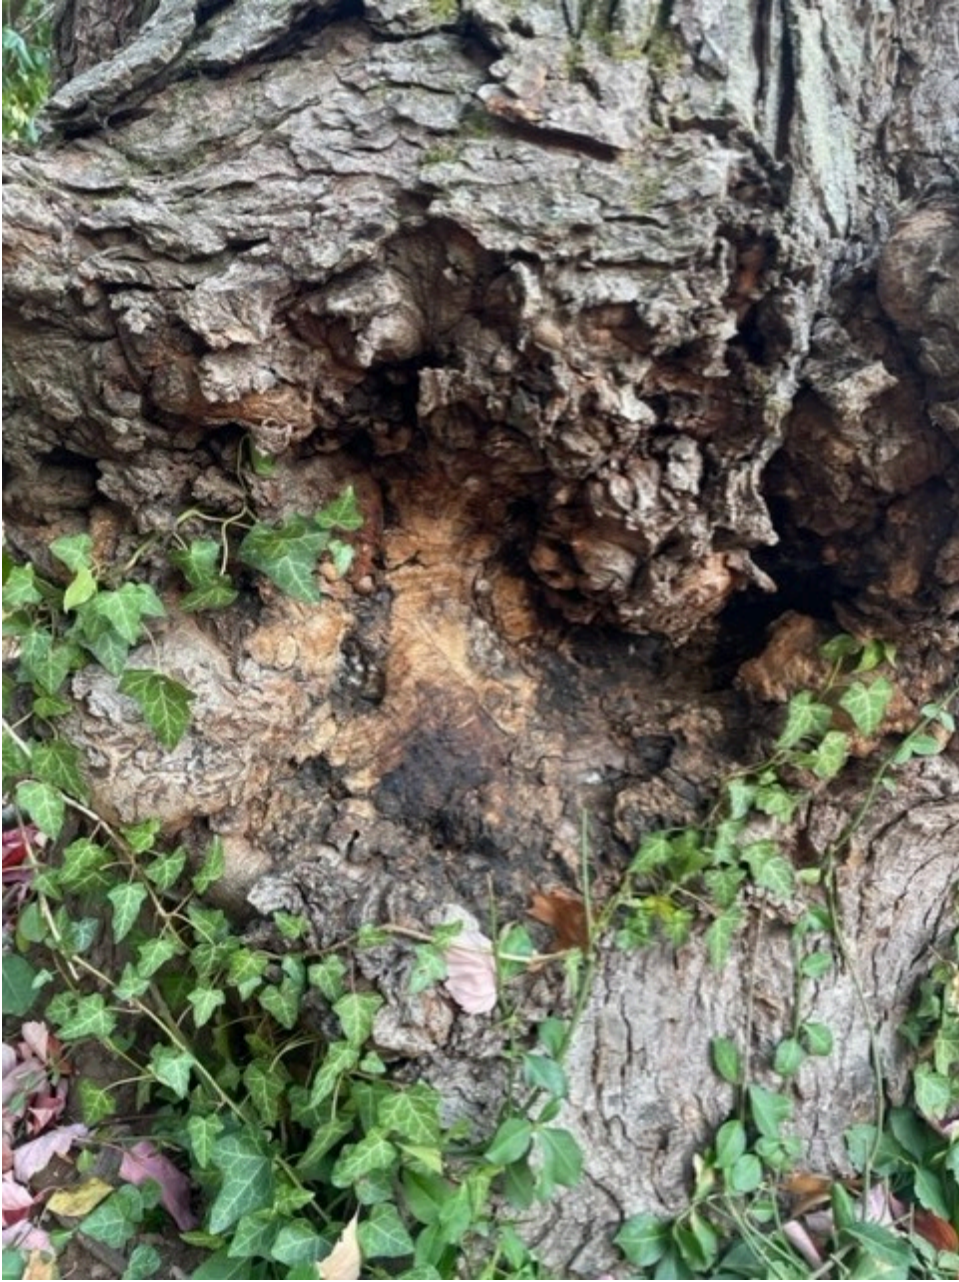
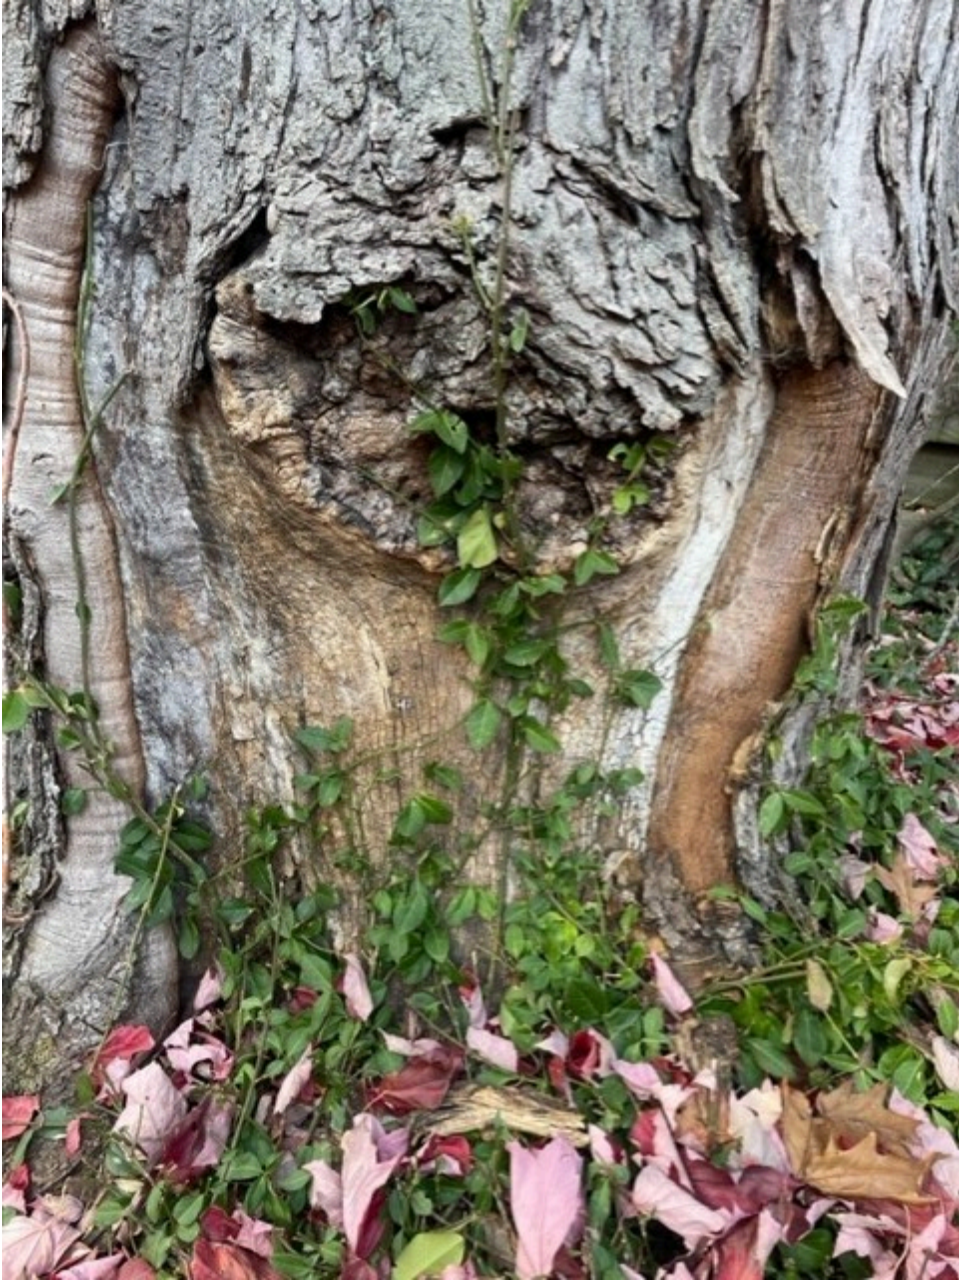
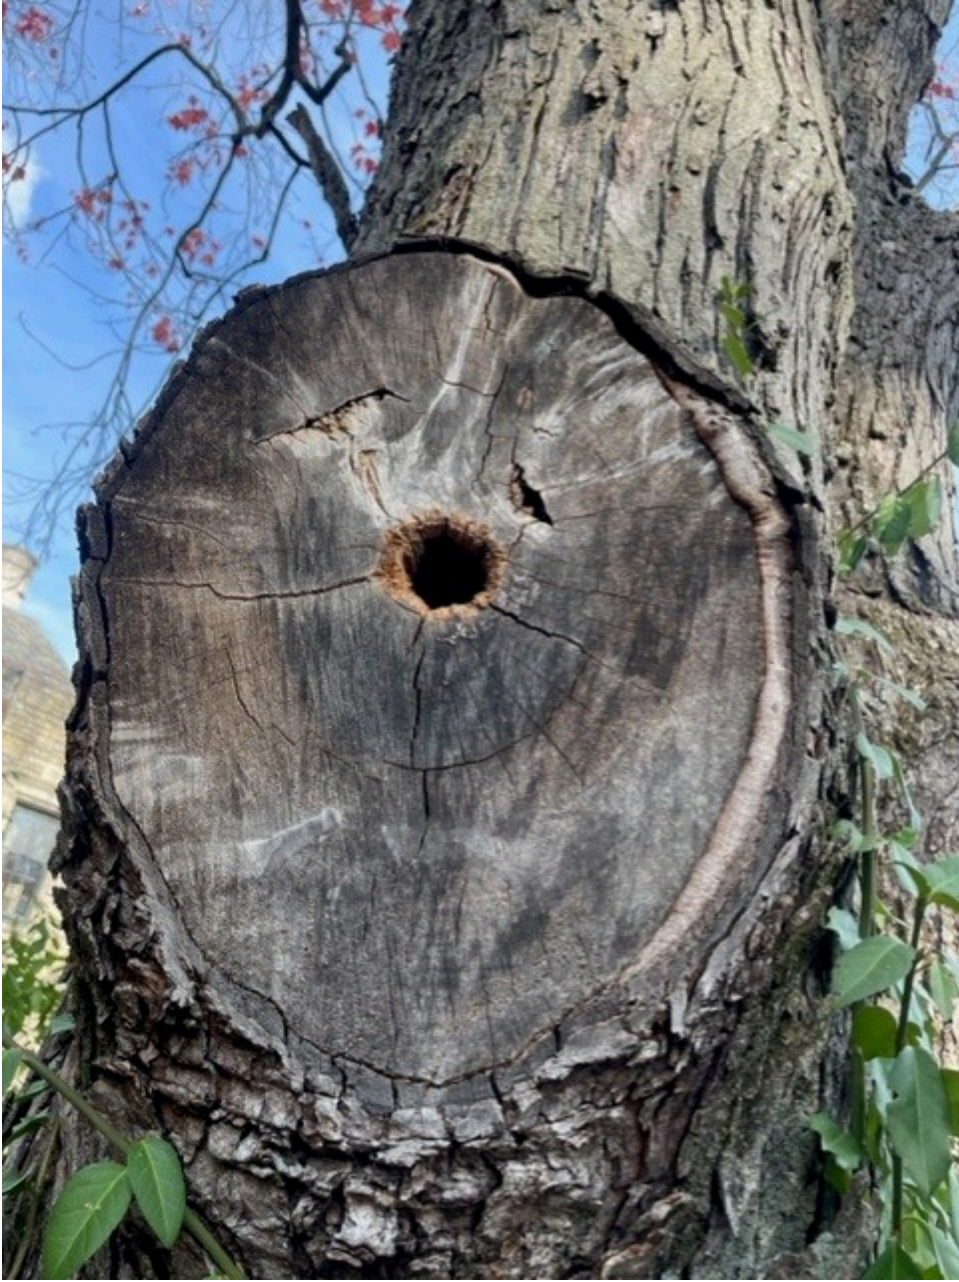
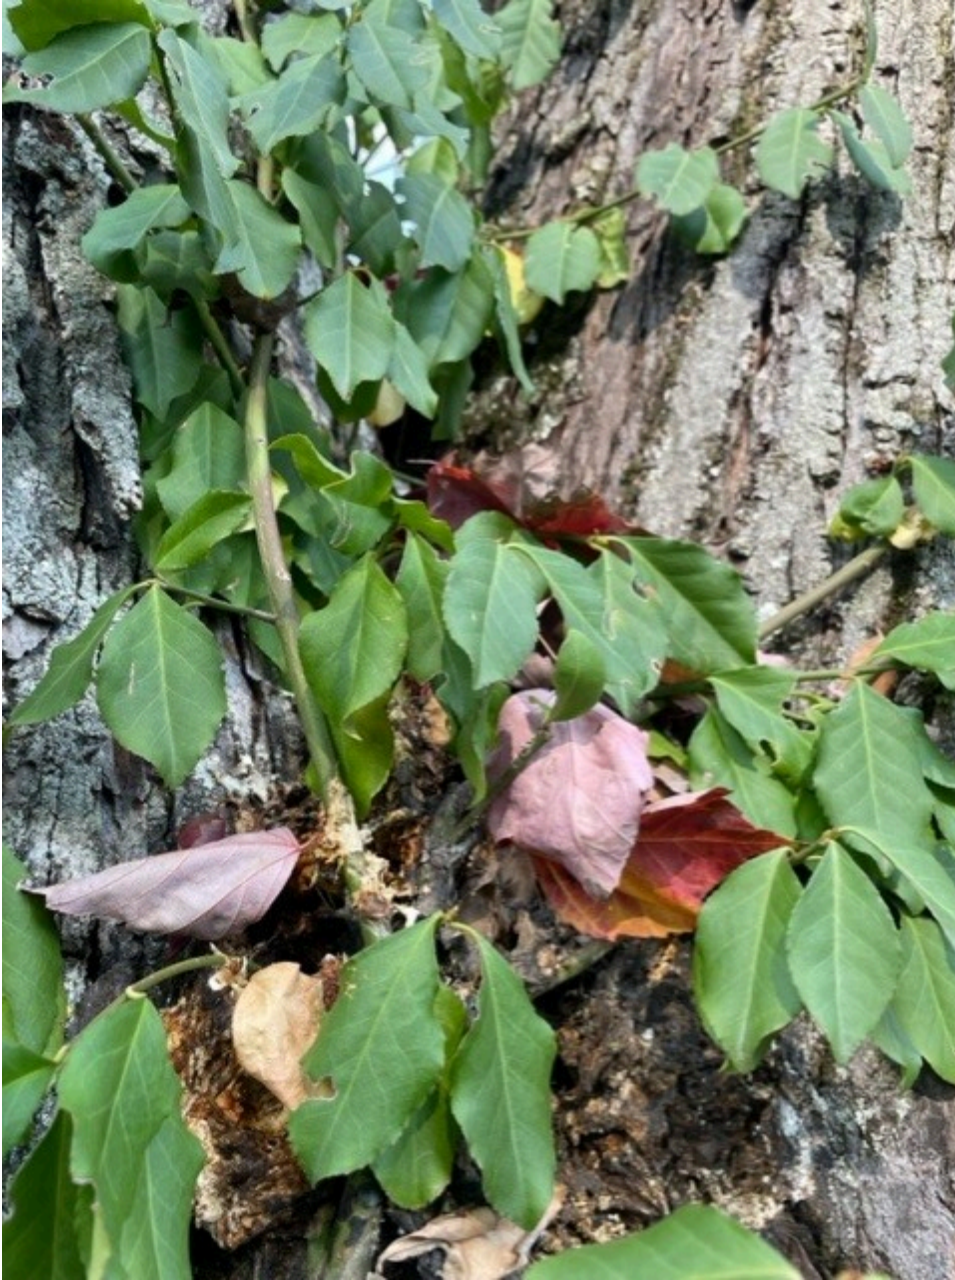
The large Red maple on the North side of the house and driveway has 3 existing steel cables to support the union where the two main stems come together. There is also decay present at this union. Additionally, there is little response growth around old existing pruning cuts indicating the overall vigor of this tree is poor. I observed two large existing wounds with decay present on the lower portions of the main stem. Removal of this tree is recommended. I have attached pictures below of the defects in this tree (the decay in the main stem attachment is partially blocked by a euonymus vine).

Below are images of Red maple North side of house/driveway 10/30
