CONNOR RESIDENCE - LANDSCAPE MASTER PLAN  
236 NORTH COLUMBIA AVENUE, BEXLEY, OHIO 43209

# Connor Residence

## 236 Columbia Ave trees

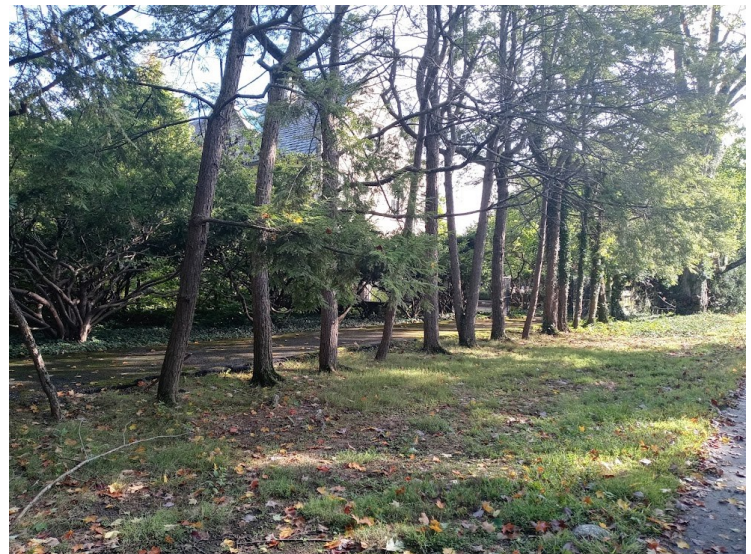
Hemlock row on North property line

The Canadian hemlocks along the North and West perimeter of this property are in fair to poor condition. The canopies are thin and have a high volume of dead limbs. A couple of the Canadian hemlocks are entirely dead. Others are infested with elongate hemlock scale which is a difficult pest to manage and will likely lead to further decline in these trees. Mature Canadian hemlock have poor regenerative growth and it is unlikely that these will ever be an effective screen or landscape plant again. Removal and replacement is recommended.

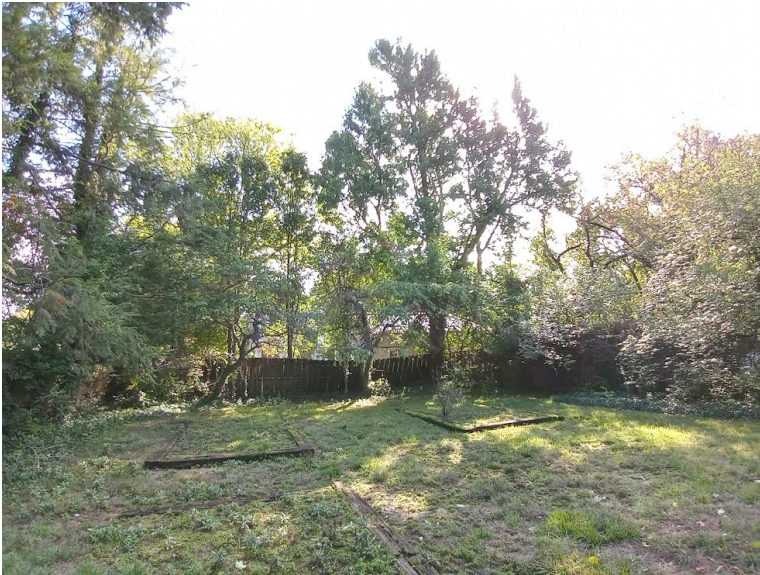
View of East property line and Large Ginkgo tree

In all, there are three mature trees I recommend making efforts to preserve on this property; the Sugar maple along the West property line, the larger of two Honeylocust trees on the SE corner of the property and the Ginkgo along the East property line (near the entrance to the Secret Garden).

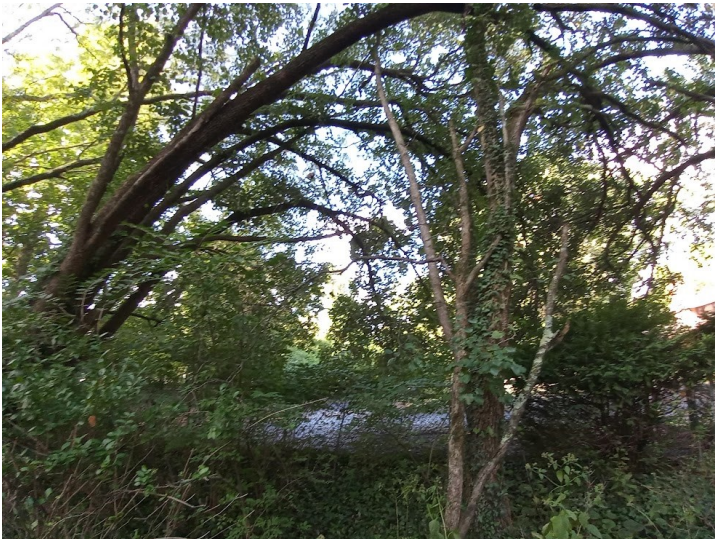
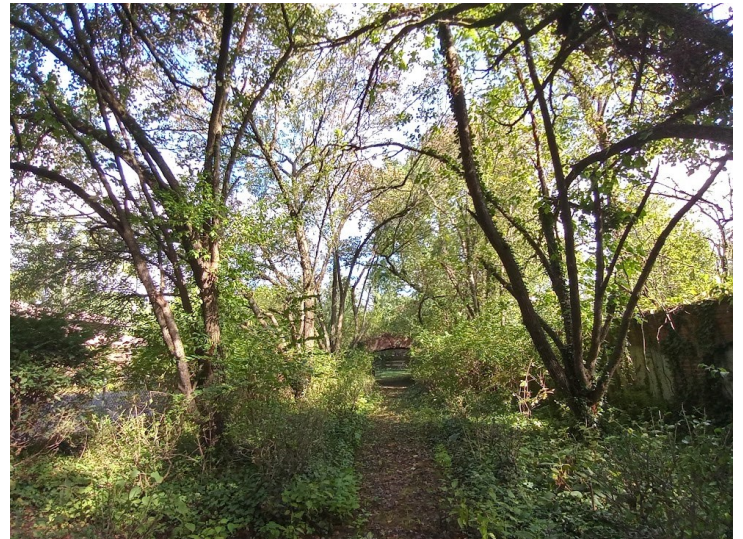
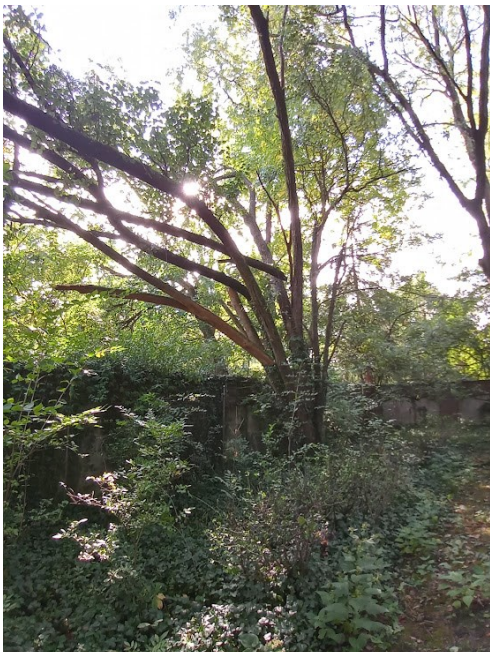
Existing Pears in "secret Garden"

The group of 10 Callery pear along the East side of the property in the secret garden have been neglected over the years and all have developed poor structure. Several of the trees have already had whole stems fail and all of the canopies have large diameter broken limbs and hangers. These trees are beyond long term preservation and removal is recommended.

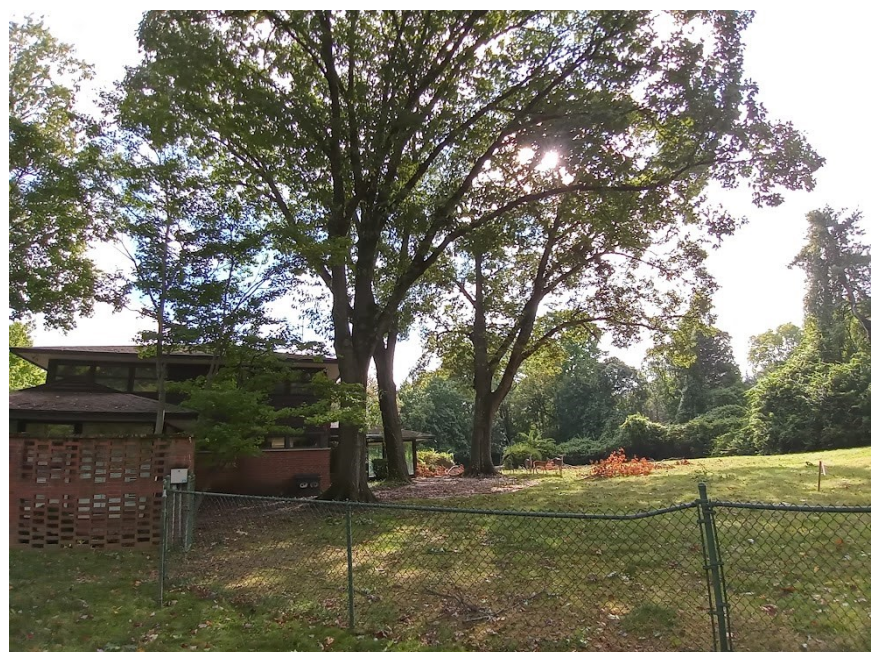
Three Oaks in the middle of the property

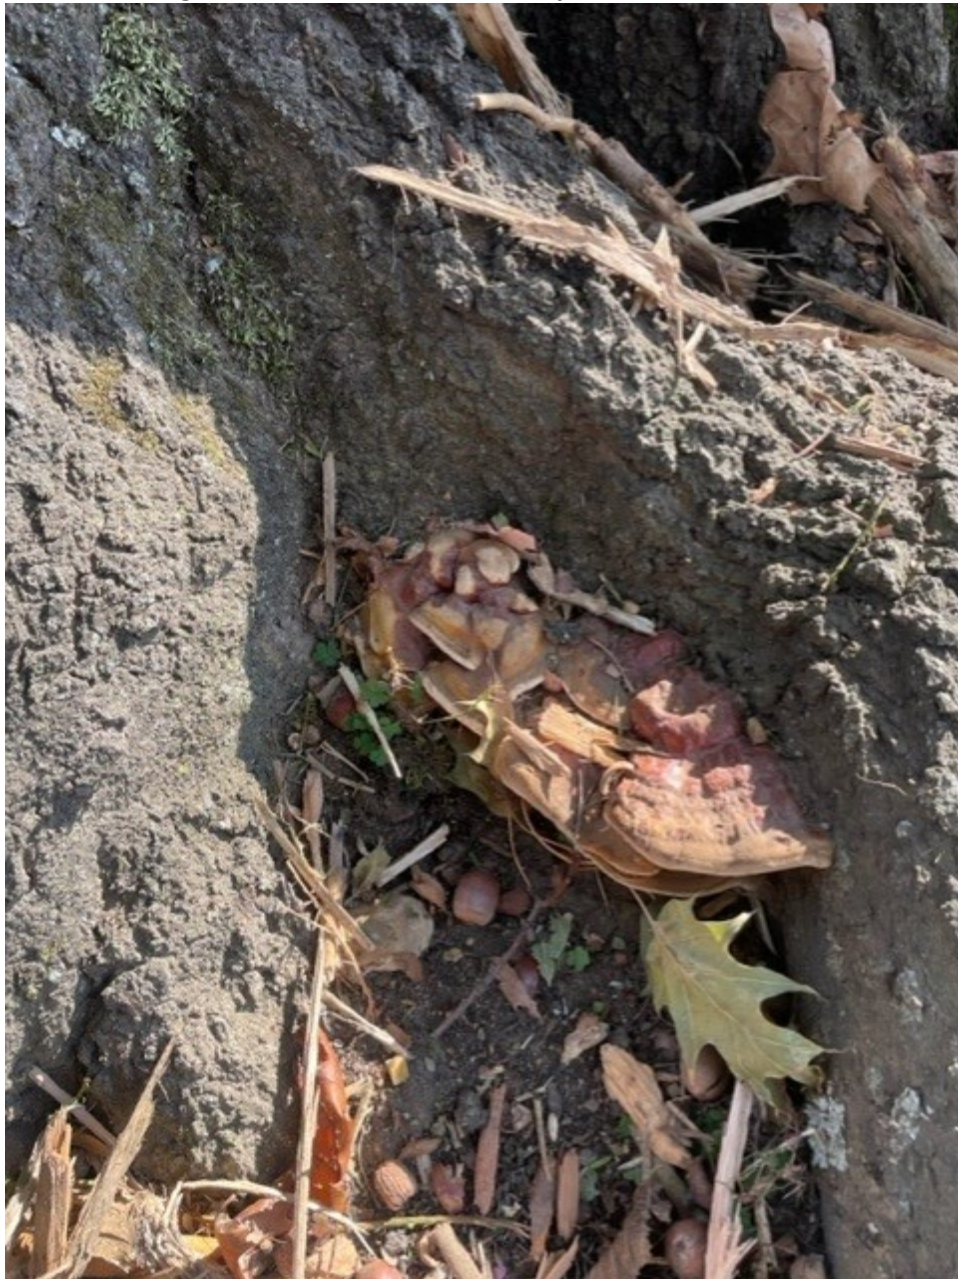
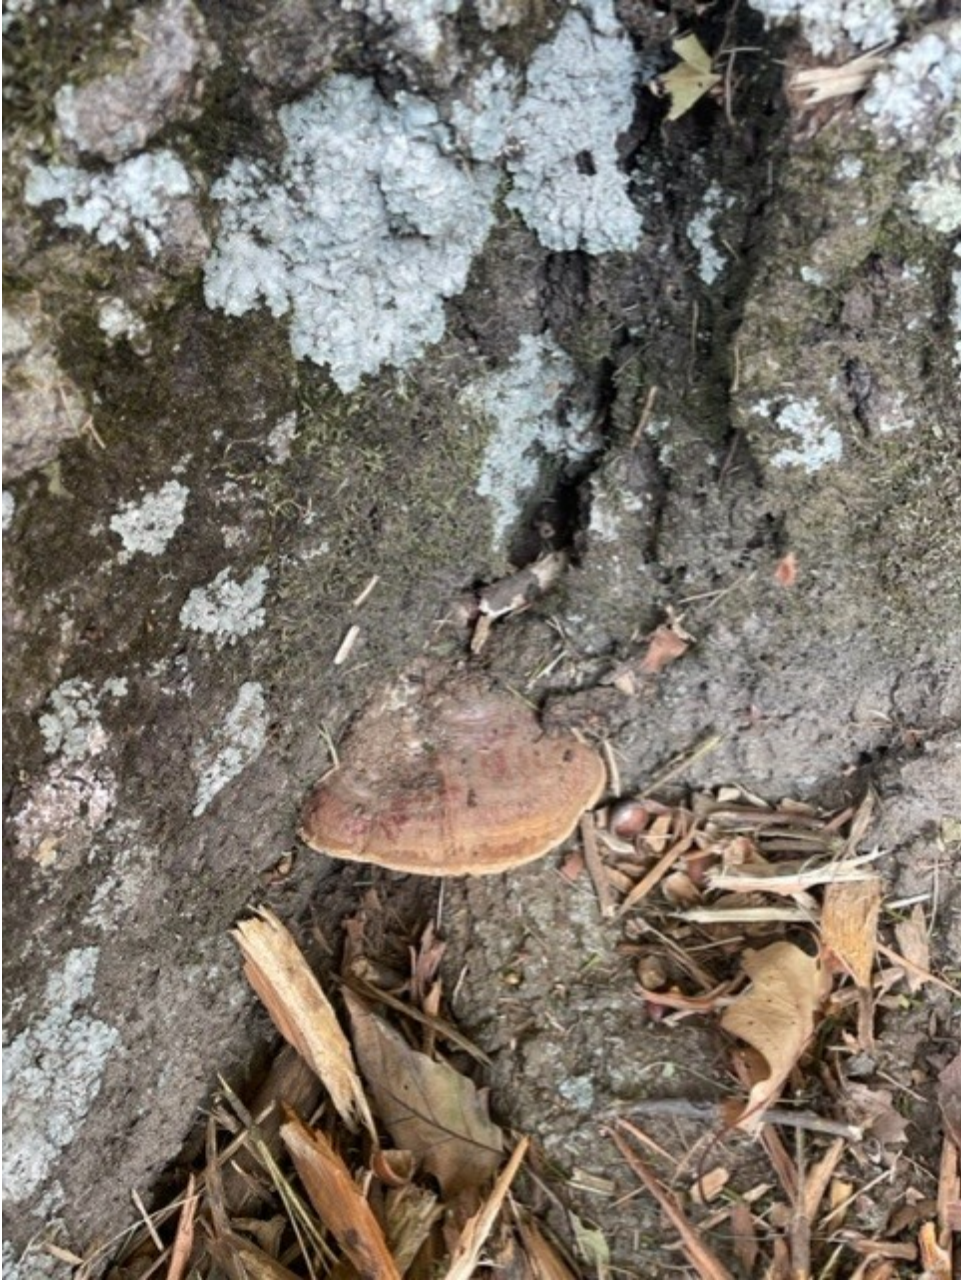
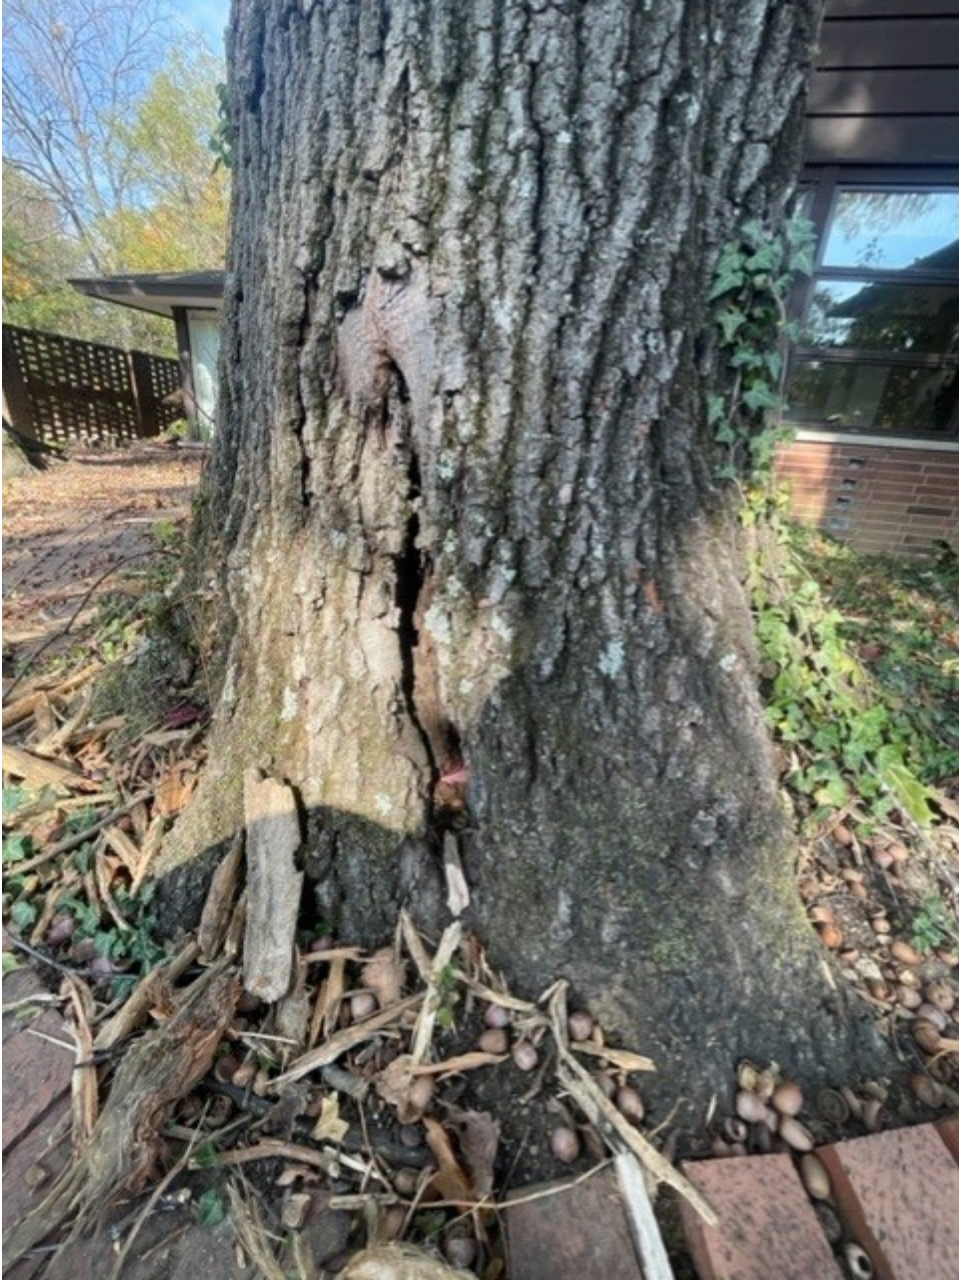
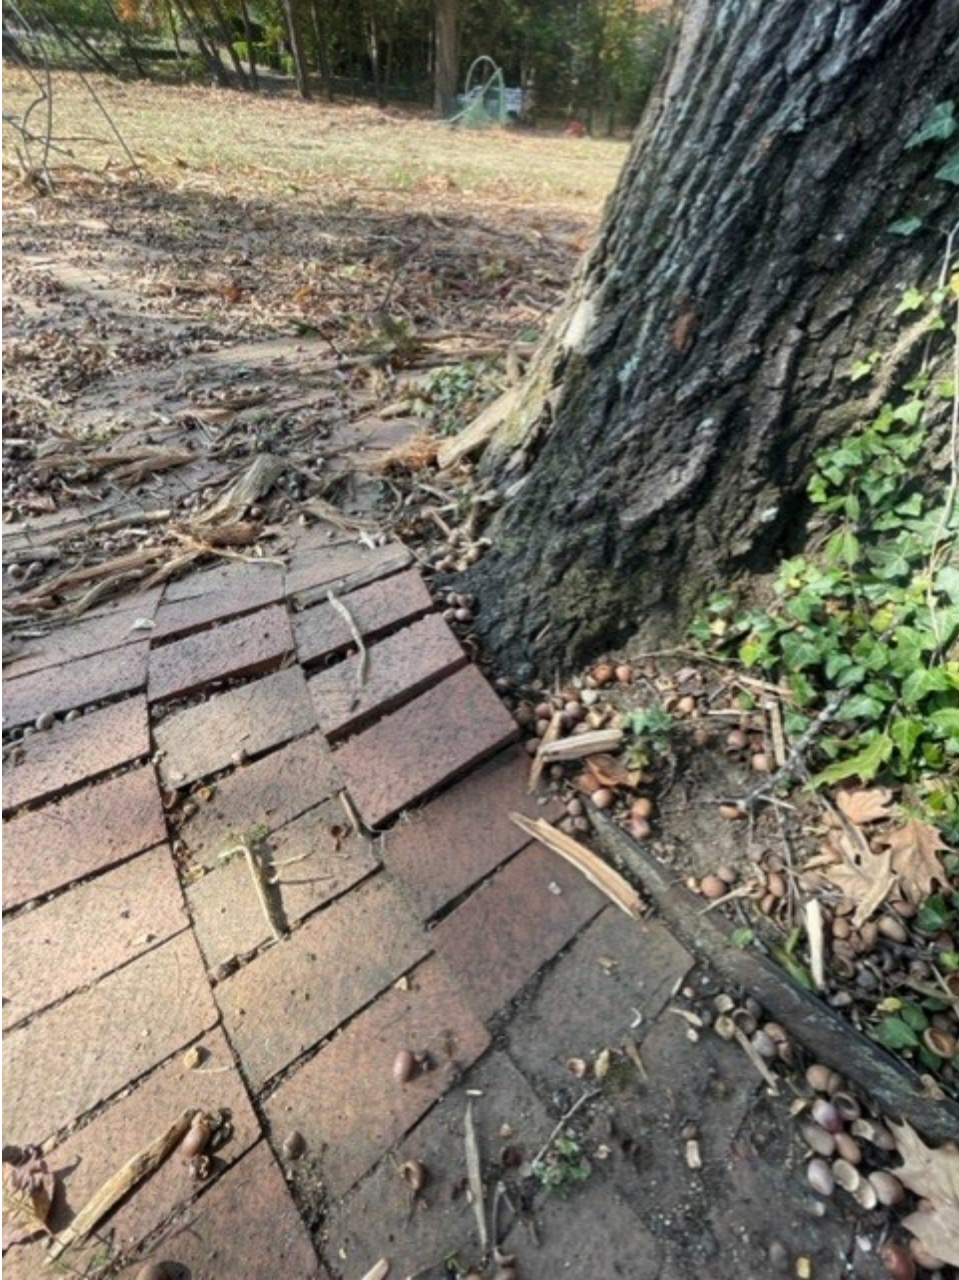
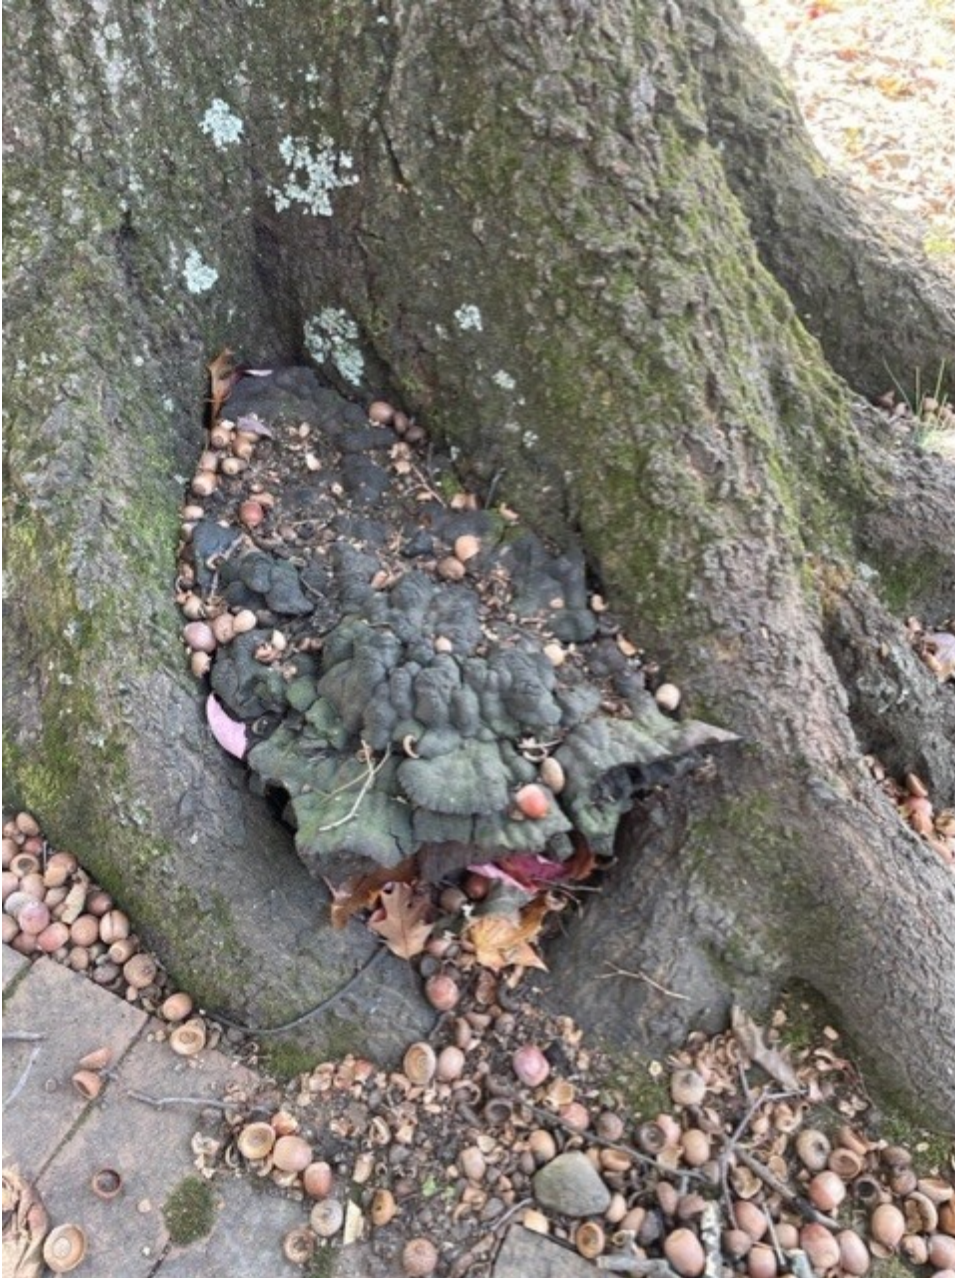
Below are images taken of the buttress root systems of three Red oak trees on SW corner of home

I observed fungal conks (which are the fruiting body of decay) and hollow cavities on the buttress roots of all three of the mature Northern Red oak on the SW corner of the house. These fungal conks are most likely the fruiting body of Ganoderma buttress rot, an aggressive decay pathogen that degrades the wood fibers of its host near ground level and ultimately impacts the stability of the tree. It is quite common for trees with Ganoderma buttress rot to fail under significant load bearing events like high winds or significant ice/snow accumulation. Removal of these three trees is recommended. I have included some photos of the defects in these trees at the bottom of this letter.

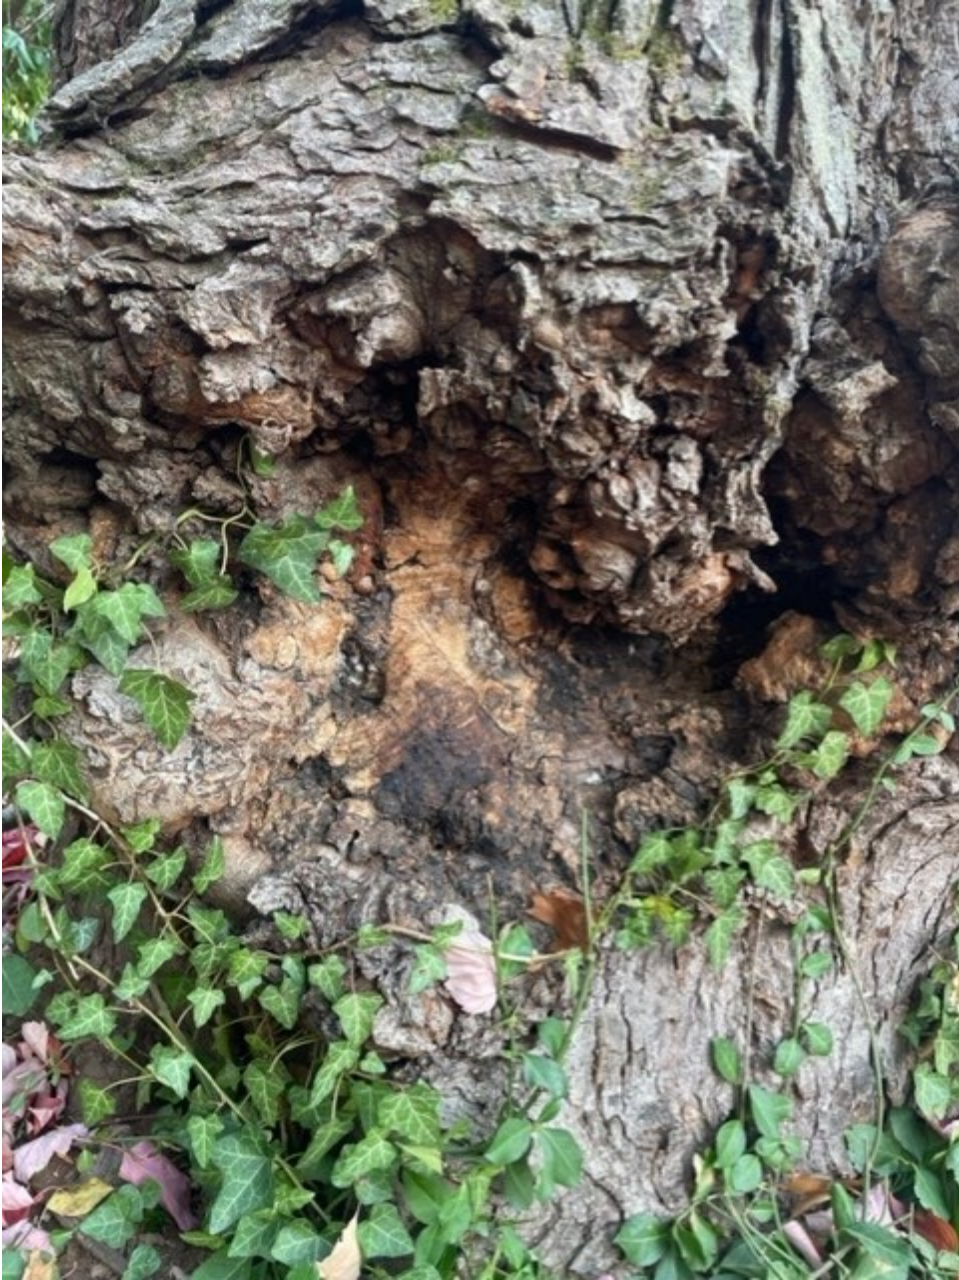
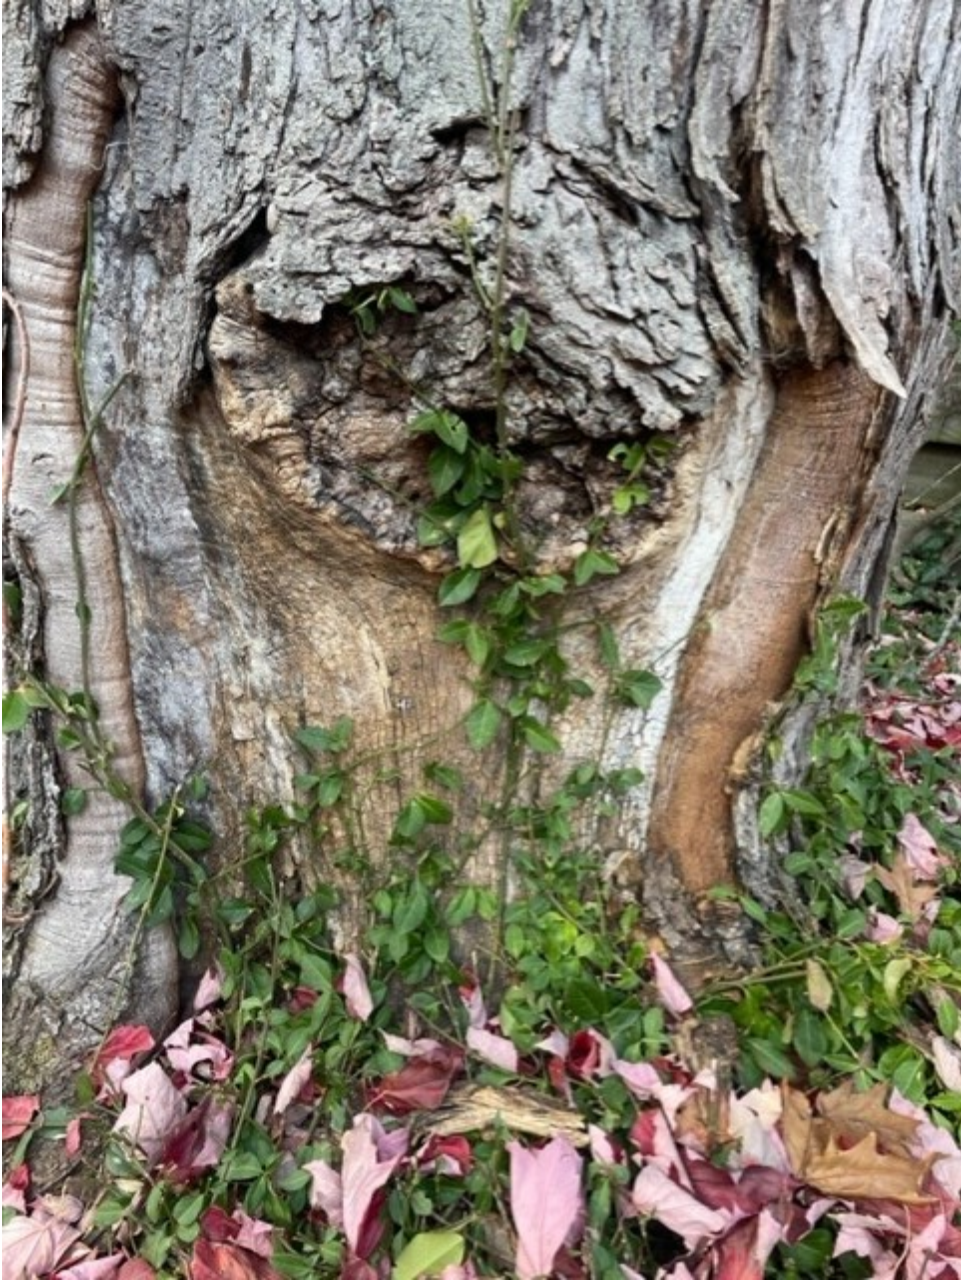
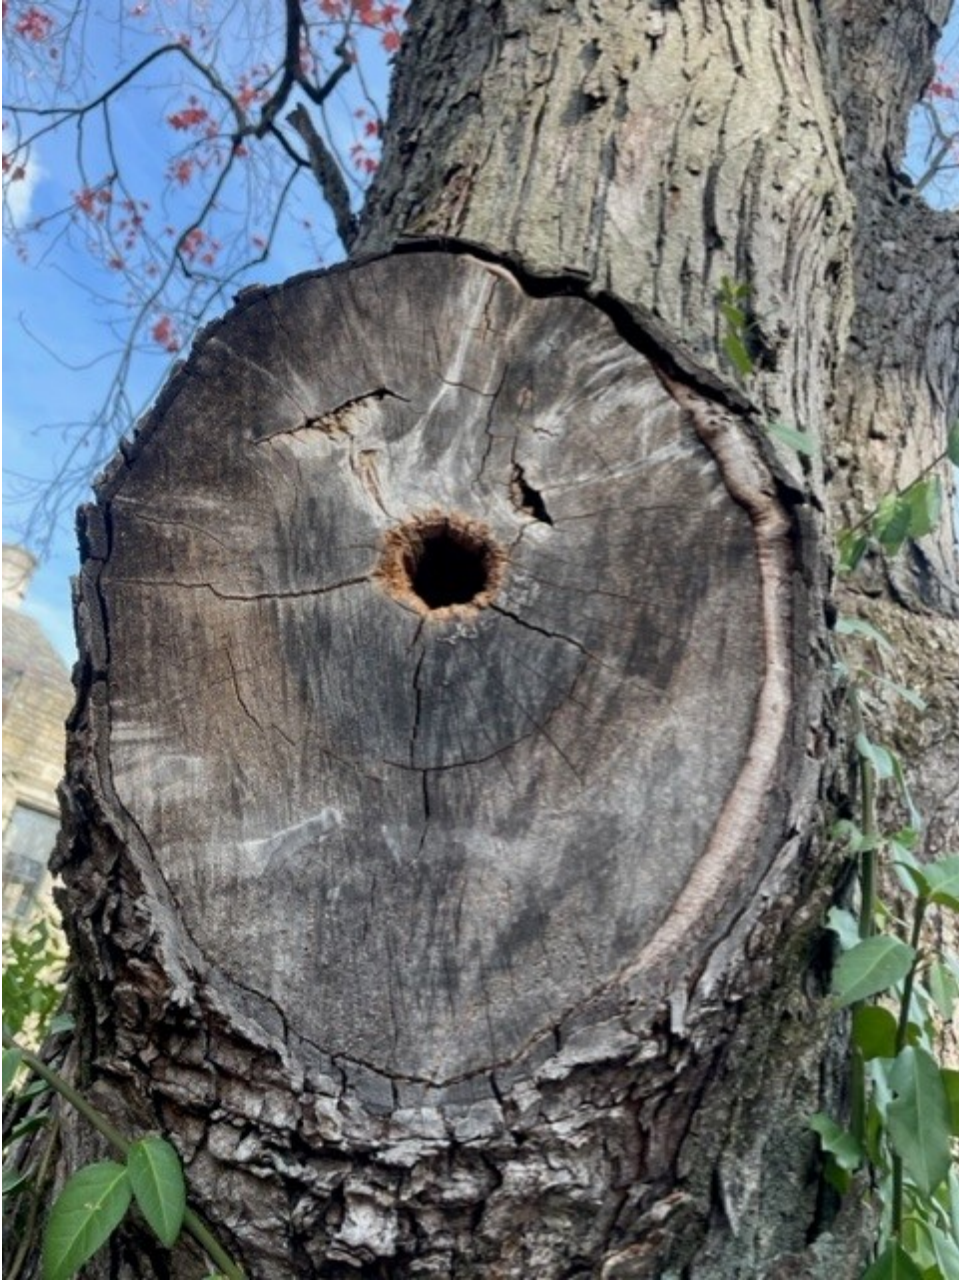
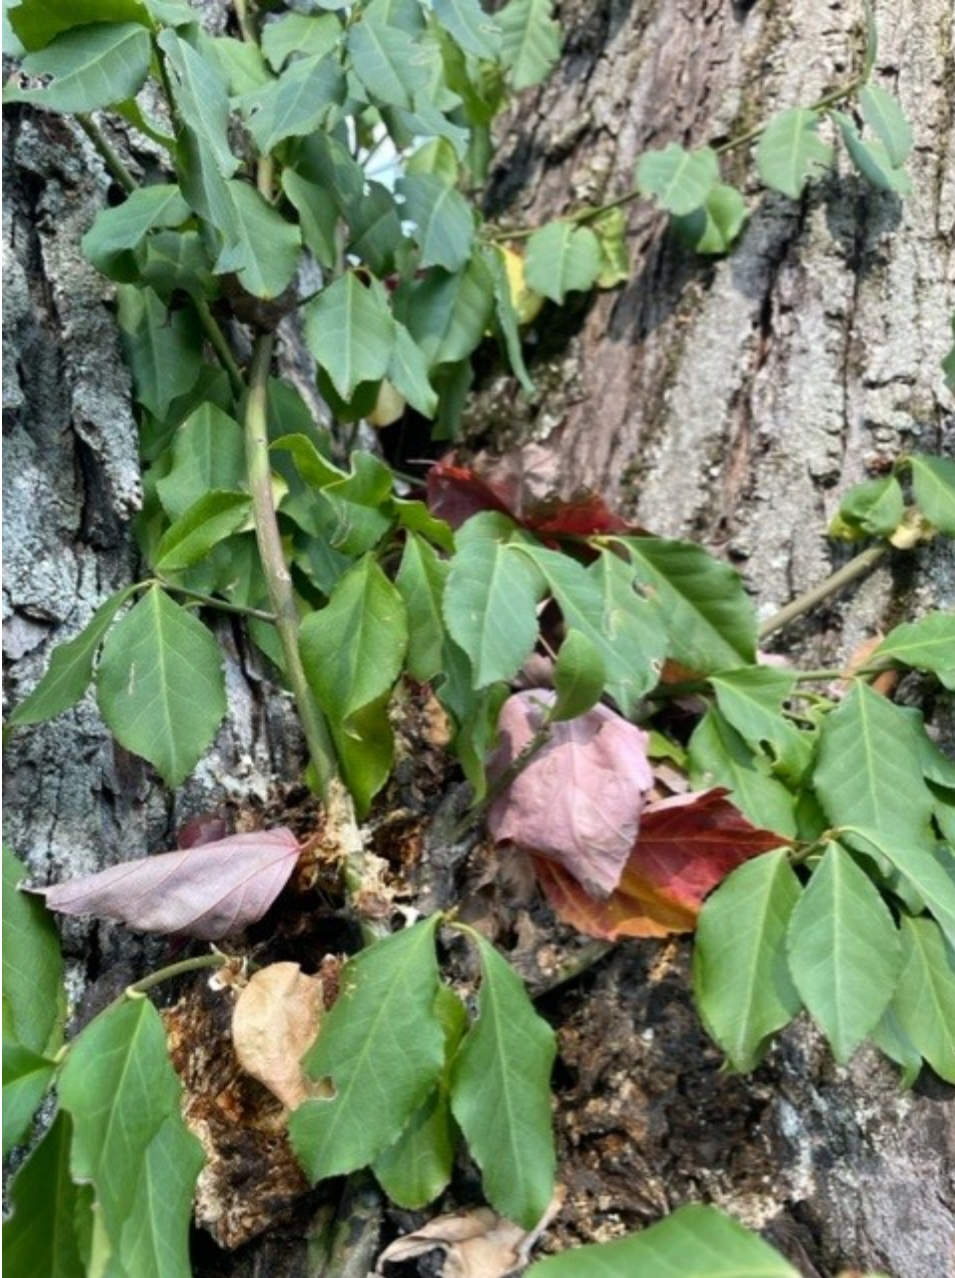
Below are images of Red maple North side of house/driveway 10/30

The large Red maple on the North side of the house and driveway has 3 existing steel cables to support the union where the two main stems come together. There is also decay present at this union. Additionally, there is little response growth around old existing pruning cuts indicating the overall vigor of this tree is poor. I observed two large existing wounds with decay present on the lower portions of the main stem. Removal of this tree is recommended. I have attached pictures below of the defects in this tree (the decay in the main stem attachment is partially blocked by a euonymus vine).
