**REPORT OF
PHASE I ENVIRONMENTAL SITE ASSESSMENT**

**PROPOSED SERVICE BUILDING SITE
MAYFIELD PLACE
BEXLEY, FRANKLIN COUNTY, OHIO**

**FOR
THE CITY OF BEXLEY**

FEBRUARY 7, 2003

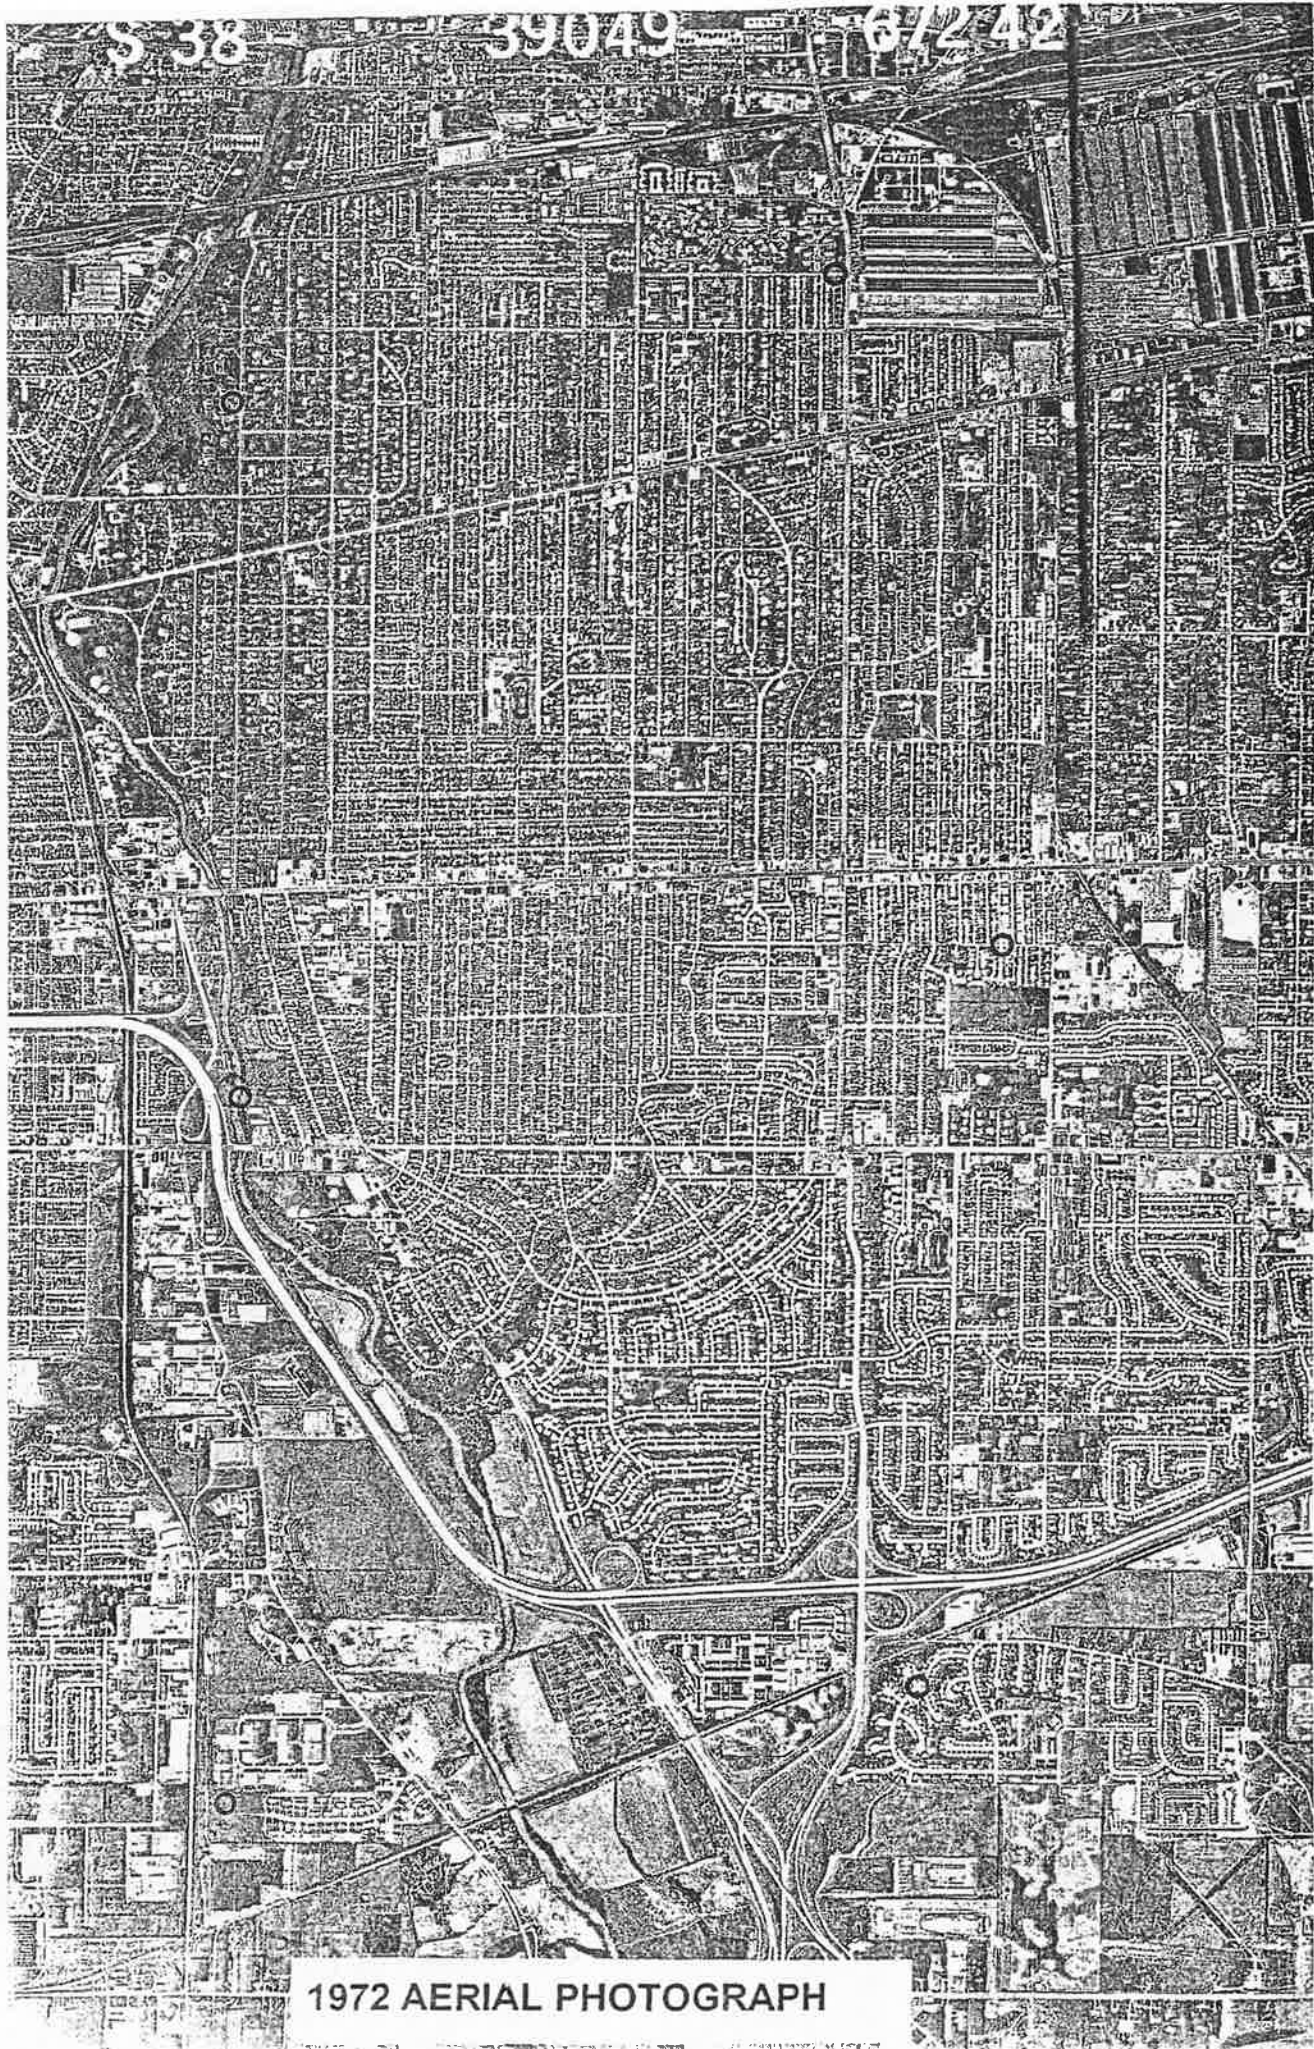
1972 AERIAL PHOTOGRAPH

No significant changes were observed to the subject site or the adjacent properties in the 1972 aerial photograph. However, a roadway similar in shape and location to present day Interstate 70 was apparent west of the site.

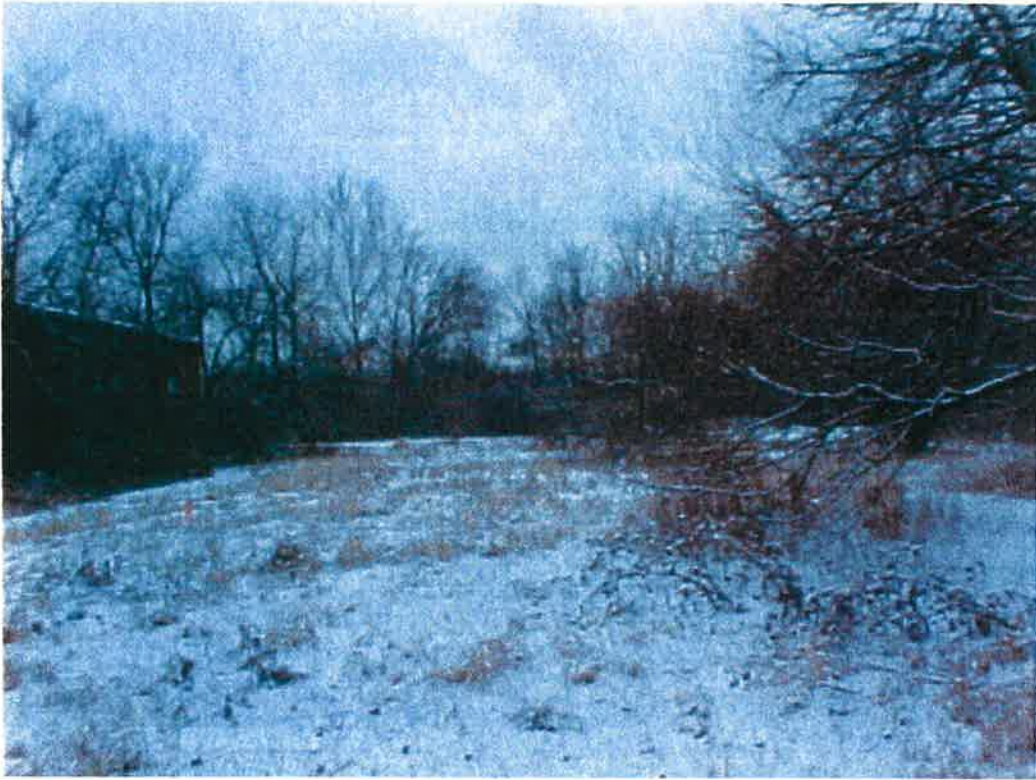
Photograph 1: General view of property looking west

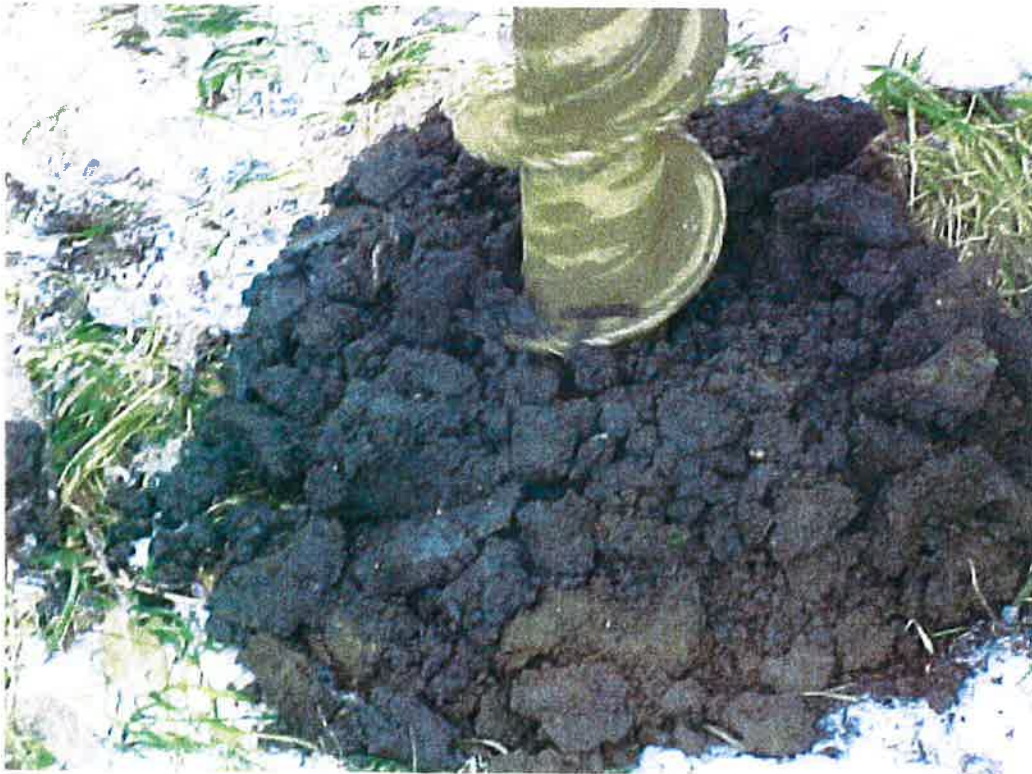
The site appeared to be undeveloped at the time of the site reconnaissance. No soil staining or stressed vegetation was observed at the site. Additionally, visible evidence indicating RECs from ASTs, USTs, PCB-containing electrical equipment, waste storage or disposal, pits, ponds, or lagoons, was not observed on the site at the time of this reconnaissance. During the site reconnaissance, drilling activities were being completed at part of a geo-technical study of the site. The soil cuttings were observed to contain glass and metal fragments. This material suggests past dumping had occurred at the site.

Photograph 6: View of soil clippings from geo-technical boring containing glass and metal fragments.

Based upon, and limited to the scope of work performed, one REC was identified at the subject site, the past use of the site as a landfill. It is HCN's opinion that soil samples collected during the geo-technical study be submitted to a laboratory for analysis of Resource Conservation and Recovery Act Metals.
