Limited Phase II Property Assessment

Bexley Ferndale Recreational Park Area
Ferndale Place
Bexley, Ohio 43209

PANDEY Environmental, LLC
4100 Horizons Drive, Suite 205
Columbus, OH 43220
Phone: 614-444-8078
www.pandeyenvironmental.com

September 12, 2018

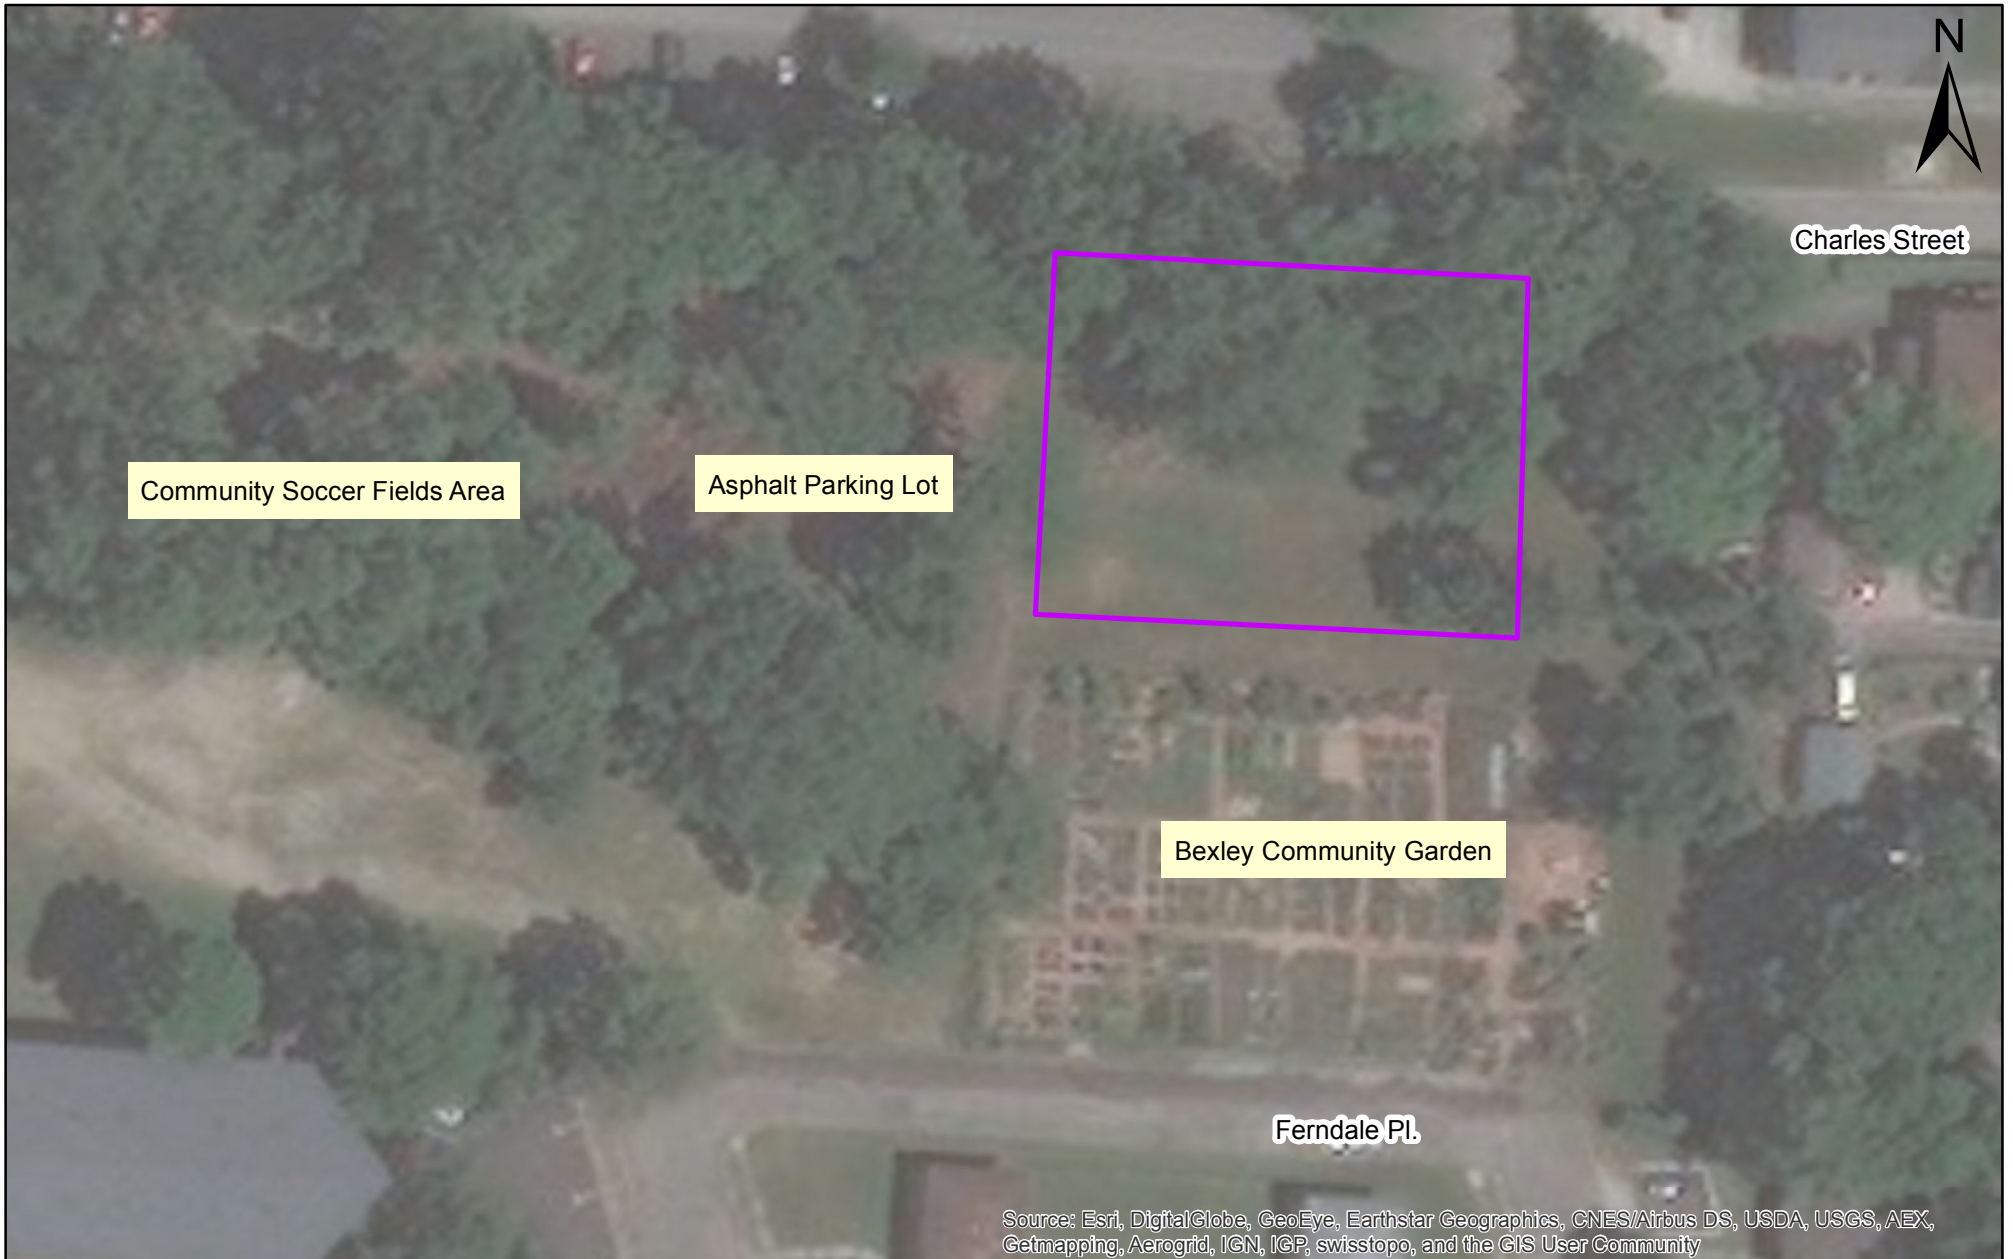
FIGURE 2: SOIL SAMPLING LOCATIONS MAP

The procedures for the sampling of soil borings HA-1 through HA-10 of this investigation are discussed below. Soil samples were analyzed by Pace Analytical Services, an Ohio EPA VAP certified laboratory. Analytical data and chain of custodies are provided in Appendix A of this report. Analytical data is summarized in Table 1 and locations of the soil bores are shown in Figures 2 and 3 of this report.

Various chemicals of concern have been identified in the 0'-2' soil horizon across the subject property during the August 2018 Limited Phase II Property Assessment. Locations of soil sample locations are shown on Figures 2 & 3, and analytical results are presented on Table 1 of this report. References to soil standards in the following discussion are to the Ohio VAP Generic Direct Contact Soil Standards for residential / unrestricted land use.

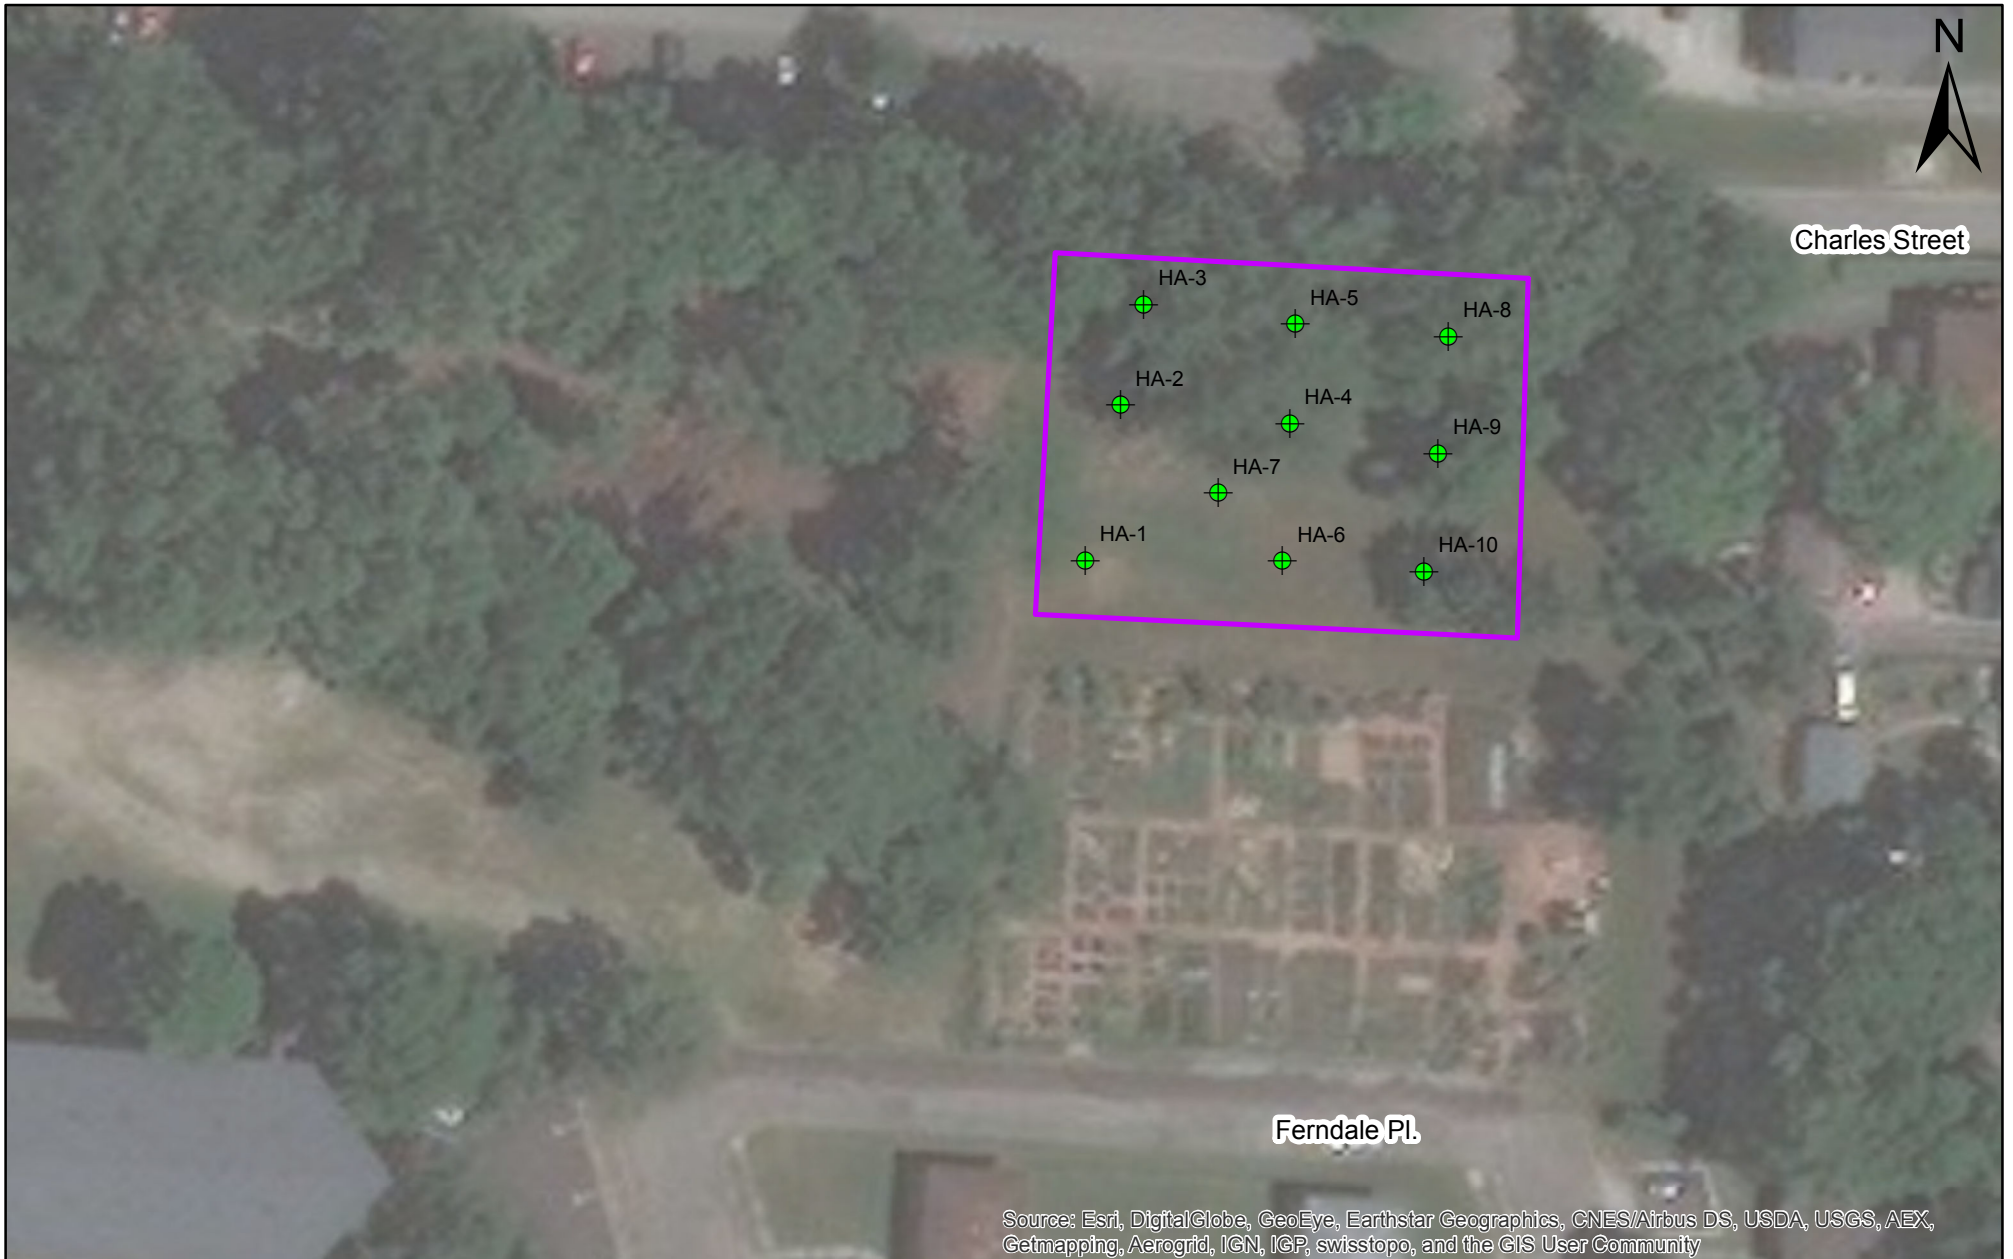
<p>Park Area Investigation Proposed Bexley Park Bexley, Ohio 43209</p> <p>Figure 2 Soil Sampling Locations Map</p>	<p>PANDEY ENVIRONMENTAL, LLC</p> <p>4100 Horizons Drive, Suite 205 Hamilton, Ohio 45011 (614) 444-8078 www.pandeyenvironmental.com</p>
--	---

A subsurface investigation was conducted on August 7, 2018 with the advancement of ten (10) soil bores (labeled HA-1, HA-2, HA-3, HA-4, HA-5, HA-6, HA-7, HA-8, HA-9 and HA-10) at the subject property. The soil borings were installed in a scatter pattern across the subject property utilizing a steel hand auger. A total of one (1) soil sample was collected from each installed soil boring. However, only five (5) soil samples were submitted for laboratory analysis. The five (5) samples chosen for laboratory submittal were chosen in a manner to obtain representative data for across the entire subject property and were biased towards soil samples that were observed to contain fill materials. Soils across the 0'-2' soil horizon across the subject property were observed to be predominantly brown sand & gravel with some silty clay. The presence of fill materials including glass shards, plastic fragments, brick fragments, etc. were observed in nearly all borings across the subject property. Although it should be noted that the heaviest volume of fill materials observed in soil were located predominantly in the western and central portions of the subject property.

Property Boundary (Proposed Park Location)
