236 NORTH COLUMBIA AVE
BEXLEY, OH
SITE PLAN

Connor Residence

236 Columbia Ave trees

CONNOR RESIDENCE - LANDSCAPE MASTER PLAN
236 NORTH COLUMBIA AVENUE, BEXLEY, OHIO 43209

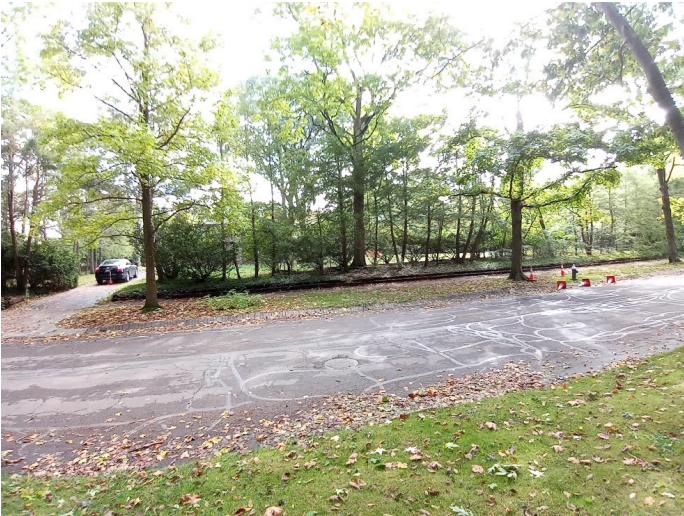
View East to property from Across the street

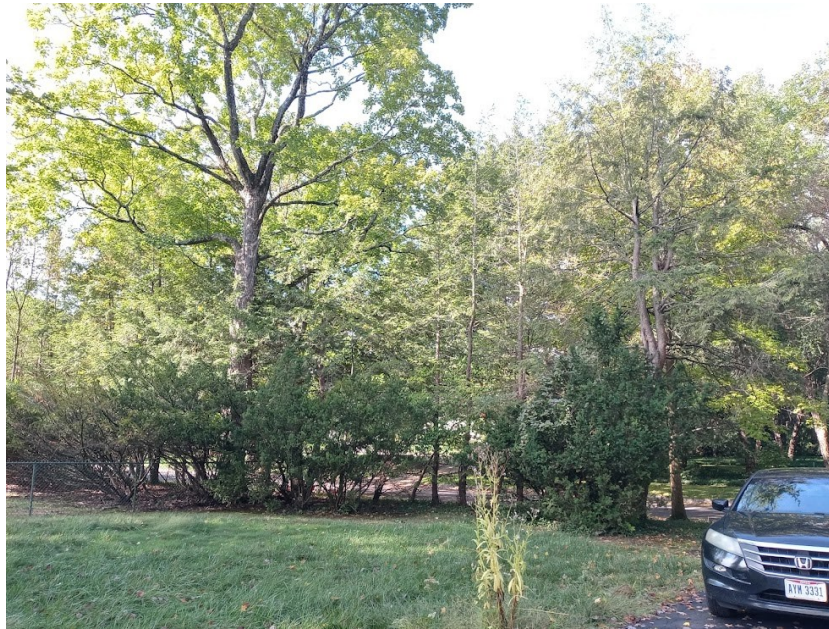
View West from driveway of large Maple near the street

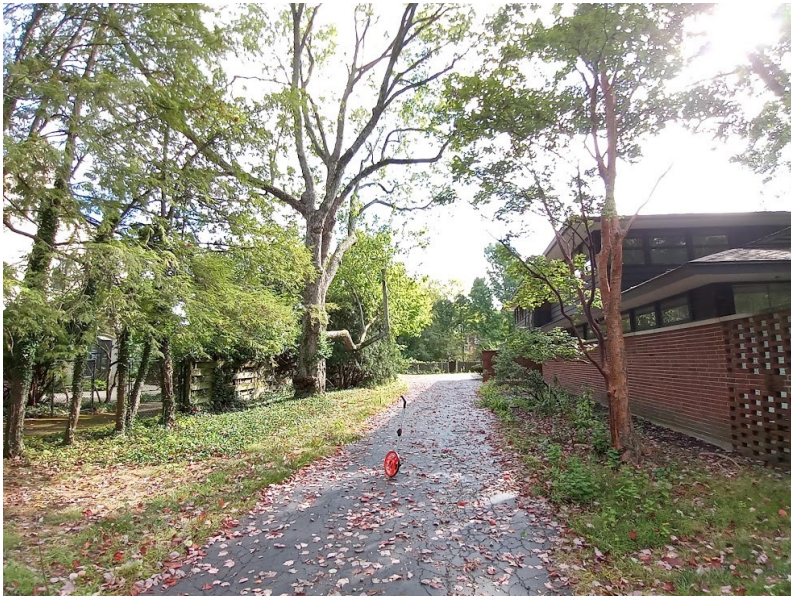
View East up driveway of Hemlock row, large Maple and Paper Bark Maple

The large Red maple on the North side of the house and driveway has 3 existing steel cables to support the union where the two main stems come together. There is also decay present at this union. Additionally, there is little response growth around old existing pruning cuts indicating the overall vigor of this tree is poor. I observed two large existing wounds with decay present on the lower portions of the main stem. Removal of this tree is recommended. I have attached pictures below of the defects in this tree (the decay in the main stem attachment is partially blocked by a euonymus vine).

The Canadian hemlocks along the North and West perimeter of this property are in fair to poor condition. The canopies are thin and have a high volume of dead limbs. A couple of the Canadian hemlocks are entirely dead. Others are infested with elongate hemlock scale which is a difficult pest to manage and will likely lead to further decline in these trees. Mature Canadian hemlock have poor regenerative growth and it is unlikely that these will ever be an effective screen or landscape plant again. Removal and replacement is recommended.

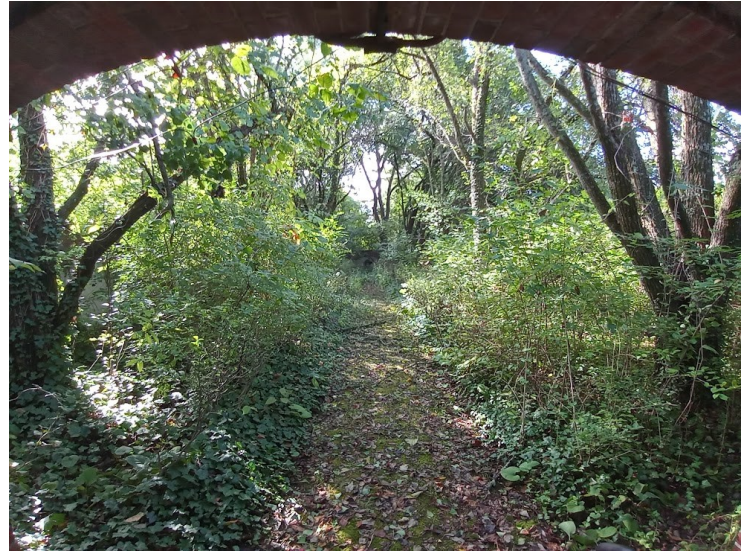
View South into "secret garden":

The group of 10 Callery pear along the East side of the property in the secret garden have been neglected over the years and all have developed poor structure. Several of the trees have already had whole stems fail and all of the canopies have large diameter broken limbs and hangers. These trees are beyond long term preservation and removal is recommended.
