CITY OF BEXLEY, OHIO

FINAL OEPA SUMMARY OF
SANITARY SEWER EVALUATION SURVEY FINDINGS
AND IMPLEMENTATION SCHEDULE

February 11, 2014

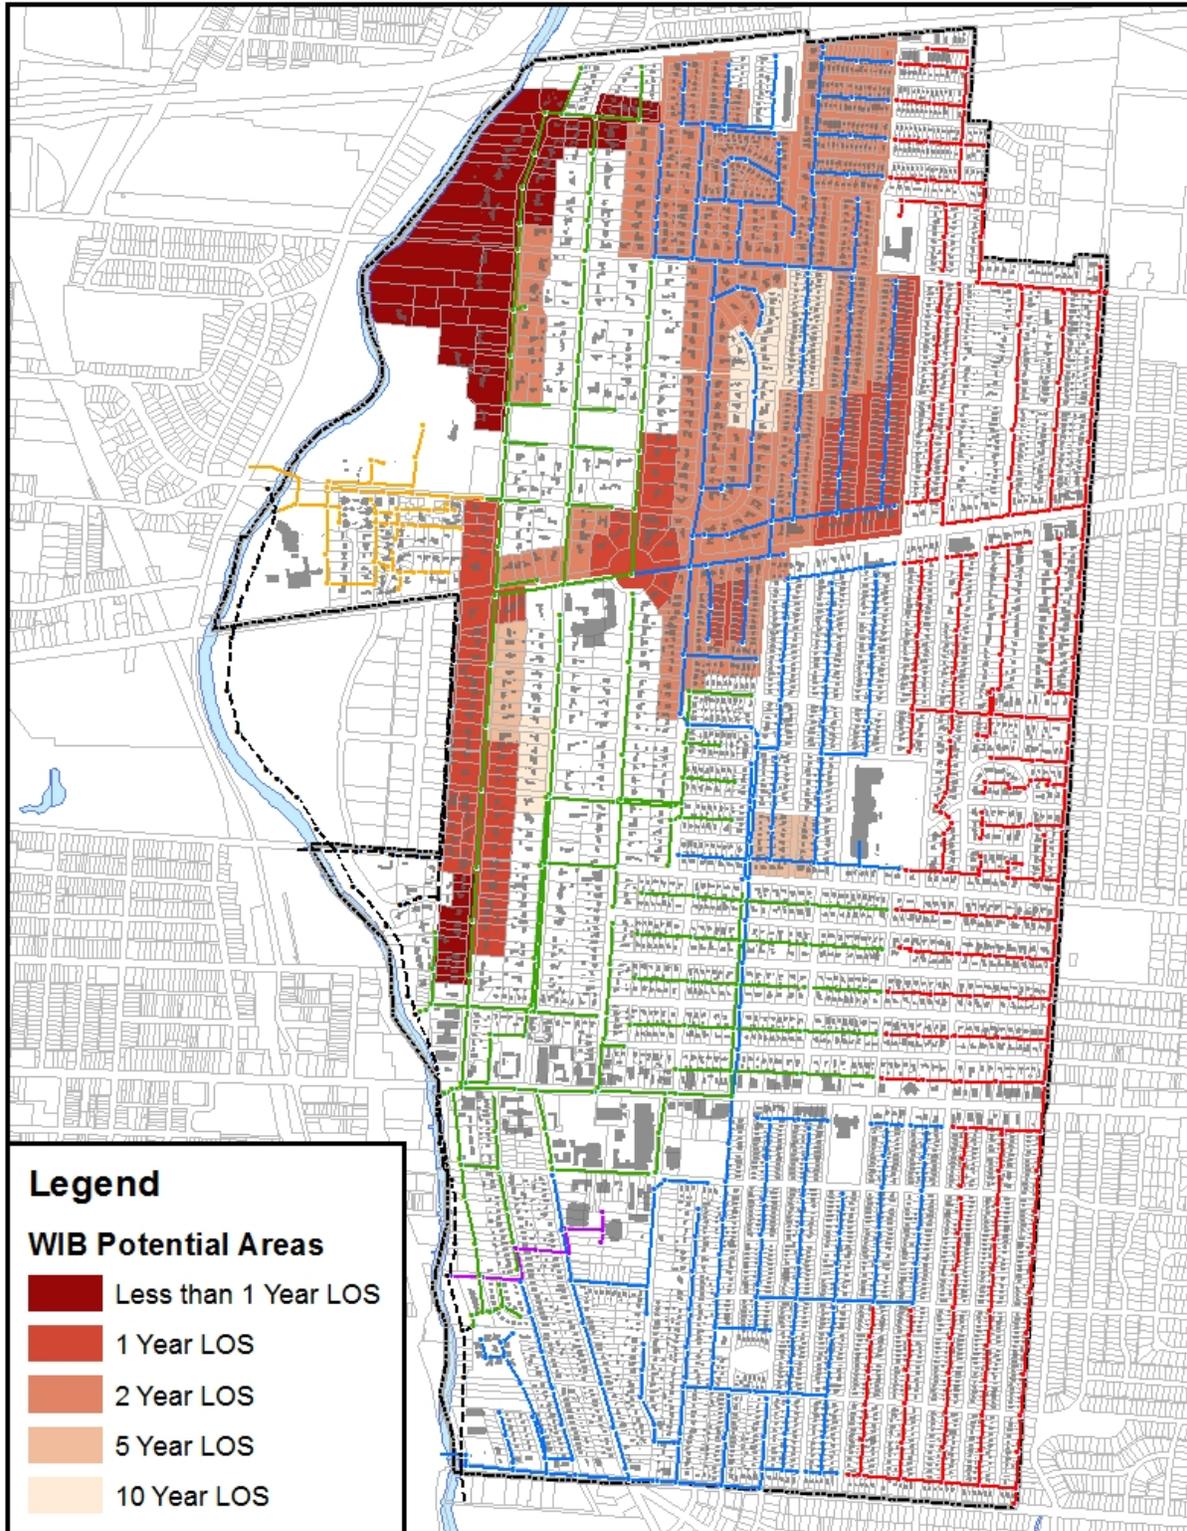
Figure 5-10: Existing System Potential for WIBs

The capacity issues in the system produce high surcharge that has the potential to cause water-in-basements. To determine where this potential exists, the highest hydraulic grade line (HGL) elevation in the model, which is estimated at each manhole, is compared to the ground elevation of the surrounding buildings. If the HGL is within 8 feet of the ground elevation, then potential for a WIB is considered. **Figure 5-10** illustrates the zones where there is potential for WIBs at each LOS.

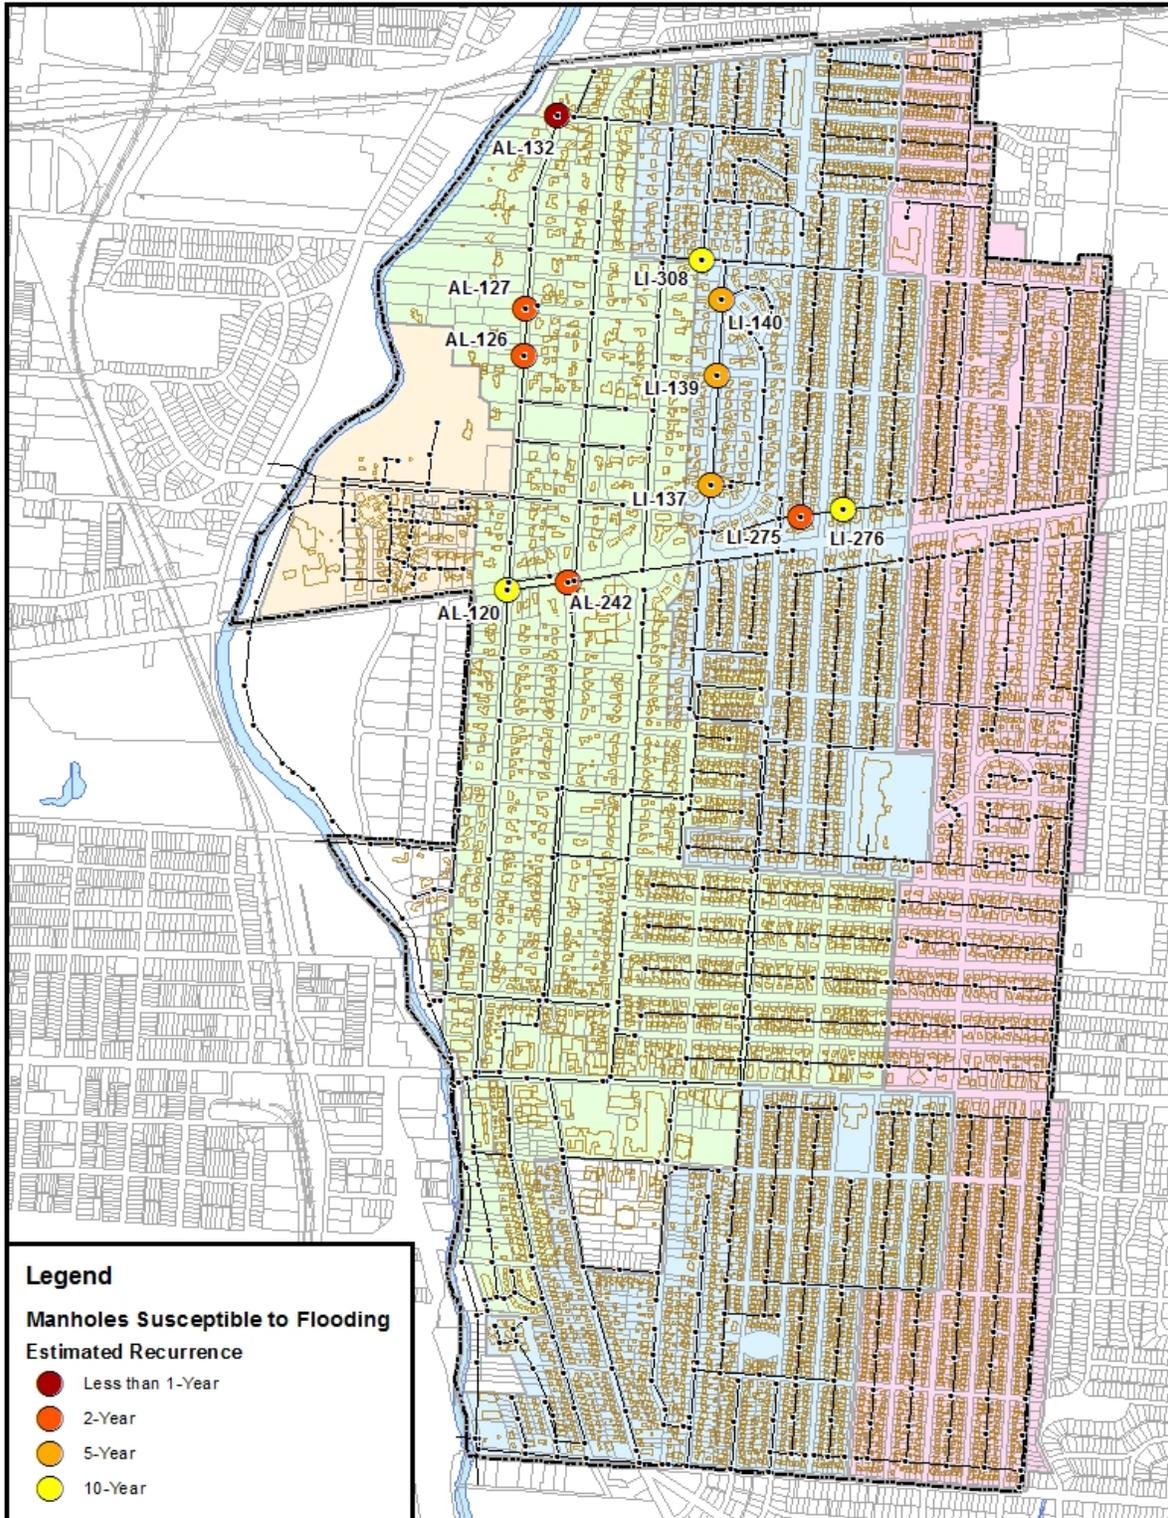
Figure 5-11: Existing System Potential for Manhole Flooding

The hydraulic model has identified 11 manholes that are susceptible to flooding due to the capacity issues and high surcharging in the existing system. **Table 5-5** lists the susceptible manholes, their location, and the frequency of occurrence. **Figure 5-11** illustrates the location of the flooded manholes.

No.	MH#	Location	Frequency of Occurrence	Potential Flooded Volume for 10-year LOS
1	AL-132	Parkview Ave. at Caroline Ave.	Less than 1-year	0.222 MG
2	AL-127	Parkview Ave. at Boston Ave.	2-year	0.049 MG
3	AL-126	Parkview Ave. south of Boston Ave.	2-year	0.018 MG
4	LI-275	Alley north of Broad St, between Cassady Ave. and Ardmore Rd.	2-year	0.144 MG
5	AL-242	Broad St. at Columbia Ave.	2-year	0.107 MG
6	LI-140	Stanberry Ave. at Ashbourne Rd.	5-year	0.131 MG
7	LI-139	Stanberry Ave. at Denver Ave.	5-year	0.018 MG
8	LI-137	Stanberry Ave. north of Clifton Ave.	5-year	0.068 MG
9	LI-276	Alley north of Broad St, between Ardmore Rd. and Cassingham Rd.	10-year	0.033 MG
10	AL-120	Parkview Ave. at Broad St.	10-year	0.014 MG
11	LI-308	Maryland Ave. at Northview Dr.	10-year	0.004 MG
