CONNOR RESIDENCE - LANDSCAPE MASTER PLAN  
236 NORTH COLUMBIA AVENUE, BEXLEY, OHIO 43209

# Connor Residence

## 236 Columbia Ave trees

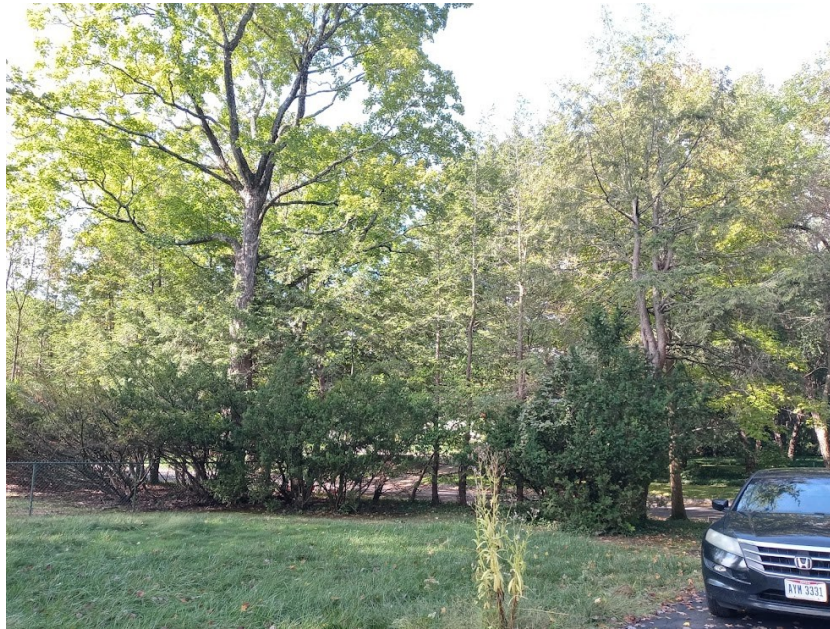
View West from driveway of large Maple near the street

The large Red maple on the North side of the house and driveway has 3 existing steel cables to support the union where the two main stems come together. There is also decay present at this union. Additionally, there is little response growth around old existing pruning cuts indicating the overall vigor of this tree is poor. I observed two large existing wounds with decay present on the lower portions of the main stem. Removal of this tree is recommended. I have attached pictures below of the defects in this tree (the decay in the main stem attachment is partially blocked by a euonymus vine).

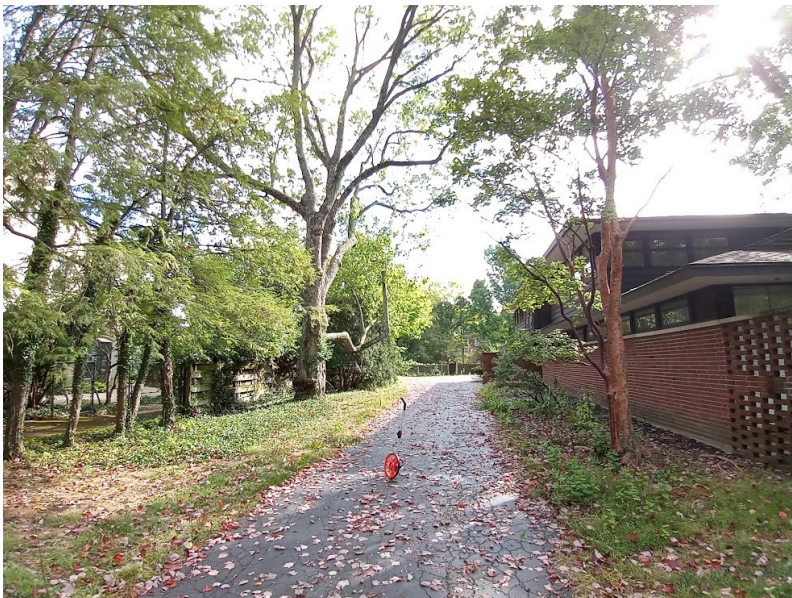
View East up driveway of Hemlock row, large Maple and Paper Bark Maple

The Canadian hemlocks along the North and West perimeter of this property are in fair to poor condition. The canopies are thin and have a high volume of dead limbs. A couple of the Canadian hemlocks are entirely dead. Others are infested with elongate hemlock scale which is a difficult pest to manage and will likely lead to further decline in these trees. Mature Canadian hemlock have poor regenerative growth and it is unlikely that these will ever be an effective screen or landscape plant again. Removal and replacement is recommended.

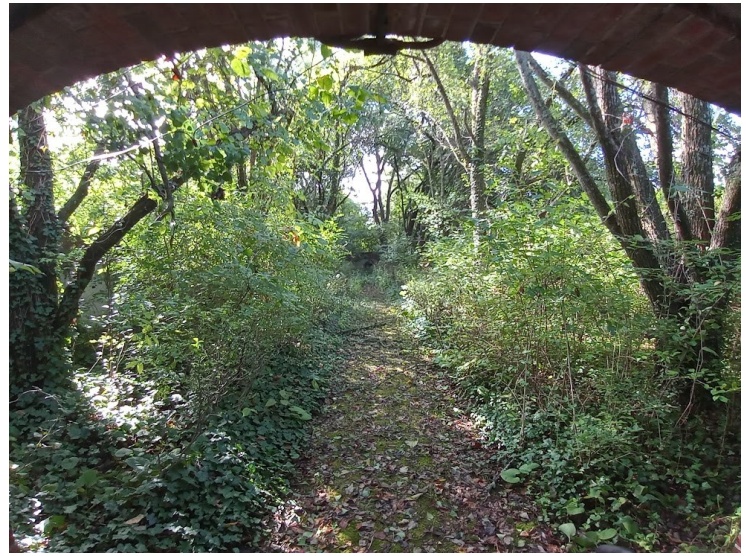
View South into "secret garden":

The group of 10 Callery pear along the East side of the property in the secret garden have been neglected over the years and all have developed poor structure. Several of the trees have already had whole stems fail and all of the canopies have large diameter broken limbs and hangers. These trees are beyond long term preservation and removal is recommended.
