**Phase I & II  
Environmental Site Assessment**

**Franklin County Parcels 020-000157  
and 020-003693  
Sheridan Avenue  
Bexley, Ohio 43209**

**Prepared for:  
City of Bexley  
2242 East Main Street  
Bexley, Ohio 43209**

**May 2007**

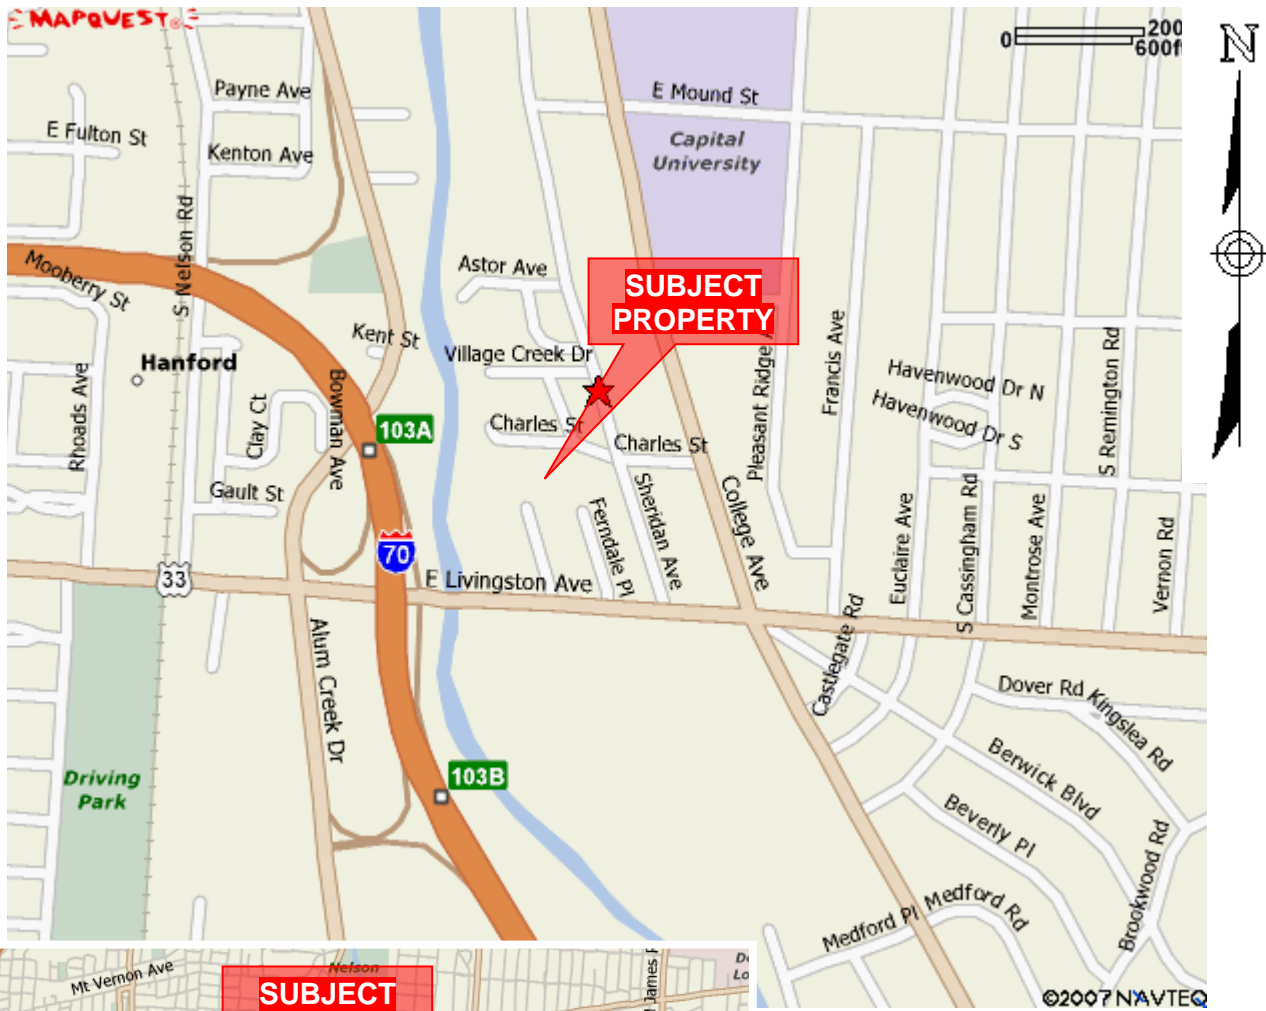
FIGURE 1 – Vicinity Map

The subject property is located on approximately 1.406 acres of land located on Franklin County Parcels 020-000157 and 020-003693. The property is located adjacent to Sheridan Avenue in the southwestern portion of Bexley and the central portion of Franklin County. Bexley is located east of the City of Columbus. The location of the subject property is shown in Figure 1 and a parcel map is shown in Figure 2.

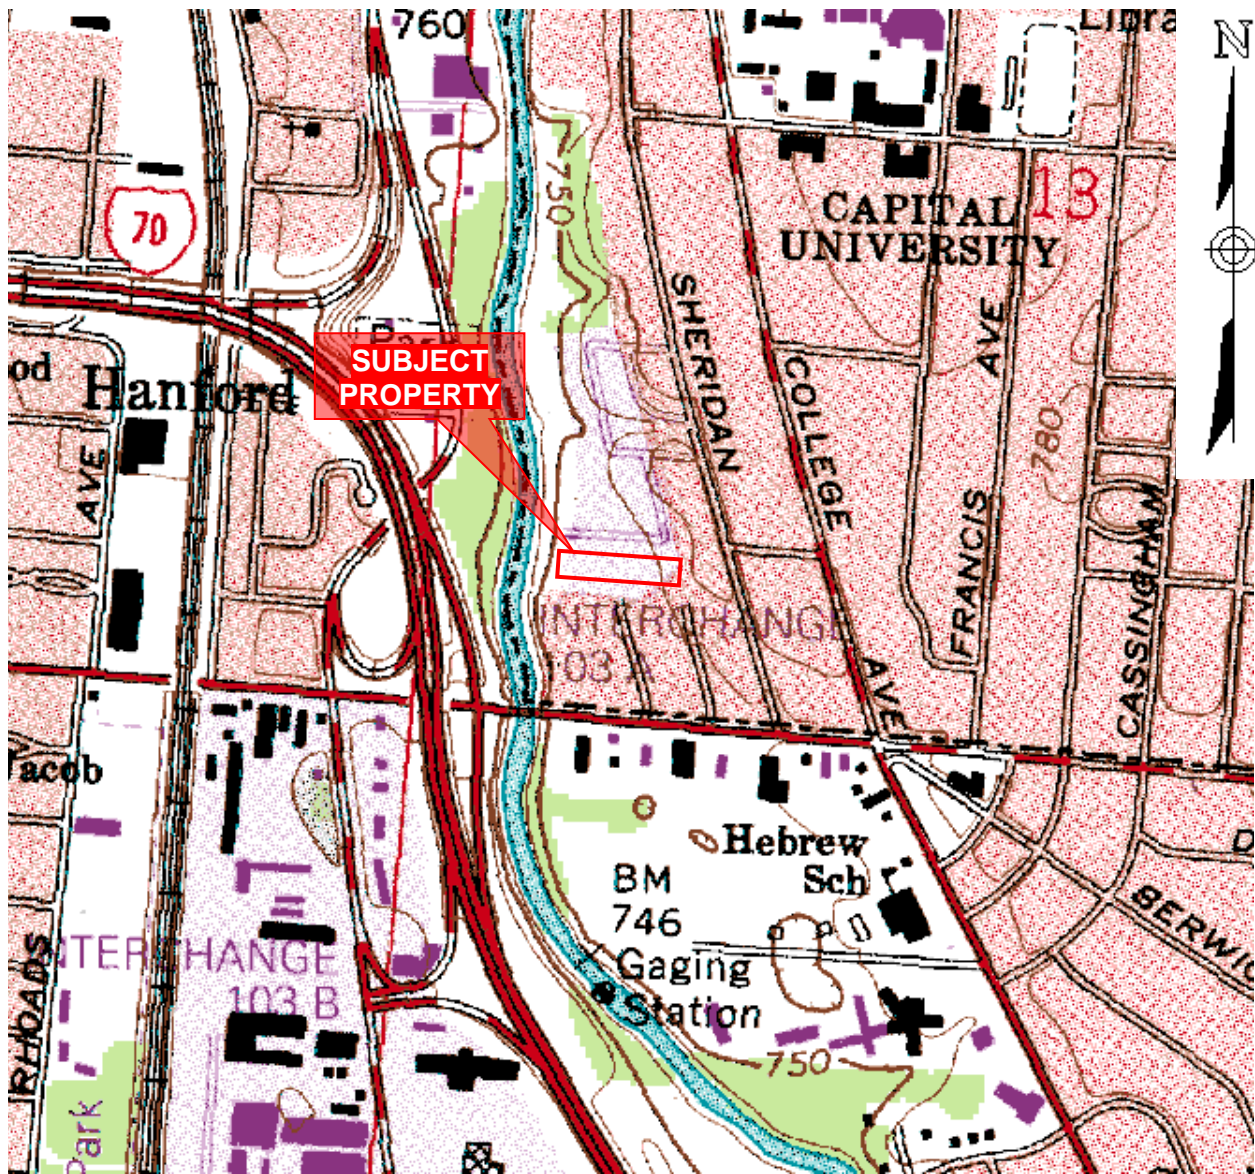
FIGURE 3 – USGS 7.5 Minute Topographic Map

The subject property is shown on the United States Geological Survey's topographic map of the Southeast Columbus, Ohio quadrangle at approximate coordinates of 39.9499 north latitude and 82.9408 west longitude. Topography at the site is gently rolling and peaks at approximately 750 feet above mean sea level. A topographic map is presented in Figure 3.

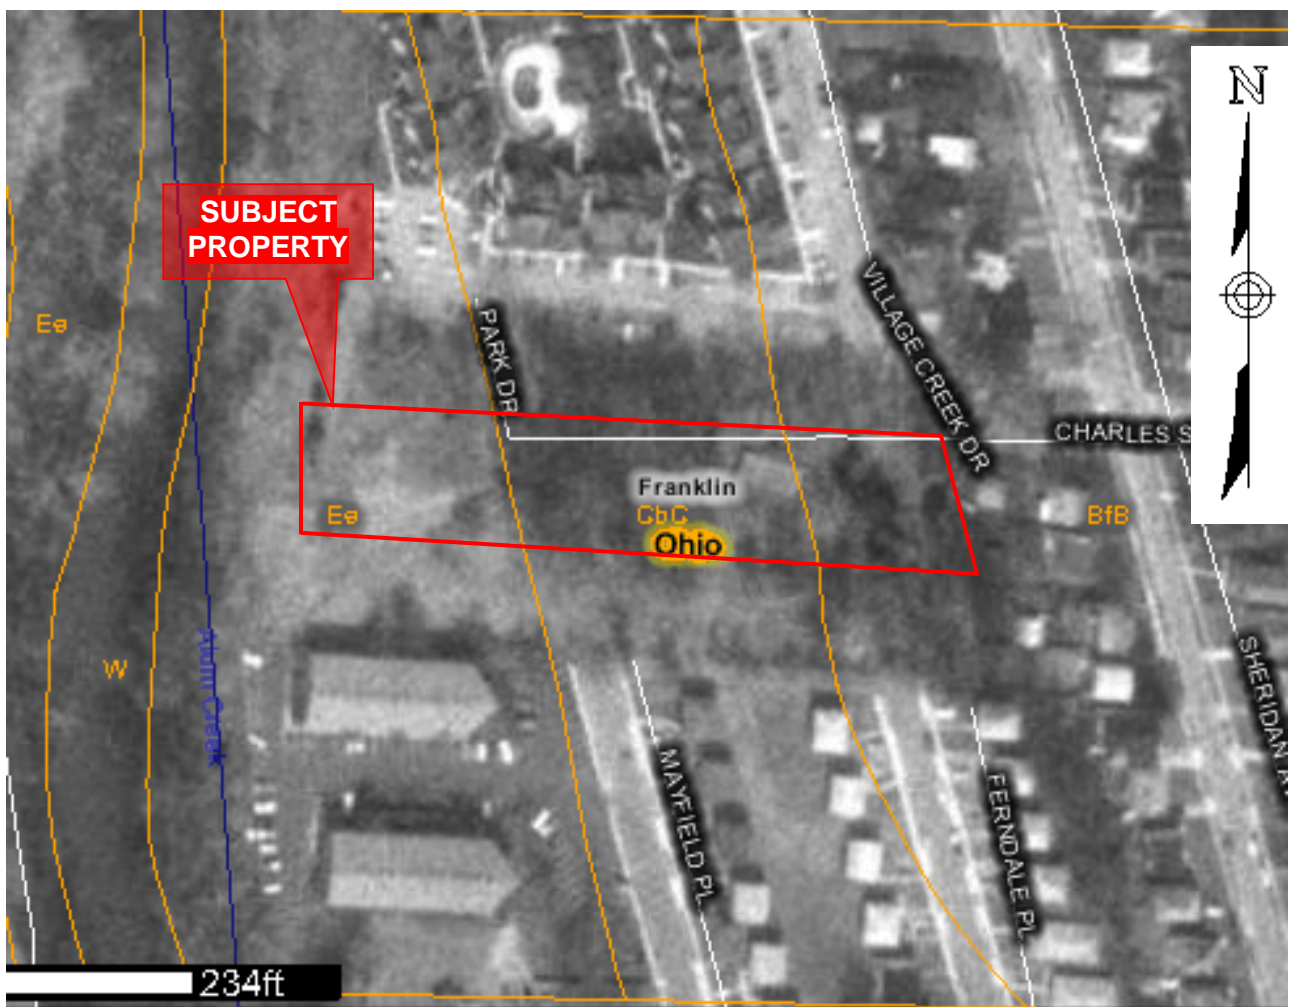
FIGURE 4 – Soil Map

The United States Department of Agriculture, Natural Resource Conservation Service identifies three soil types on the subject property: Bennington-Urban land complex, 2 to 6 percent slopes (BfB); Cardington-urban land complex, 6 to 12 percent slopes (CbC); and Eel silt loam, occasionally flooded (Ee). A soil map is presented in Figure 4. Descriptions of the soils are presented below:

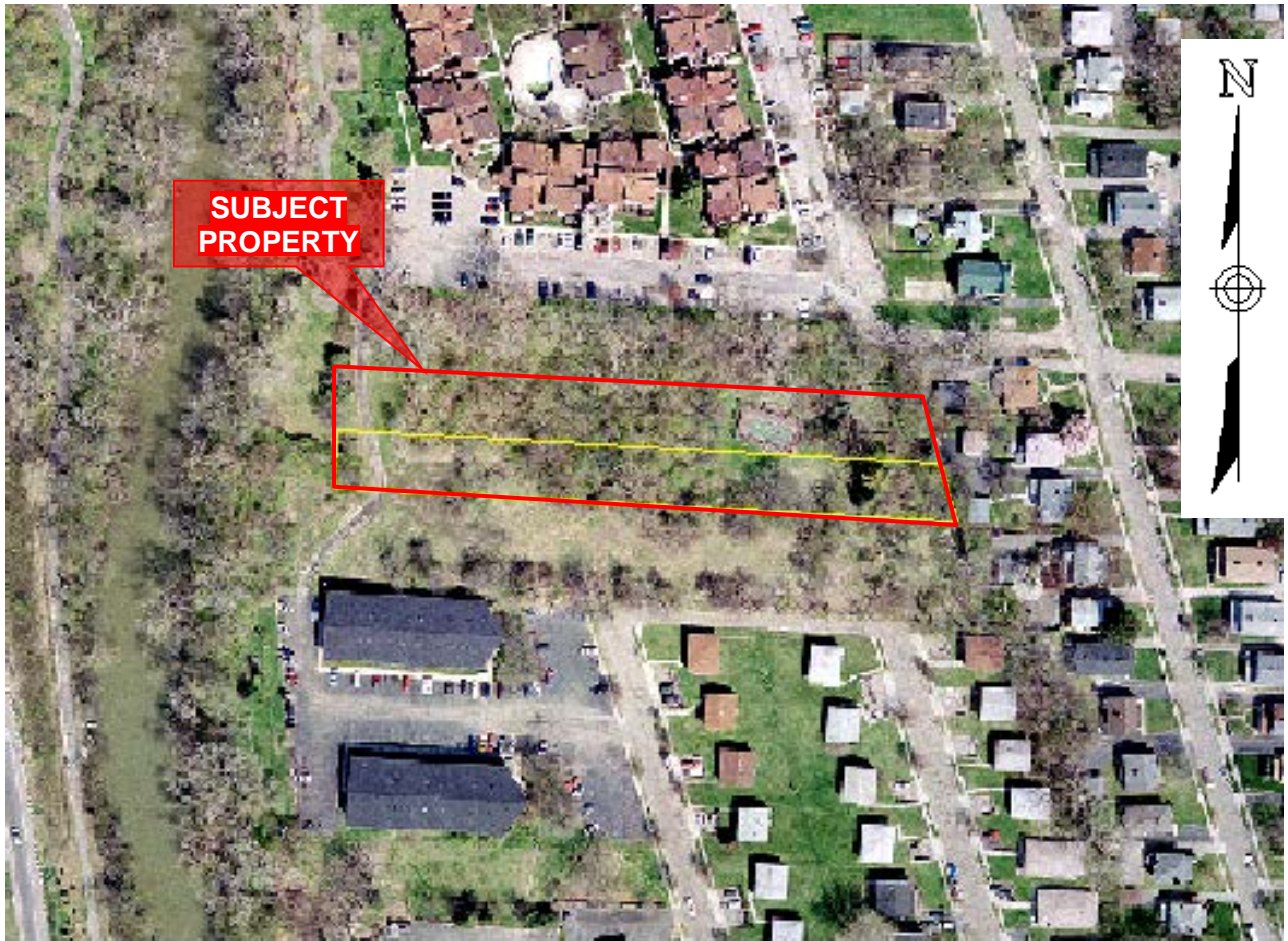
FIGURE 5A – 2004 Aerial Photo

Aerial photographs were available from 1938, 1950, 1957, 1964, 1972, 1980 and 1989 from the Franklin County Soil and Water Conservation District office, and from 1994 and 2004 from Internet resources. The photographs are presented in Figures 5A – 5I. A description of the subject property as it appears in the photographs follows.

Aerial photographs of the subject property and adjoining properties are presented in Figures 5A – 5I. Adjoining properties as they appear in historical aerial photographs are described below:

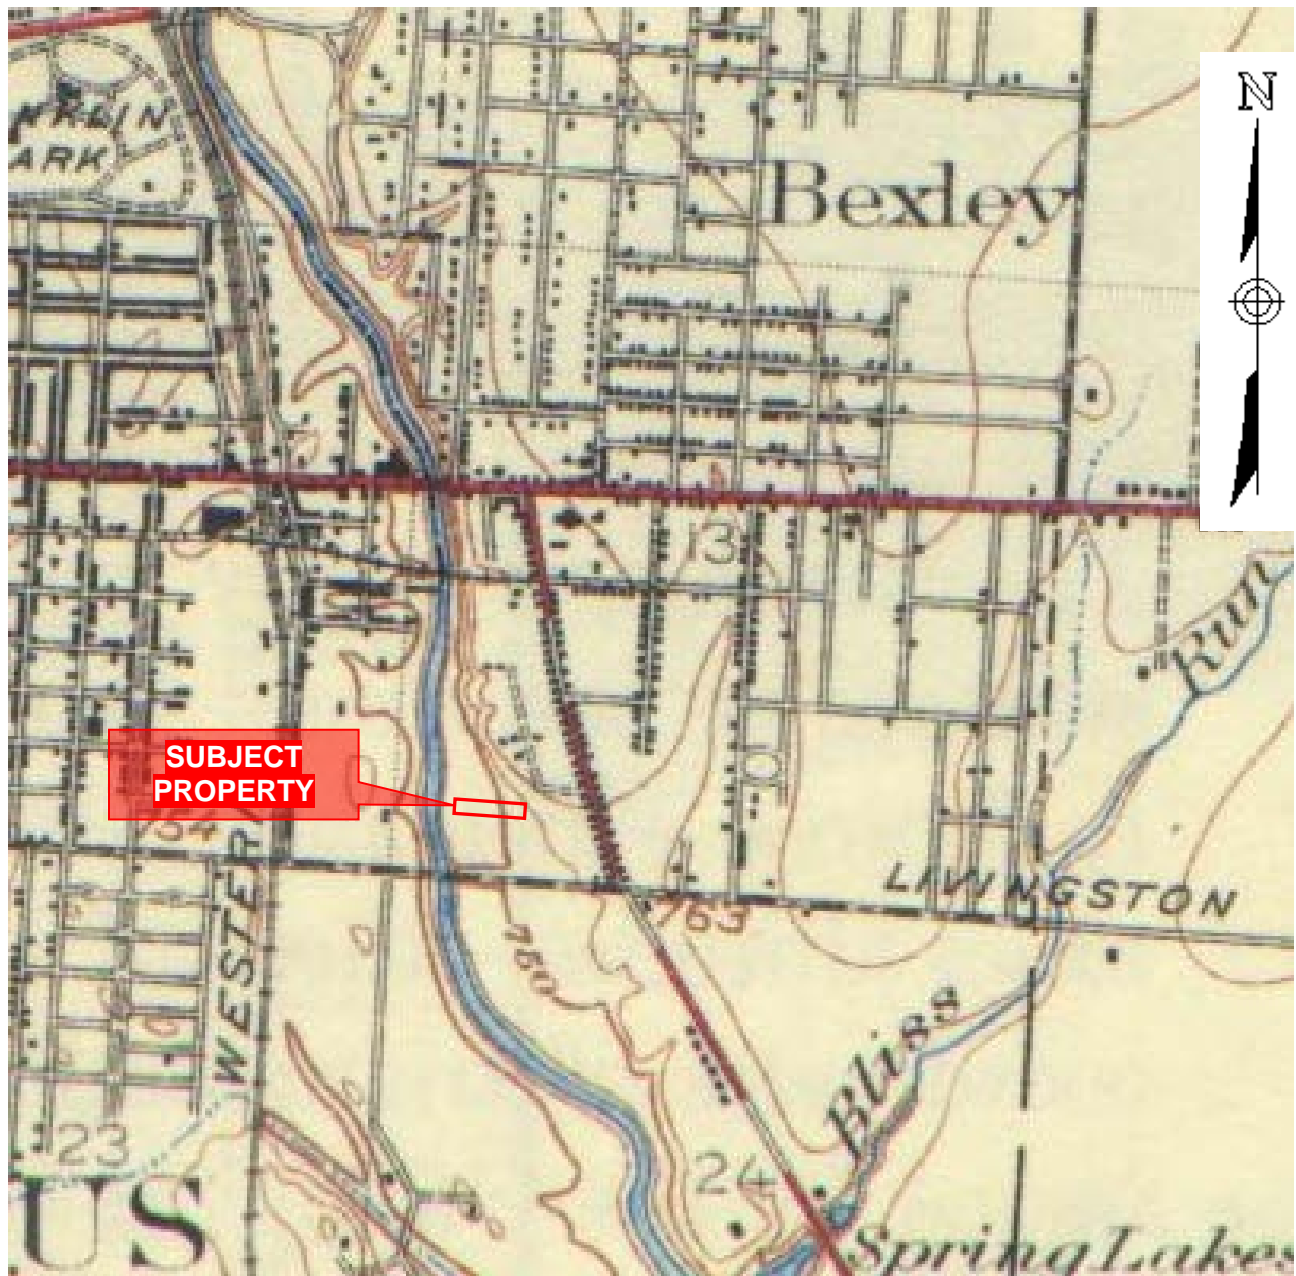
FIGURE 6A – 1925 USGS 7.5 Minute Topographic Map

Two USGS 7.5 Minute topographic maps dated 1925 and 1943 were available from Internet resources. The 1925 map shows no development on the subject property or on adjoining property. The 1943 map shows no development on the subject property. The maps are presented in Figures 6A-6B.

Two USGS 7.5 Minute topographic maps dated 1925 and 1943 were available from Internet resources. The 1925 map shows no apparent development on adjoining properties. Alum Creek is located further west of the subject property. An unimproved road and some residential development appear further north of the subject property. Livingston Road is located further south of the subject property. The 1943 shows Alum Creek is located west of the subject property. North and east of the subject property are built-up areas. Livingston Road is located to the south of the subject property. The maps are presented in Figures 6A-6B.
