PORCH RENOVATION  
 Wilson Residence  
 2404 Bexley Park  
 Franklin County Bexley, Ohio

EXTERIOR  
 ELEVATIONS

SHEET NO.  
 A401

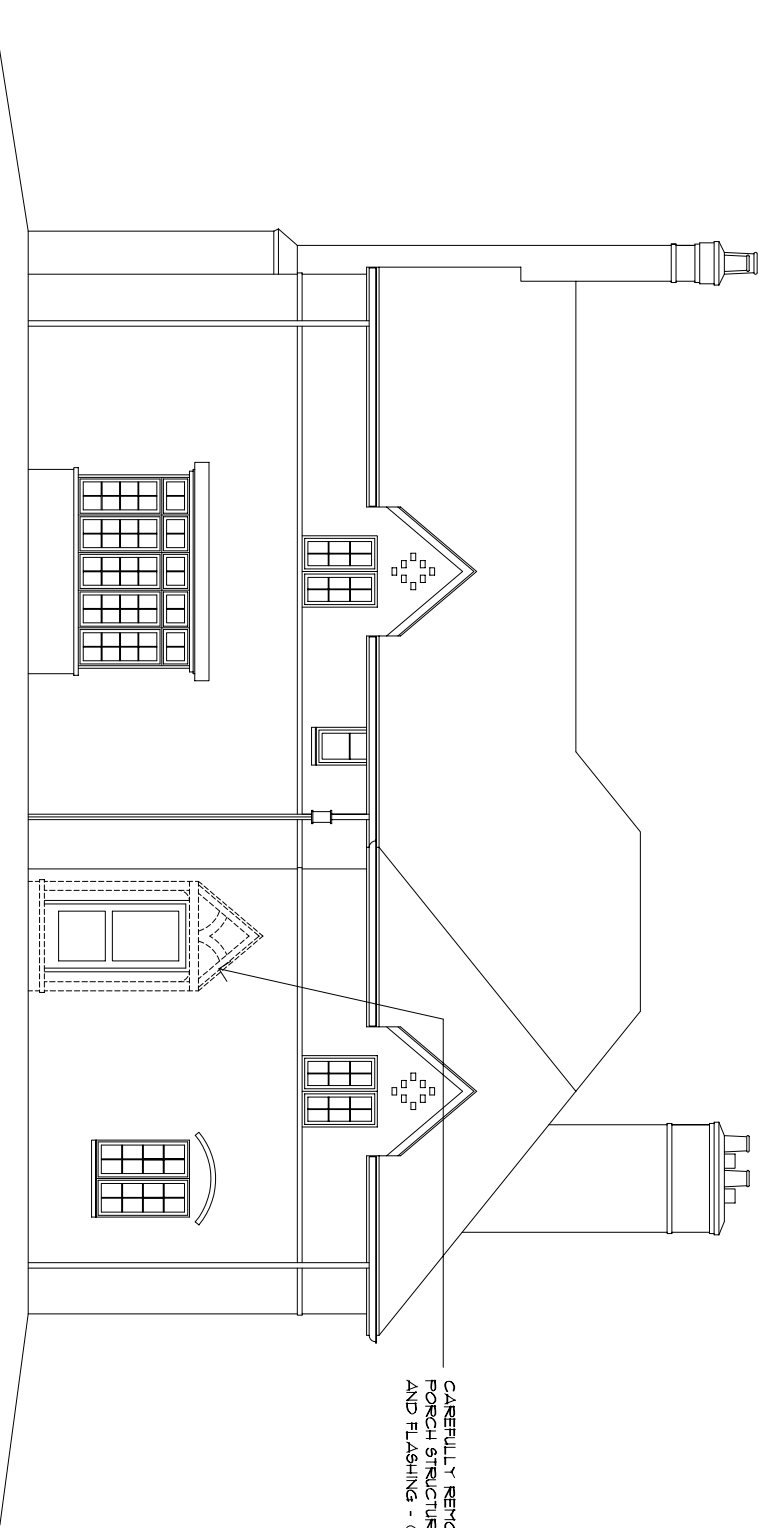
1 EXISTING SOUTH ELEVATION  
 1/4" = 1'-0"

CAREFULLY REMOVE EXISTING PORCH STRUCTURE, FOUNDATION, AND FLASHING - (SHOWN DASHED)

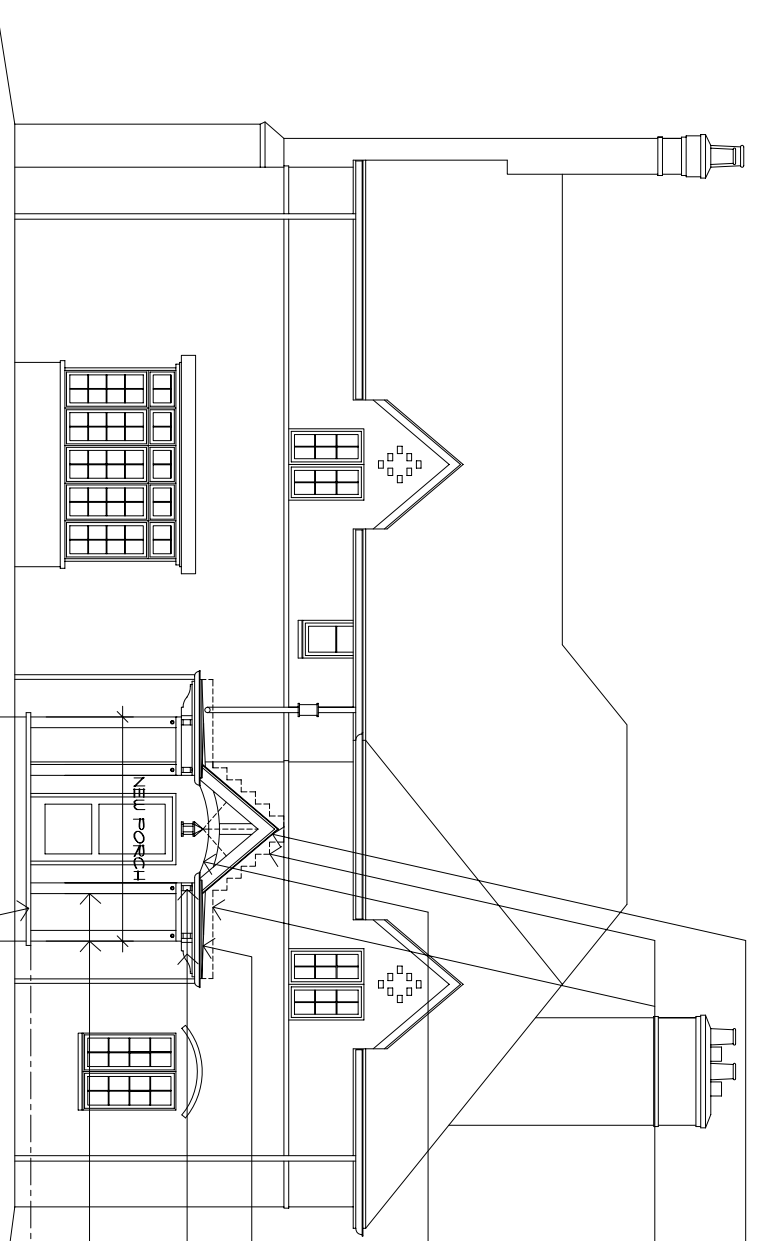
2 SOUTH ELEVATION  
 1/4" = 1'-0"

SLATE ROOFING SYSTEM ON  
 ICE DAM PROTECTION

COPPER STEP & WALL FLASHING  
 (CUT INTO EXIST. MORTAR)

6" X 6" ROUGH TIMBER RADIAL  
 BEAM (PAINT - COLOR BY OWNER)

FULLY ADHERED 20# EPDM  
 ROOF SYSTEM (TYP.)

3" X 10" SMOOTH OUTRIGGER  
 (PAINT - COLOR BY OWNER)

6" X 6" ROUGH TIMBER POST  
 (PAINT - COLOR BY OWNER)

MORTARED STONE ON 4" CONC.  
 MUD SLAB (SELECTED BY OWNER)
