ASTM E1527-13

Phase I Assessment Report

**Bexley Ferndale-Mayfield Properties
Ferndale Place & Mayfield Place
Bexley, Ohio 43209**

September 17, 2018

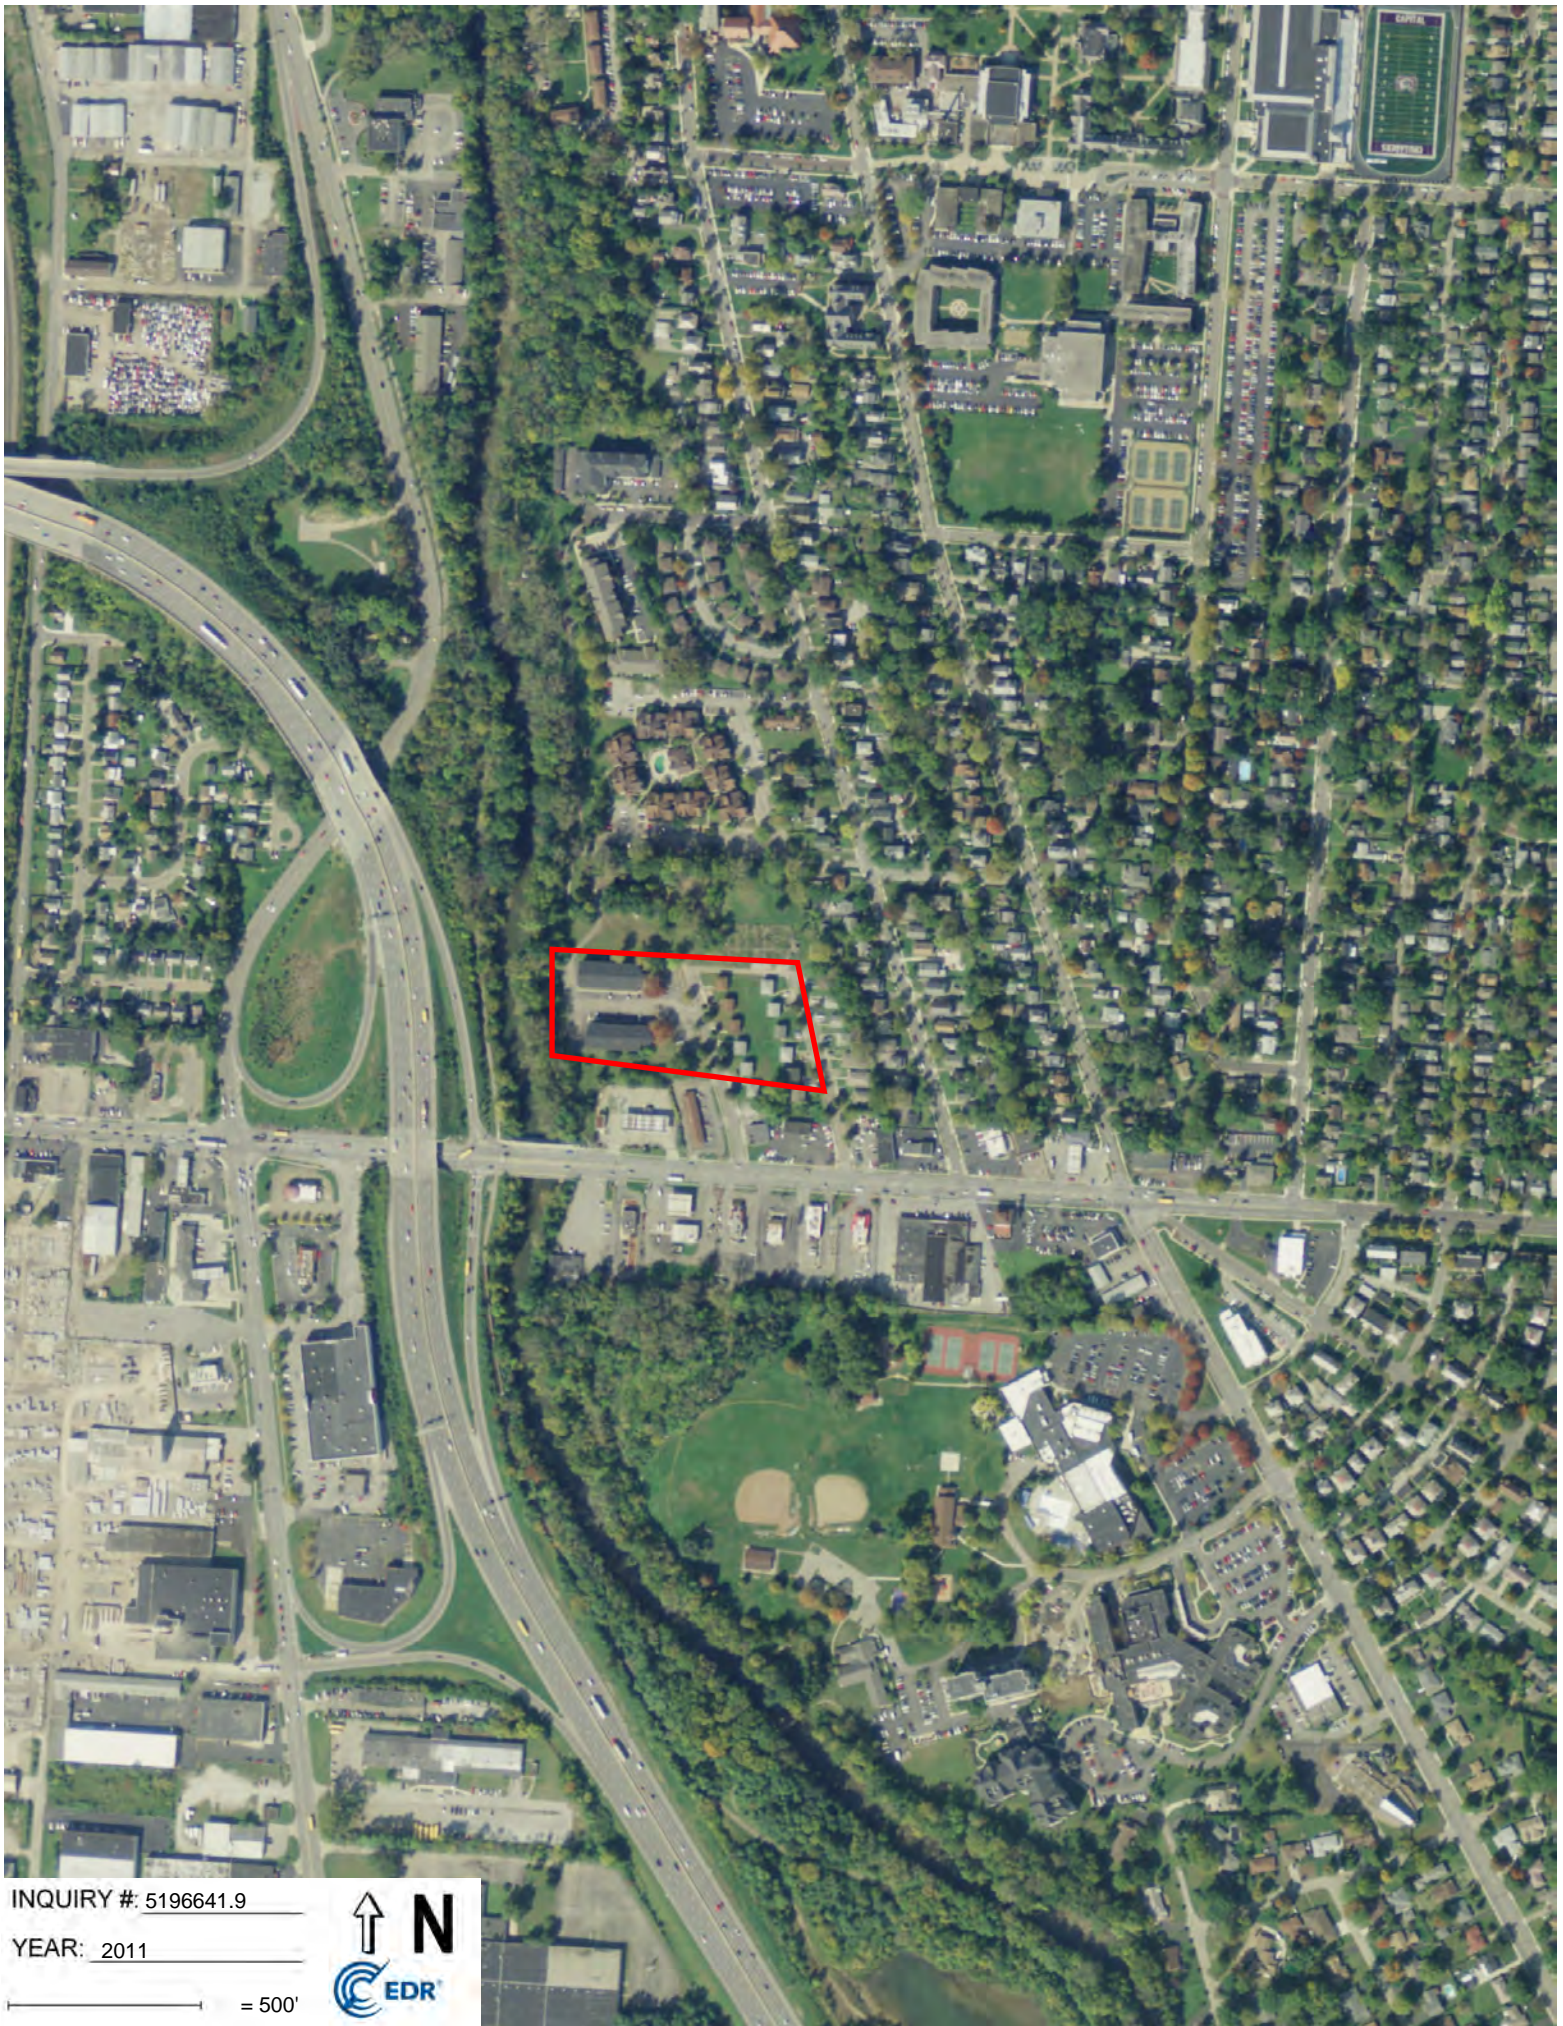
YEAR: 2011

The 2011 photograph shows no significant change from the 2006 photograph. However, the eastern half of the vacant, grassy field adjacently north appears to be actively utilized as a garden based on symmetrical rows of planting beds observed in the aerial.

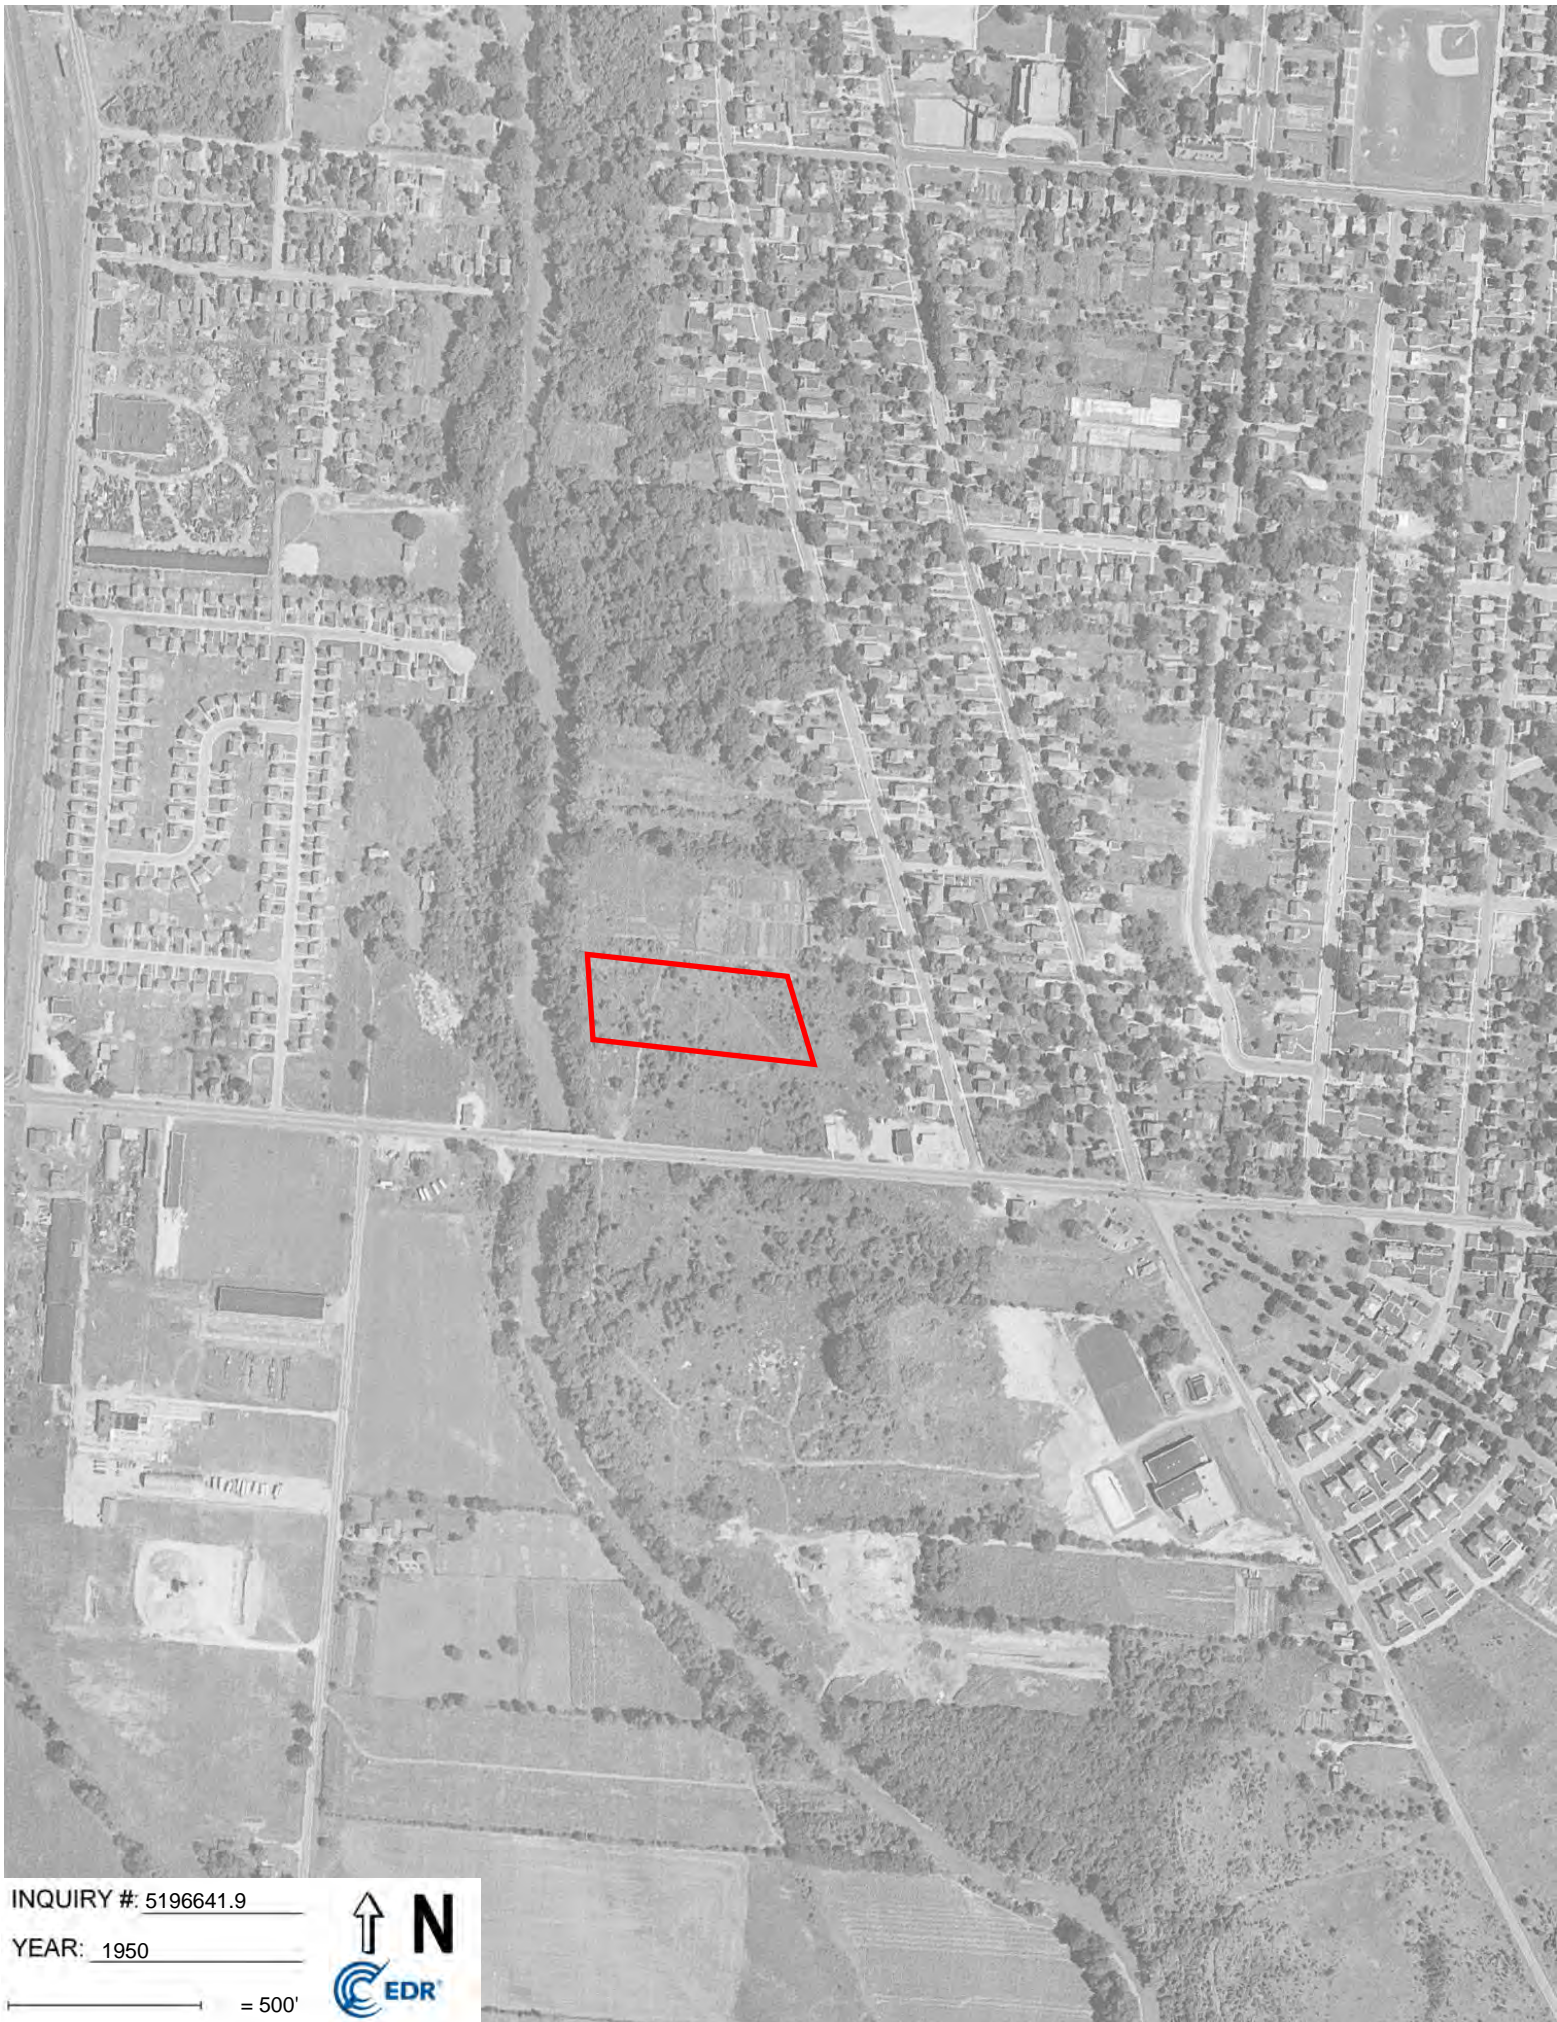
YEAR: 1950

The 1950 photograph shows the subject property as a vacant area covered with trees and vegetation. The land disturbance observed in the previous aerial is now covered up and has grown over with grass and trees. No structures are located on the subject property. Surrounding sites appear to be the same as observed in the 1938 aerial. It should be noted that the large disturbed area south of E. Livingston Avenue (south of the property) is also overgrown and similar in its appearance to the subject property. It appears that whatever operations or disturbance occurred at the property were also occurring south of E. Livingston Avenue based on the 1938 and 1950 aerial photograph.

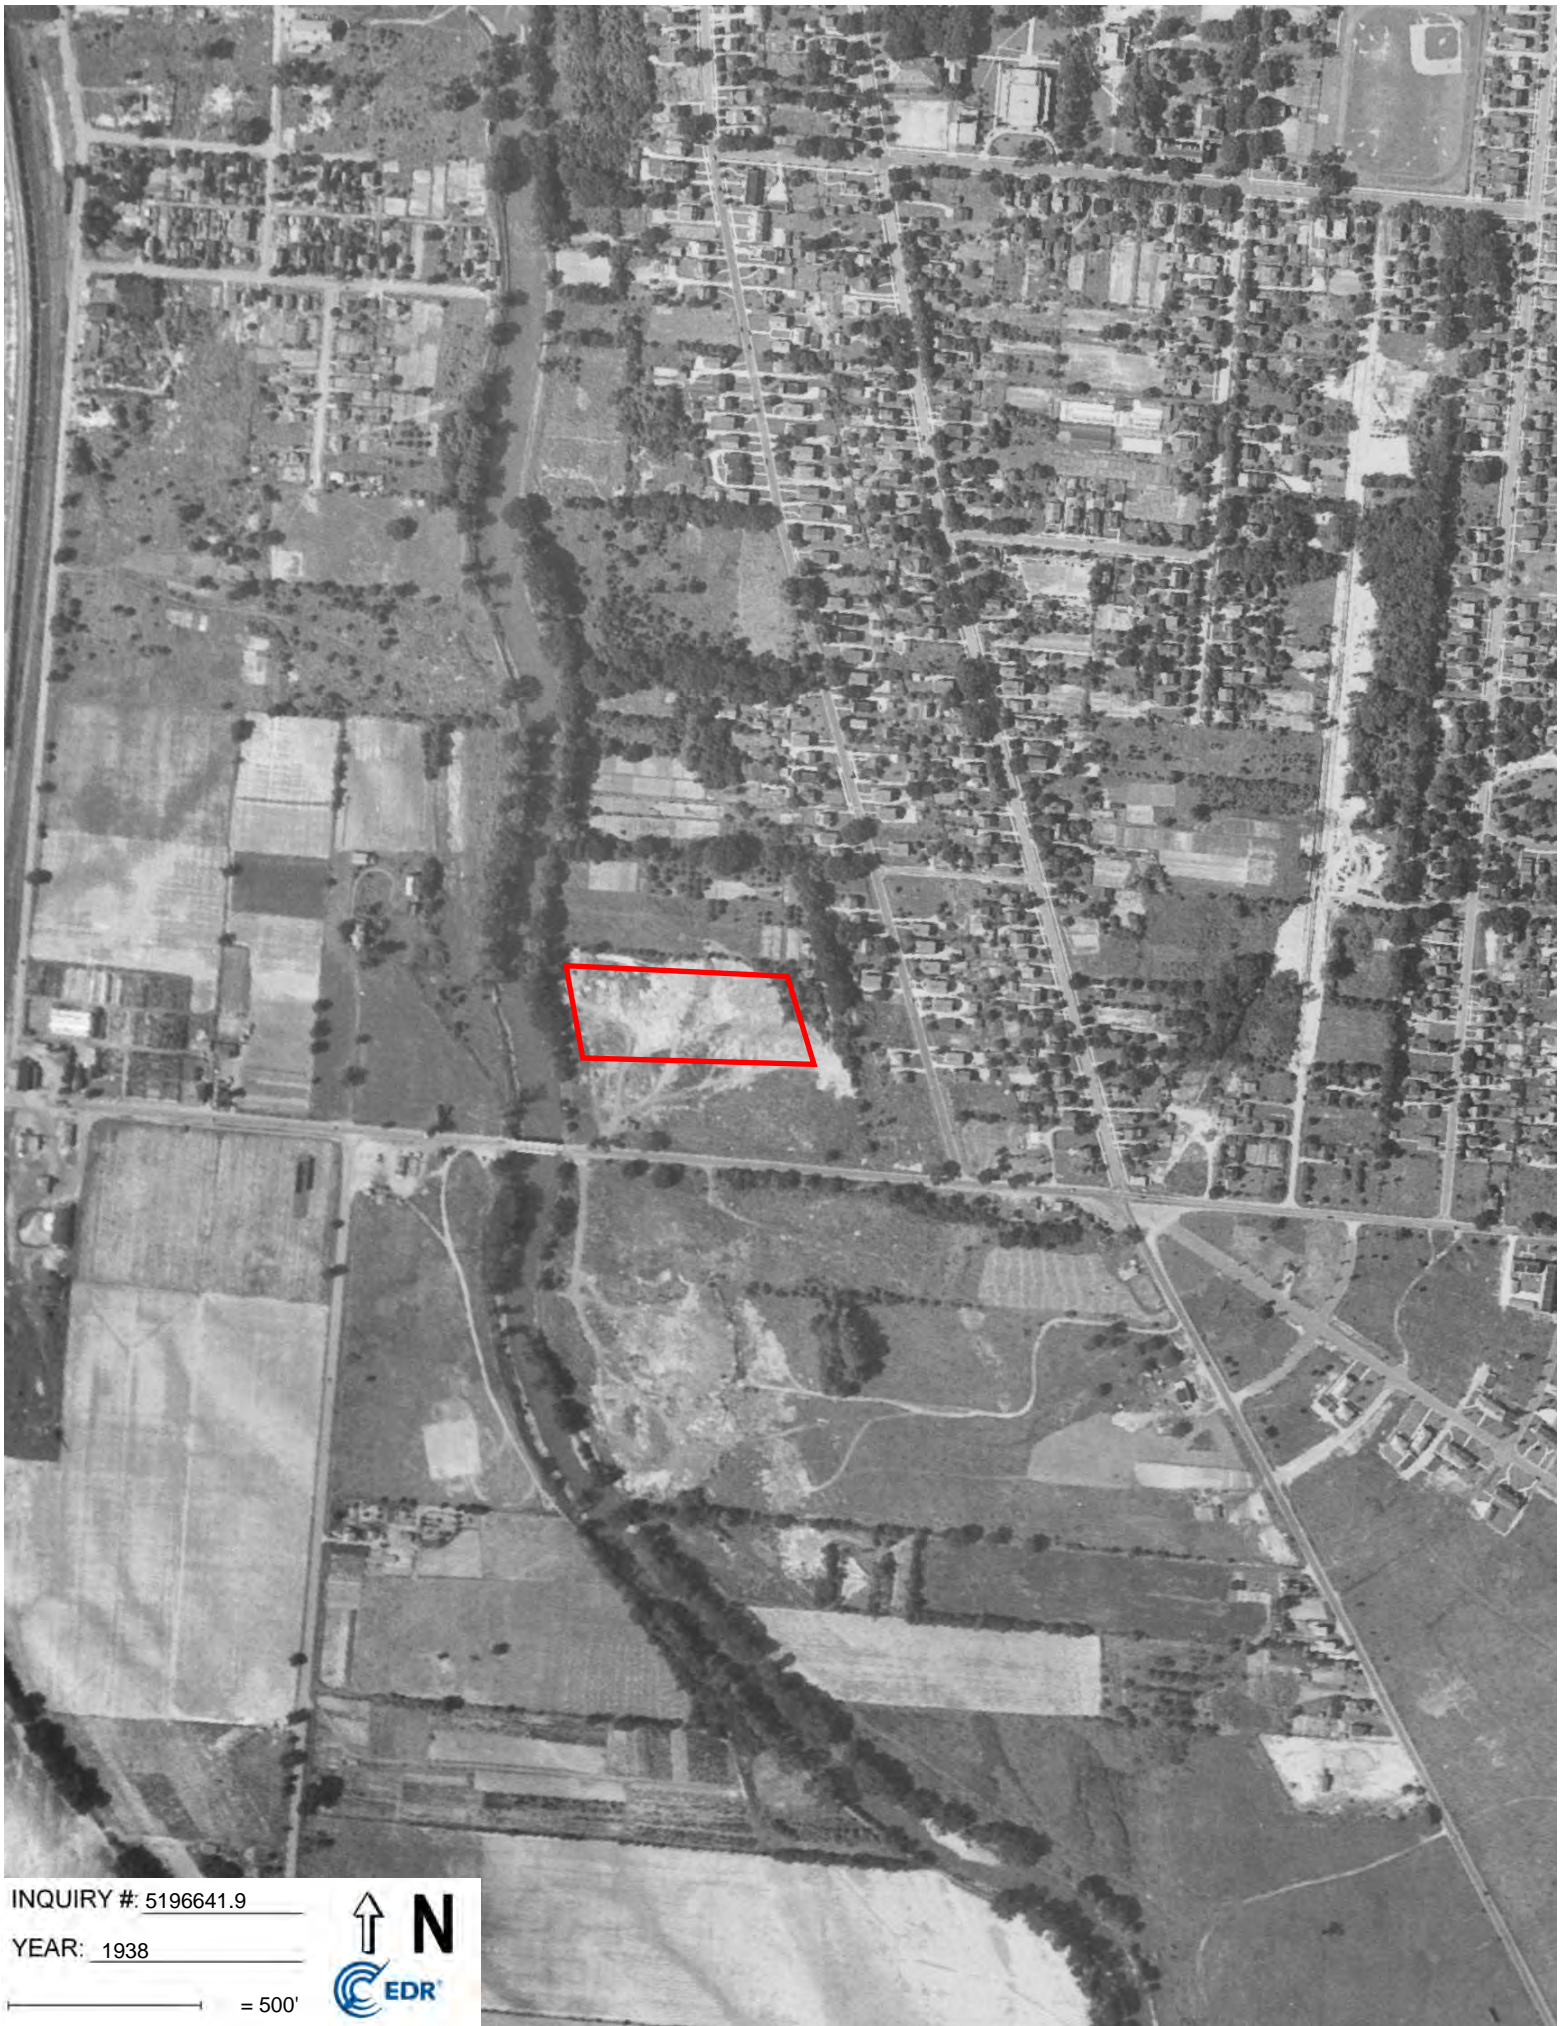
YEAR: 1938

The 1938 photograph shows the subject property as heavily disturbed. A road enters the subject property from the north side of E. Livingston Avenue which then branches off into multiple access routes. Each access route appears to lead to a large overarching area of disturbed land. This disturbance and the pattern of access roads is consistent with historical areas of dumping or landfills. Adjacent east of the subject property area are residential homes, and to the north is farmland and vacant fields. A disturbance of a large area of land, similar to that observed on the subject property, is seen on the south side of E. Livingston Avenue as well.

The earliest available record concerning the subject property is an aerial photograph from 1938. At that time, the subject property appeared to be the location of a landfill or dumping site based on the photograph. No structures were observed on the property and the streets (Ferndale Place along with the Mayfield Place) which occupy the subject property did not exist prior to the late 1950s to early 1960s. The earliest record showing structures on the subject property is from an aerial photograph taken in 1964, which shows multi-family residences developed in their current configuration on the eastern portion of the site, and two (2) apartment buildings developed in their current configuration on the western portion of the property. The property since then has appeared to contain the same multi-family residences in a row along Ferndale Place, and the same two (2) apartment complexes along Mayfield Place. According to historical records, between 1964 and 2011, the subject property has remained the location of multi-family residences and apartments throughout the history of the site. Adjacent north of the subject property is the Bexley Community Garden and newly developed recreational soccer fields along with an associated parking lot. Beyond the recreational area is an apartment complex along Charles Street. Adjacent east of the property is a residential neighborhood, directly west of the property is Alum Creek, and to the south are multiple commercial businesses which are situated along E. Livingston Avenue.

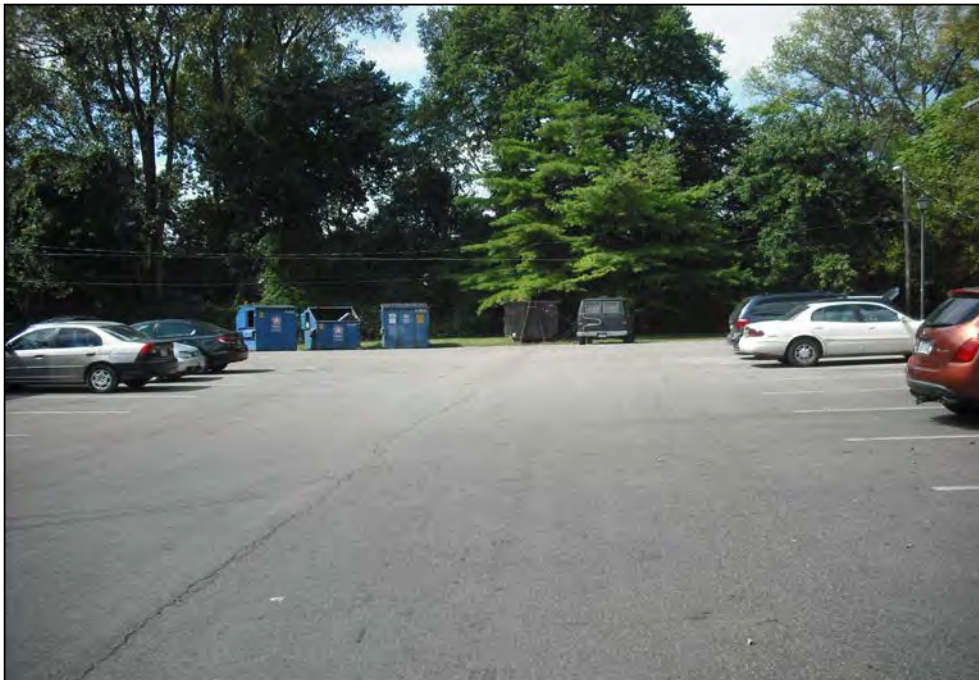
View west of the shared parking lot between the two on-site apartment buildings. Three domestic waste dumpsters present with benches and a path leading down to Alum Creek are located in the background.

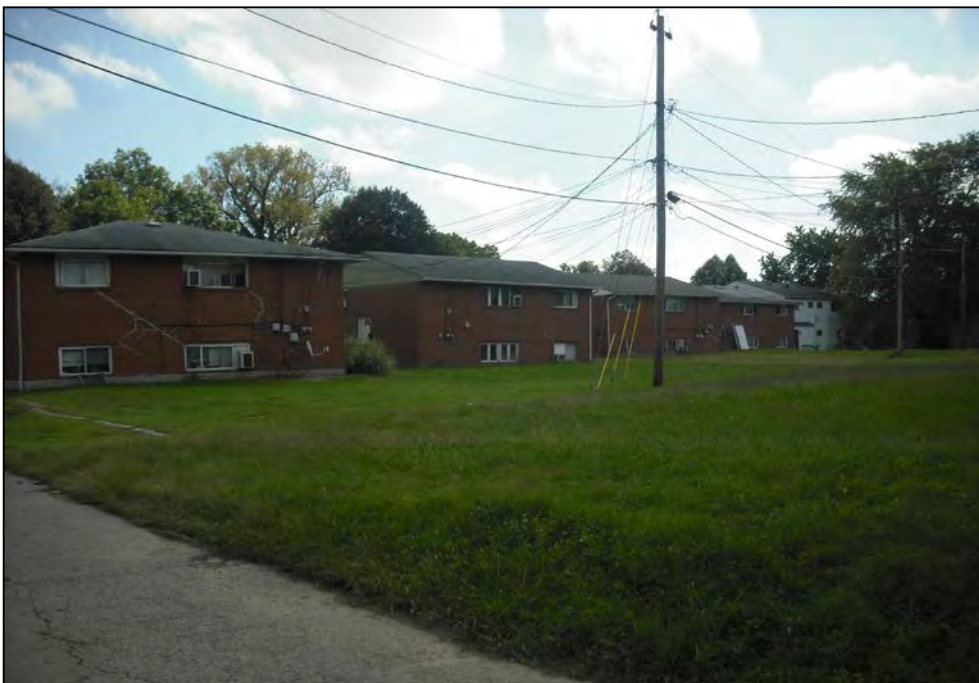
View of the multi-family residences located on the eastern portion of the subject property along Ferndale Place. Note the cracking and patches in the building foundations and uneven terrain in the shared yard space.

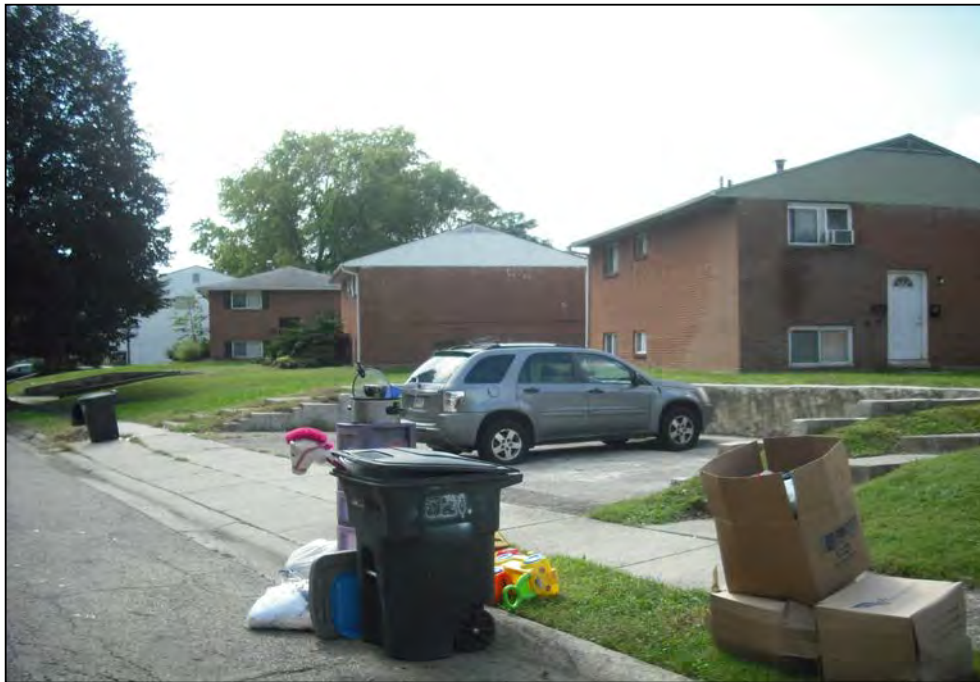
View south along Ferndale Place of the on-site multi-family buildings and parking spaces servicing the dwellings. Note the cracked concrete and uneven terrain of the walking paths leading to the on-site buildings.
